L634-
A.10.26

To: **After Sales Official Network**
Subject: **Lambda sensor cable tie replacement**
Date: **21/04/2026**
Pages: **4**

Campaign name:
Lambda sensor cable ties replacement

Model:
Temerario

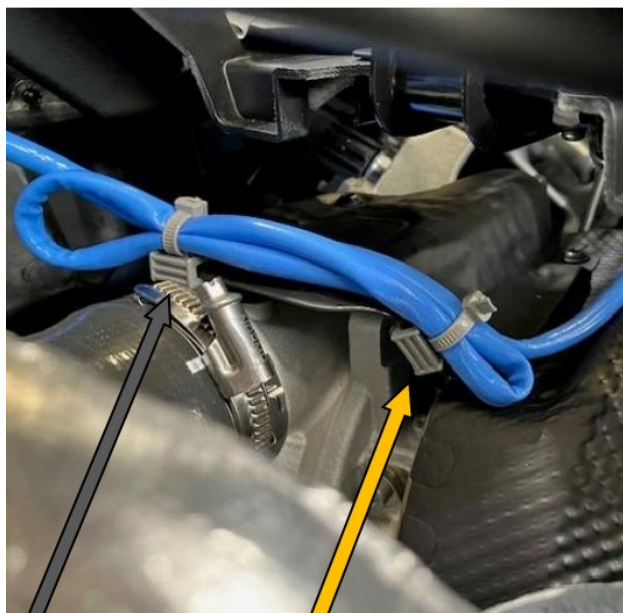
If the car has the following configuration with two cable ties that holds lambda sensor tie for each side, please select operation A. No more operations is necessary to do; in other cases please proceed with operation B

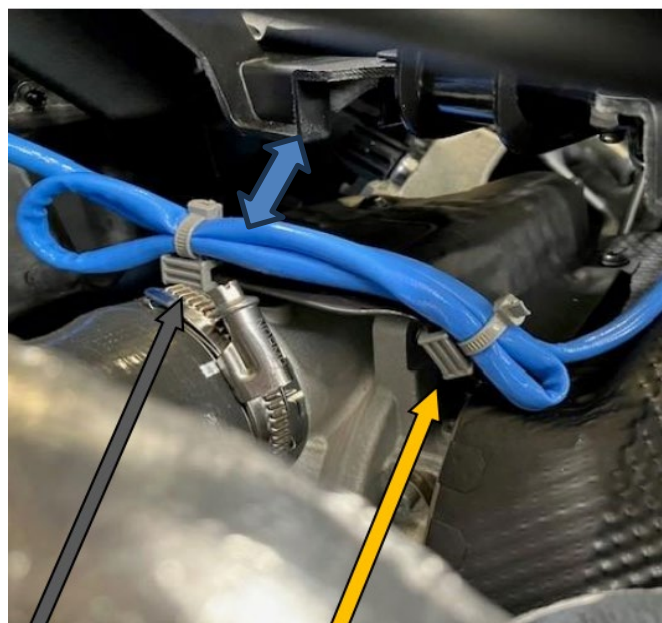
During ongoing product monitoring, Automobili Lamborghini S.p.A. requires verification and possible reworking of lambda sensor cable ties

Then for both version install the two cable ties 6R0971497 for each side carefully to keep distance with the hinge and heat resistant shield

On the right side stay rear by the vent pipe
