L634-
A.11.26

To: After Sales Official Network
Subject: BL26.5.1 Update PN 4LA990100D REV0152
Date: 20/04/2026
Pages: 13

Campaign name:
BL26.5.1 Update PN 4LA990100D-REV0152

Model:
Temerario

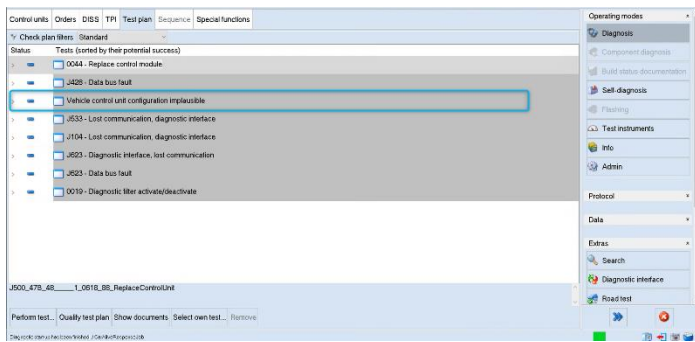
23. Check the DTCs from the ECU 0019: If the DTC “**C12A5F0: Vehicle electrical system configuration implausible**” is present and is in “active” status, please perform the GFF “**Vehicle configuration implausible**” from the Test Plan, as shown below:

Entries in event memory	
Number:	C12A5F0: Vehicle electrical system configuration implausible
Error type 2:	active/static
Symptom:	8519691
Status:	00001001

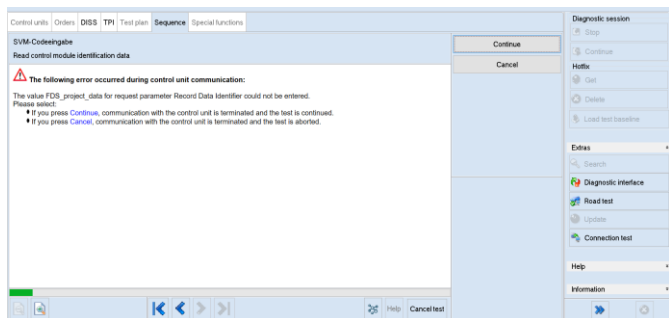
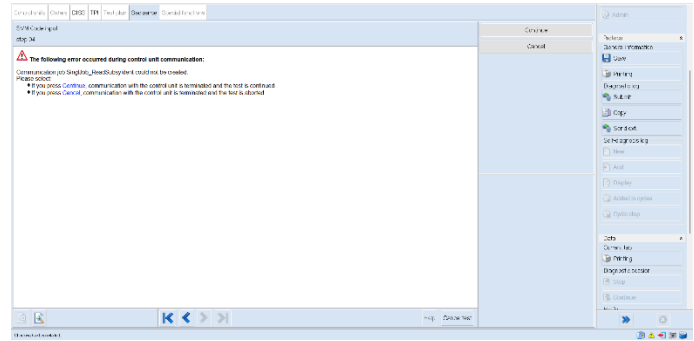
29. If the following error screen is displayed, the error does not indicate an issue, please press “Continue” and continue with the campaign.

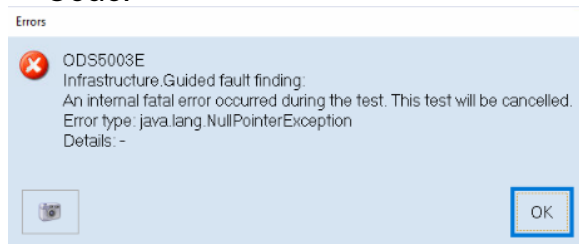
- **8118** → please perform a sleep cycle. Be sure the control unit 5F has been updated to correct software (see previous steps). Check the software level via 5f – control unit identification and compare it to the reference table. Repeat SVM code and contact Technical Support if not resolved.
- **8037** → Please check your O.D.I.S Service version and hotfix as indicated in “Preliminary operation” section.
- **9999** → for the owners of the new D3 Edge Box, please refer to the informative bulletin Bl.08.24 to check the correct O.D.I.S Service connection setup.
- **ODS5003E** → If the following screen appears please close and repeat the SVM-Code.

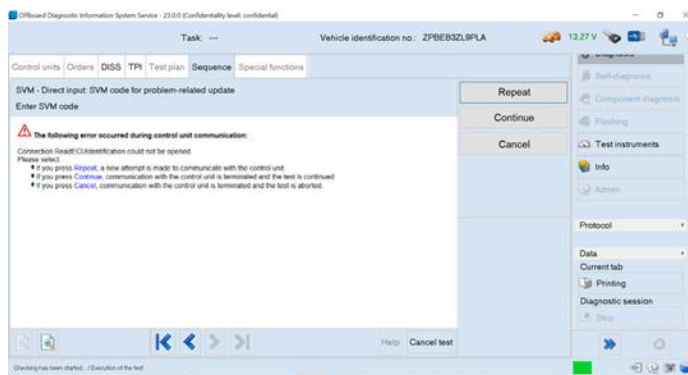
- A. If the following error screen is displayed, abort the guided function by clicking on “Cancel Test” and contact Technical Support.

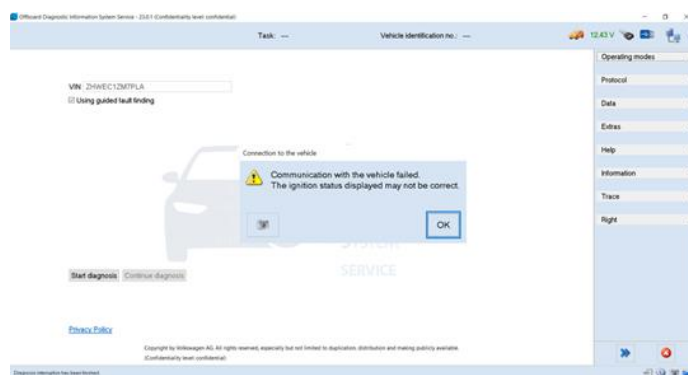
- B. If an error is displayed that regards the hardware interface, and the "connection to vehicle" and "key state" icons appear as shown in the figure below:

- Click “Cancel”;
- Repeat installation of the interface VAS6154/6154A/6154B for the instructions in procedure (*) “Checking the VAS 6154”, selecting the right-hand “Extras” menu in O.D.I.S. Service and clicking on the “Diagnostic interface” button.

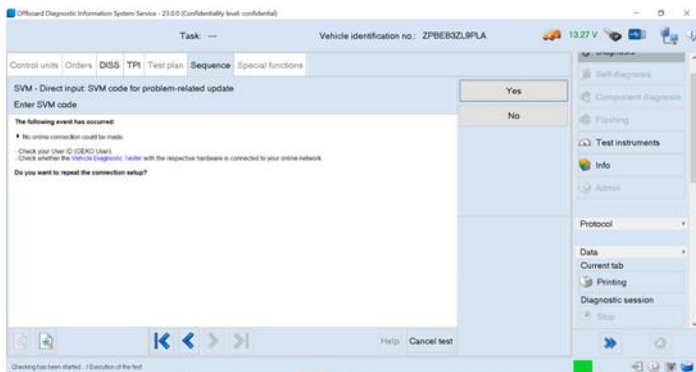
C. If the following connection error is displayed like in the following example screenshots:

- It is not possible to connect to the central server; check that your laptop is correctly connected to the Internet and retry by clicking on “Yes” or “Done/continue”, as appropriate.

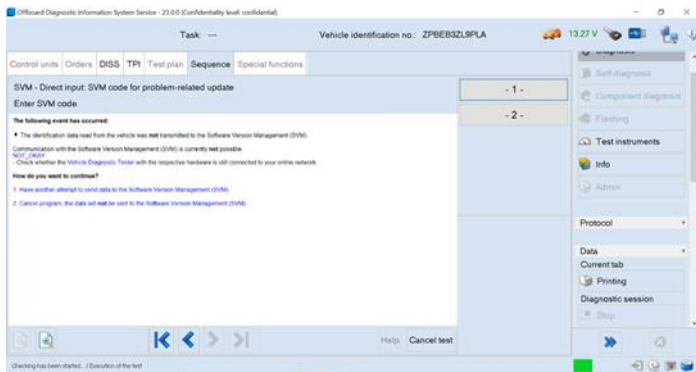
D. If the connection is dropped during the target/actual comparison during the SVM procedure:

- It is not possible to connect to the central server; check that your laptop is correctly connected to the Internet and retry by clicking on “1”.
