Insufficient Heating Output Due To Broken Refrigerant Line Between Refrigerant Compressor And The condenser (Hot Gas Line)

Topic number	LI83.20-P-076623
Version	5
Function group	83.20 - Heating
Date	5/5/26
Validity	EQA (H243), EQB (X243)
Reason for change	Attachments

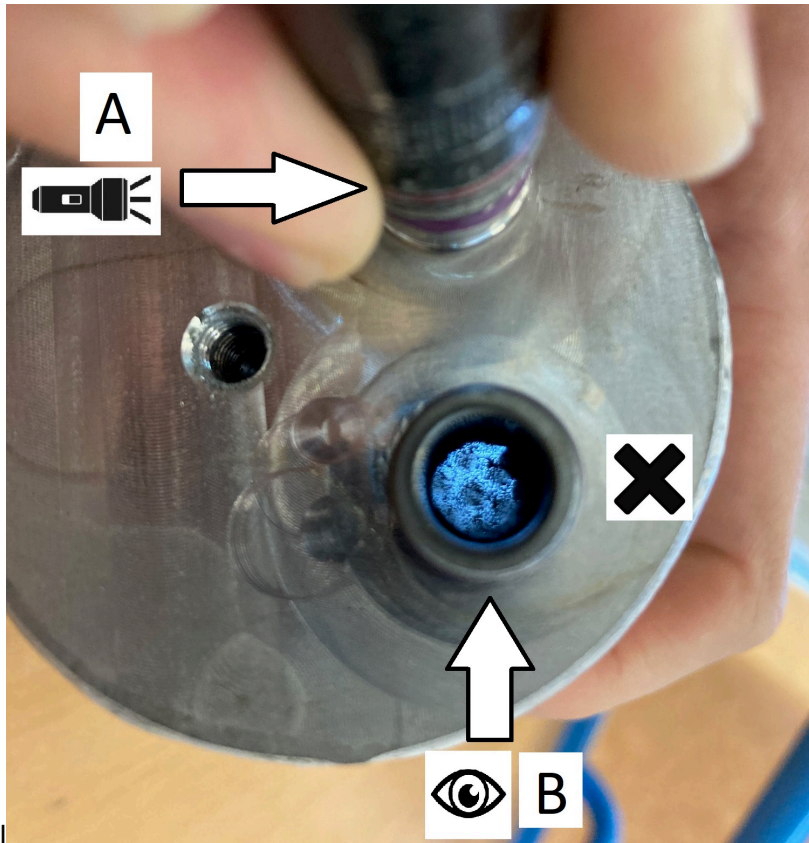
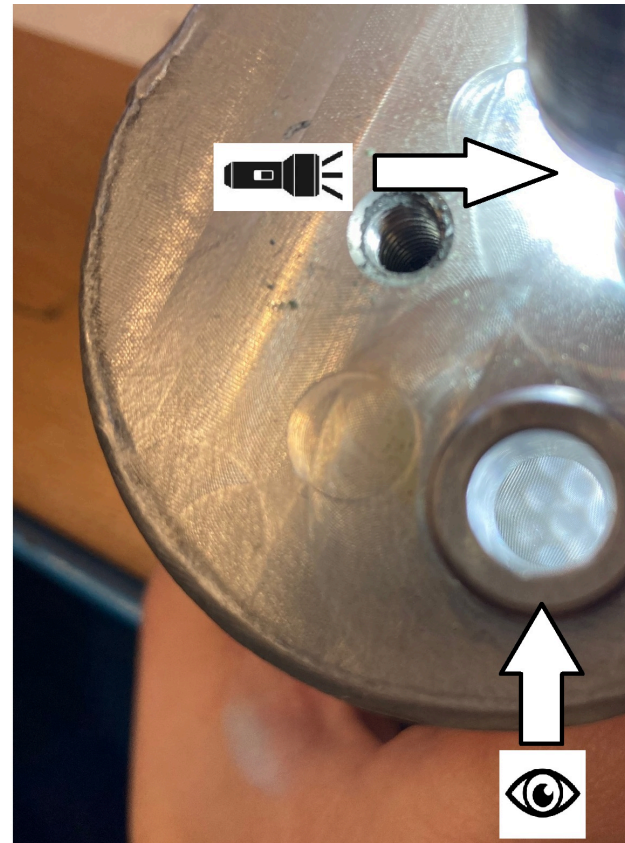
2. Check dryer cartridge at condenser for particles: Remove dryer cartridge, illuminate inlet of dryer cartridge using flashlight (A), and examine filter screen through outlet of dryer cartridge (B) -> see comparison picture bad/good
