718 GTS 4.0 - Brake Booster (Power Brake) Warning in Instrument Cluster

Models	Model Year	Model Type	VIN Range	Vehicle-Specific Equipment
718	2021 - 2024	982160 982360 982370	n/a	n/a

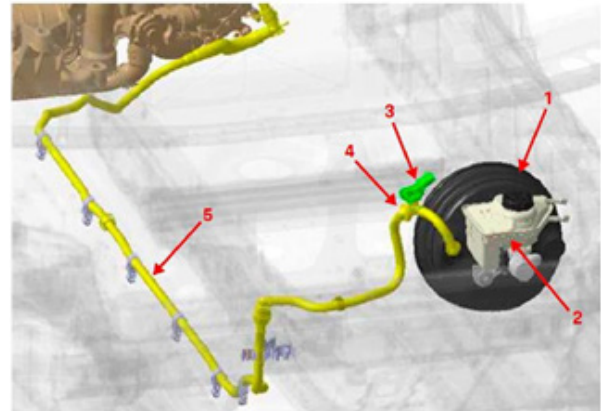
The value of the vacuum line pressure sensor (3 in Figure 1 below) upstream of the brake booster is stored immediately after Terminal 15 is activated. The value is recorded again after 1.5 seconds. Fault P055600 sets if the difference between the two values does not meet or exceed the threshold defined by the DME.

Although this fault is possible at any altitude, it is more likely to occur at higher altitudes due to the lower ambient pressure.

A software solution is available as of PIWIS Tester release 42.900.010.
