ASA3 – Re-Program Reversing Camera Control Unit and, if necessary, Replace Reversing Camera and Surround View Cameras (Recall Campaign)

Model Year: **As of 2024 up to 2026**

Model Line: **Macan Electric (XAB)**

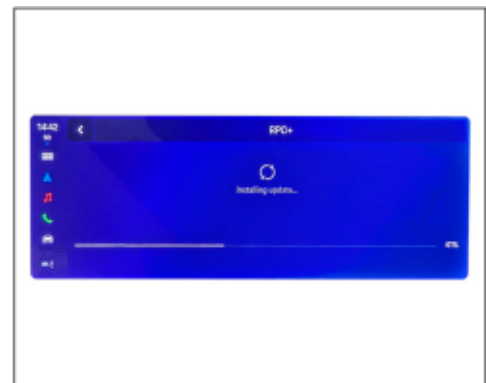
Update progress on central display
