**Windshield Water Ingress in the Area of the Front Overhead Console (34/26)**

Model Line: **Macan (XAB)**

Model Year: **As of 2024 up to 2026**

Concerns: **Windshield**

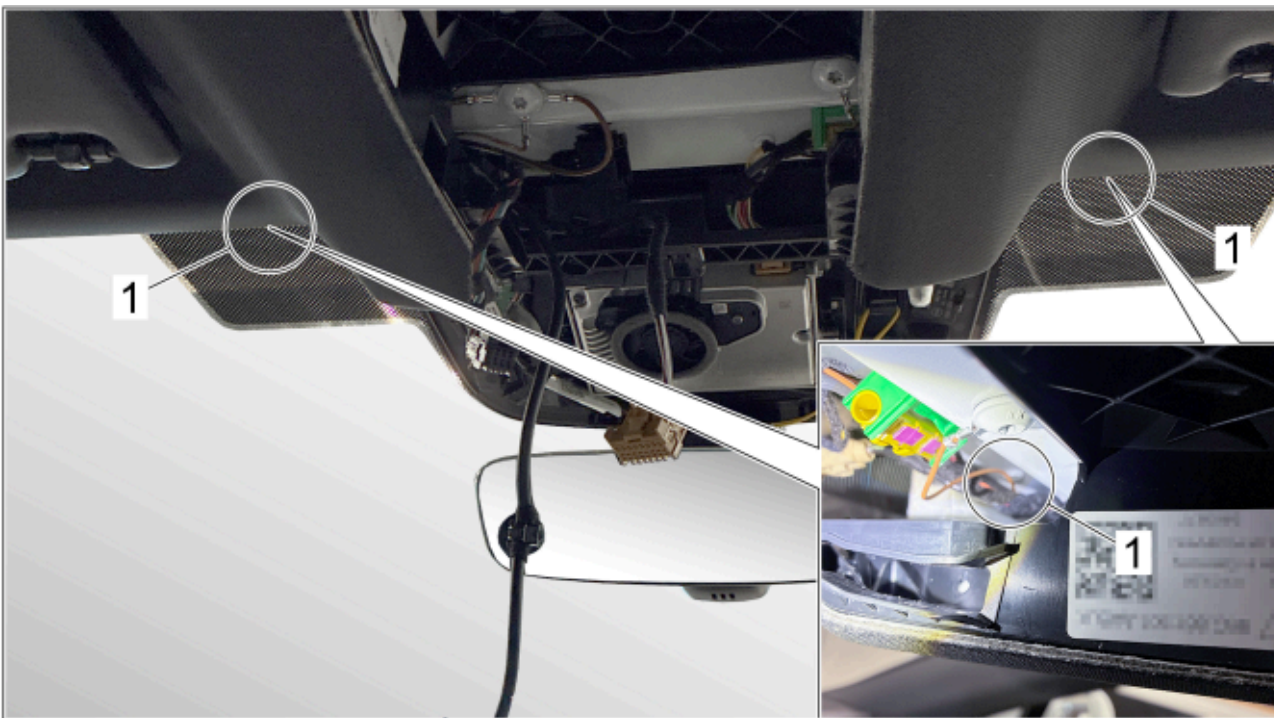
Bonding test area

- 4 Check and evaluate bonding at the rivet points ⇒ *Bonding test area -1-* in the front overhead console area.  
 The test takes place through the opening of the overhead console. Lift roof trim panel **slightly** in the windshield area if necessary.

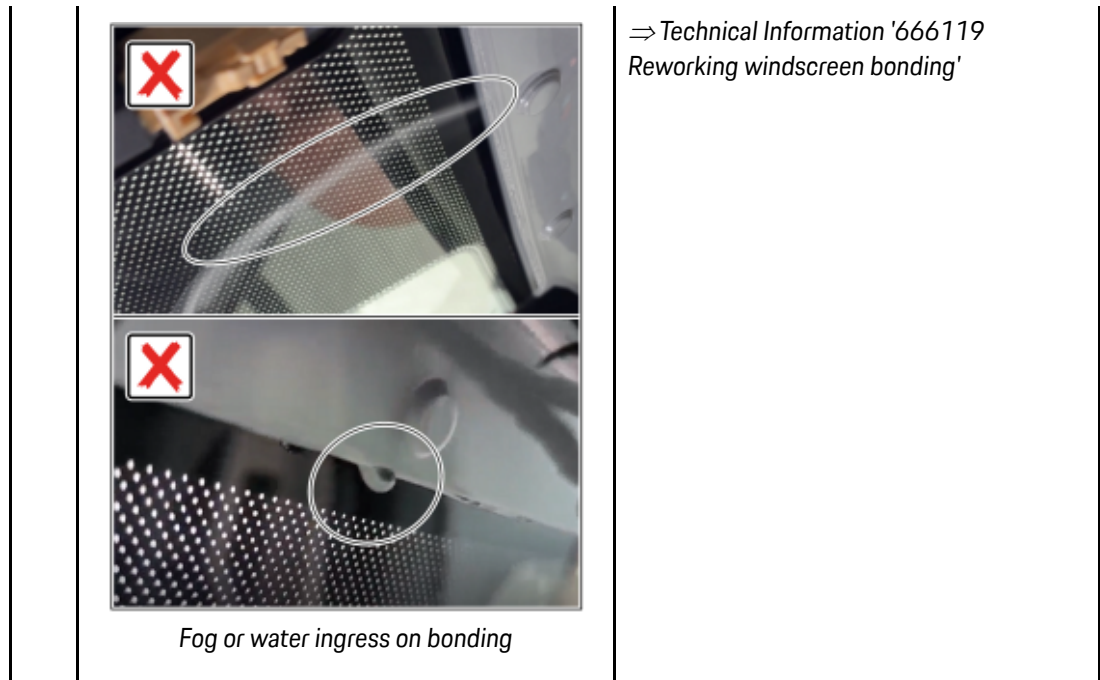
| Assessment | | Action |
|---|---|---|
| (x) | Fog or water ingress ⇒ <i>Bonding test area -1-</i> is detected in the area of the riveting points.<br>⇒ <i>Fog or water ingress on bonding</i> | Windshield <b>bonding is not OK.</b><br>Continue with: |

- Work Procedure: 1 Remove windshield, but do not cut back residual adhesive material yet.  
⇒ Workshop Manual '641219 Removing and installing windscreen'
- 2 Check residual adhesive material on the windshield and body and ensure that there is full-surface adhesion to the windshield and body.  
If this is not the case, remove loose residual adhesive material in accordance with the repair instructions.

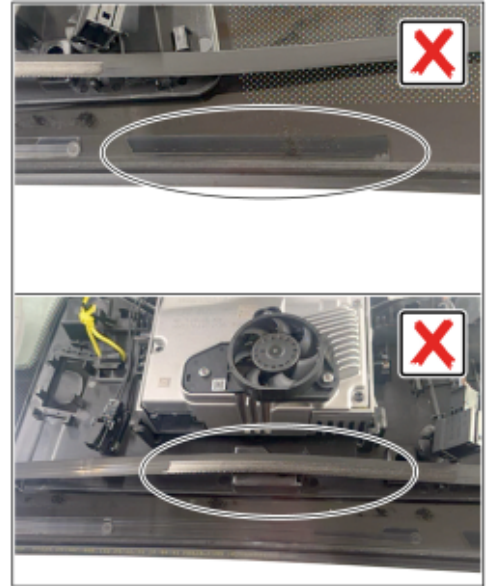
It must be ensured that there is a full bond between the residual adhesive material and the windshield or body.

Windshield adhesion is not OK

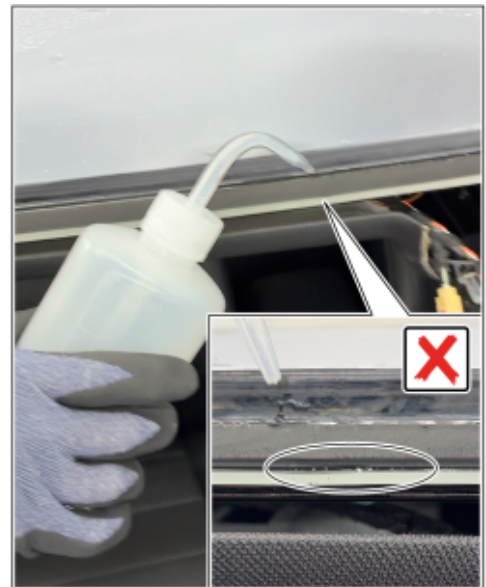
Body adhesion is not OK

Before installing the windshield, cut back the residual adhesive material on the body and windshield in accordance with the repair specifications.  
⇒ Workshop Manual '6X70IN Working with Porsche 2-component window adhesive Information'

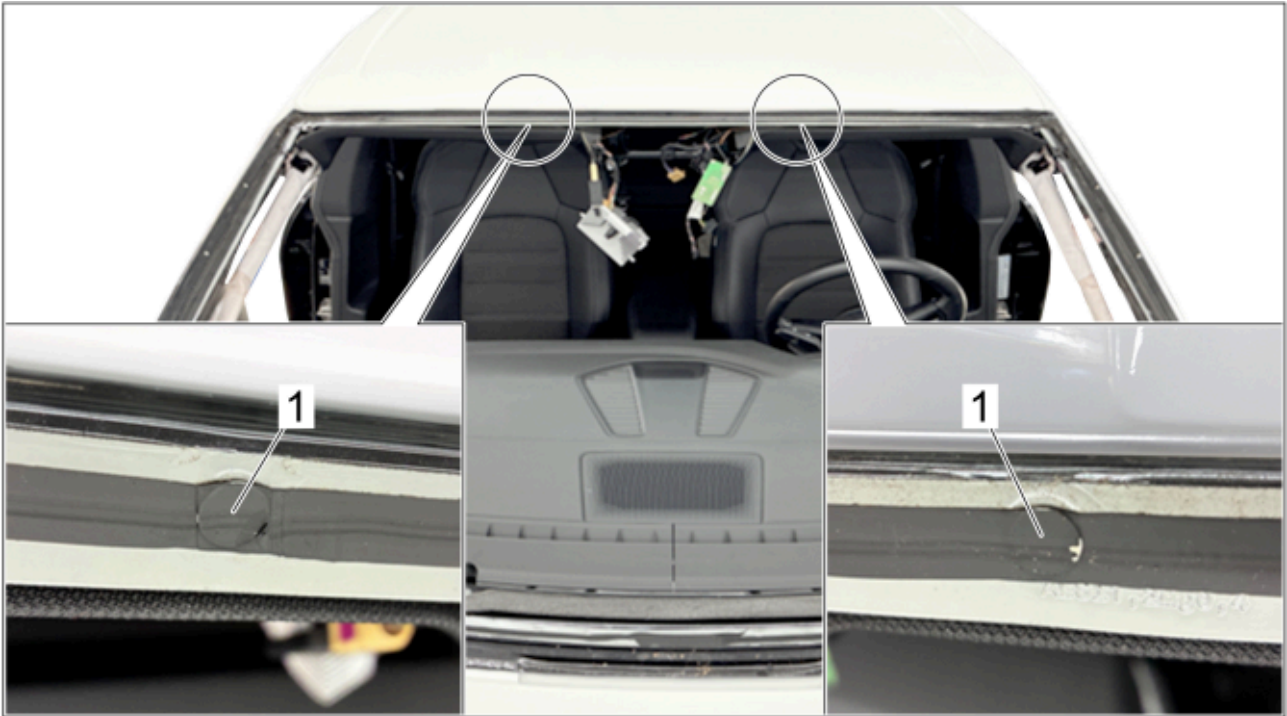
Cause: In rare cases, a leak can occur due to faulty bonding of the windshield in the overhead console area.

- 4 Installing windshield.  
**Apply a slightly increased amount of window adhesive in the area of the two rivets ⇒ Affected rivets in front overhead console area -1-** if they have not already been pre-treated with window adhesive.  
⇒ Workshop Manual '641219 Removing and installing windscreen'
