Misfiring at High Revs (59/15)

Model Year: **As of 2014 up to 2016**

Vehicle Type: **911 GT3 (991)**

Concerns: **Engine malfunction (Misfiring at high revs)**

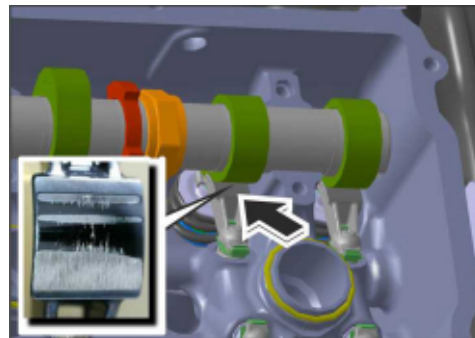
Wear on valve lever

- Rough surface on the cams of the cylinder in question. If there is a significant amount of wear, the contour of the tip of the cam will be "square" and will show significant tempering colors (blue/brown discoloration of the material caused by high temperatures).
- The valve lever shows significant signs of linear wear on the contact surface to cam ⇒ *Wear on valve lever -Arrow-* at the edge of hydraulic valve clearance compensating element ⇒ *Wear on valve lever -Magnifier-*. The black coating is worn down and the silver base material can be seen.

- 3 **If there are visible signs of wear on the camshafts and/or valve levers:**
Create photo documentation and replace all camshafts and all valve levers.

- 3.1 Take photos of the damaged areas on the camshaft and associated valve levers ⇒ *Wear on valve lever -Arrow-*. Make sure that the photos clearly show the installation position of the valve levers in question.
