Malfunction Indicator Light Active / Warning Message All-Wheel Drive Disturbed: Fault Memory Entry "U140500 - Terminal 15, Signal Implausible" in Various Control Units (35 / 26)

Model Line: **Cayenne (9YA / 9YB)**

Model Year: **As of 2024 up to 2026**

Concerns: **Main wire harness in passenger compartment, front left**

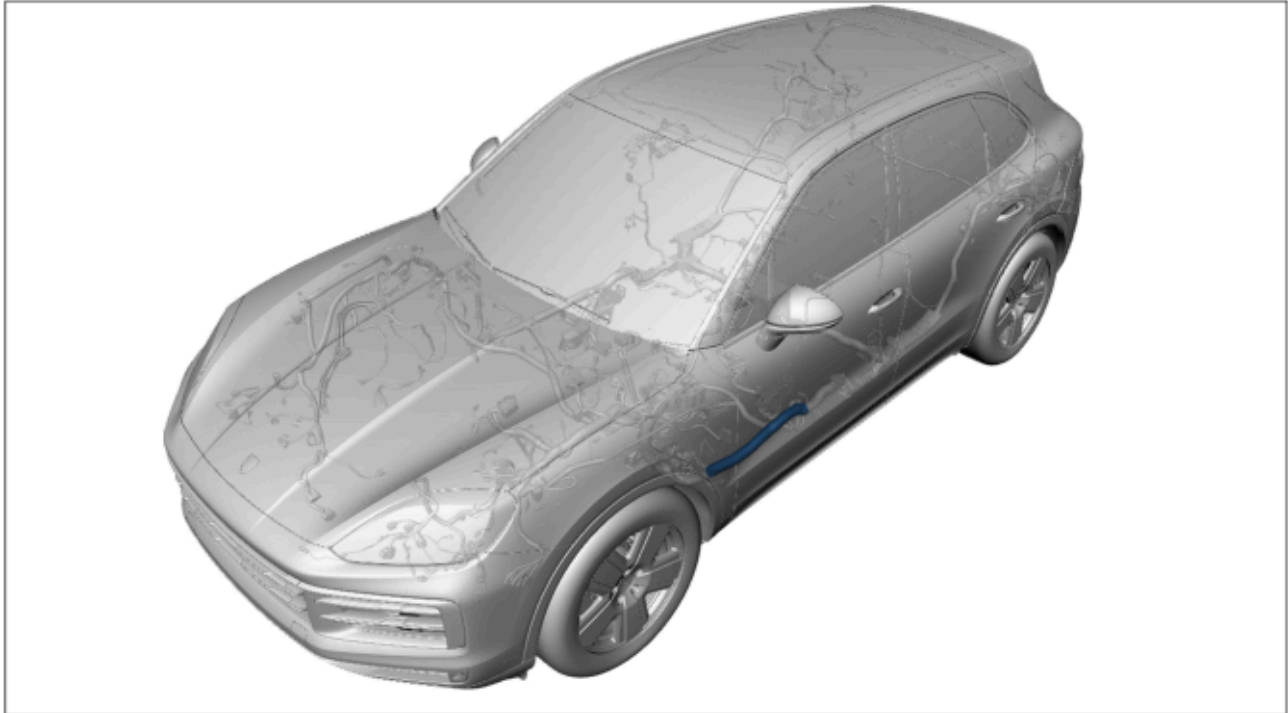
Installation position: front left main wire harness (splice connections area)

This complaint can be caused by unsealed splice connections on the main wire harness in the front left passenger compartment being corroded by condensation.

Action: In the event of a complaint and if the specified fault memory entry is stored, check the splice connections on the main wire harness in the front left passenger compartment for corrosion and repair if necessary.

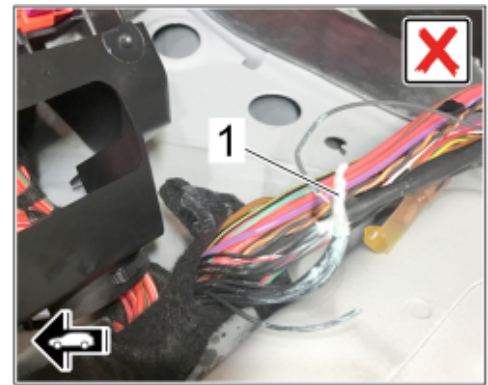
Corroded splice connection (shown as an example)

- Work Procedure: 1 Check splice connections on the exposed main wire harness for corrosion and ⇒ *Corroded splice connection (shown as an example) -1-* repair corroded splice connections if necessary.
For work procedure, see: ⇒ *Workshop Manual '9797INA1 Information on electric crimp / splice connections'*
