Y1A, Y1B, Y1C- High-Voltage (HV) Battery Measurements during HV Battery Repair

Models	Model Year	Model Type	VIN Range	Vehicle-Specific Equipment
Taycan	All	Y1A, Y1B, Y1C	All	N/A

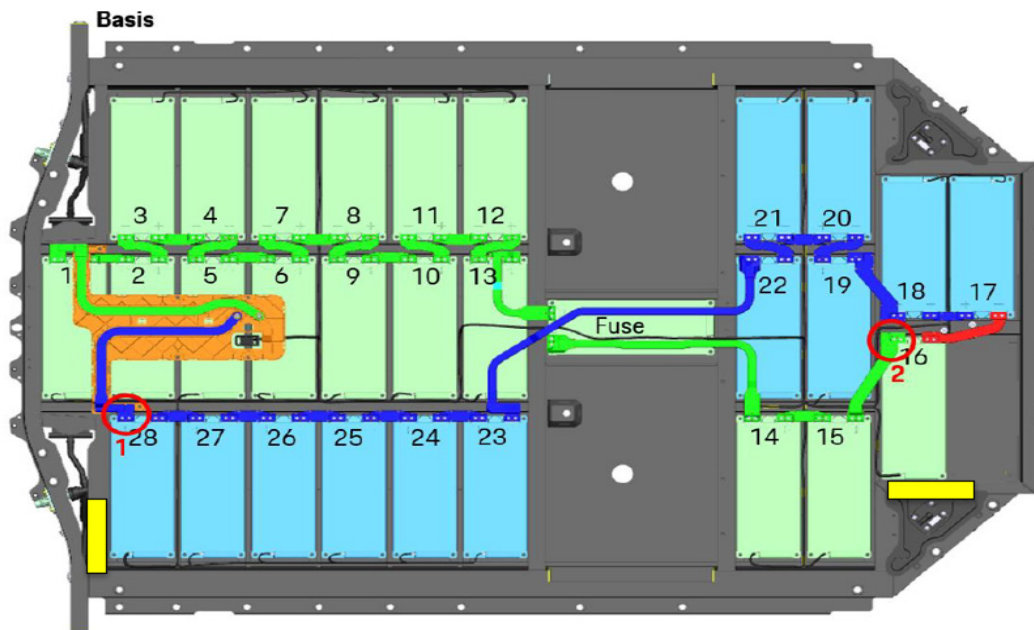
Figure 1 - 28-module HV Battery measurement points

- Only two DSTs are required on a 28-module battery pack during repair.
- The busbar indicated in red must be removed prior to measurements at either point.

- Perform an IR test at points 1 and 2 before the DST at those points.
- Perform a DST only at points 1 and 2 shown below for each repair scope.
- The yellow boxes in *Figure 1* designate the sections of frame where a lid screw can be hand-started to ground the dielectric strength tester.

- Also perform IR tests at points 1 and 2 after a DST, with the negative probe in contact with a clean spot on the silver frame surface designated by the yellow boxes.

- If the final IR test at **measurement point 1** fails, remove busbars and CMC connections from each module shaded in **light blue** for further IR testing as described in the following *Updated IR Measurement Procedure* sections.

- If the final IR test at **measurement point 2** fails, remove busbars and CMC connections from each module shaded in **light green** module for further IR testing as described in the following *Updated IR Measurement Procedure* sections.

- EXAMPLE: Point 1 passes DST and point 2 fails.
 - Perform IR tests on each light green module in the failing section (In this example, section 2). No additional work is required for the passing modules in section 1.

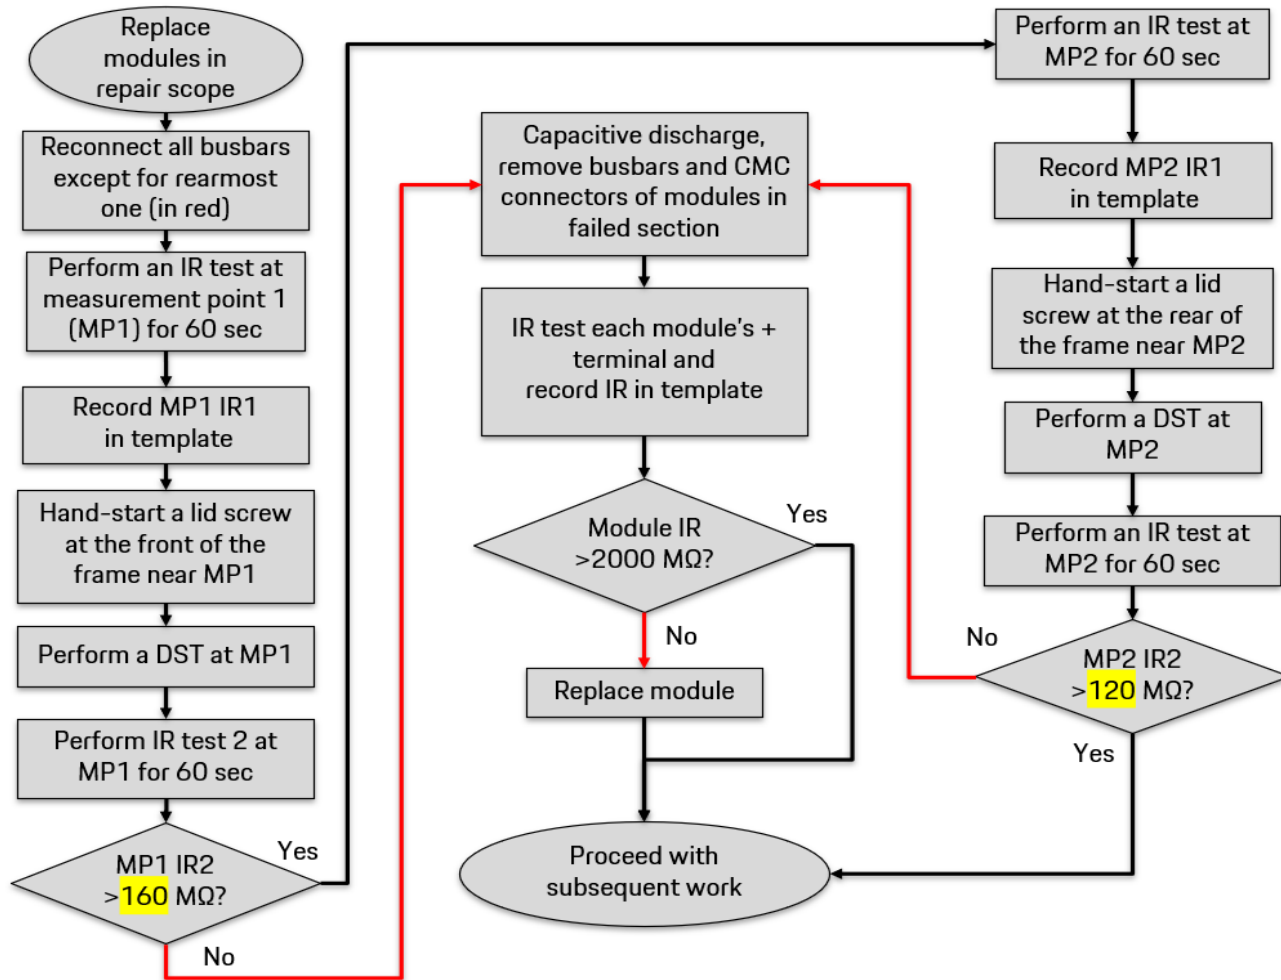
Figure 2 - 28-module Flowchart

Flowcharts of this process for each battery variant are available in figures to follow. The end step "Proceed with subsequent work" can refer to the next measurement point or completion of the repair depending on scenario.

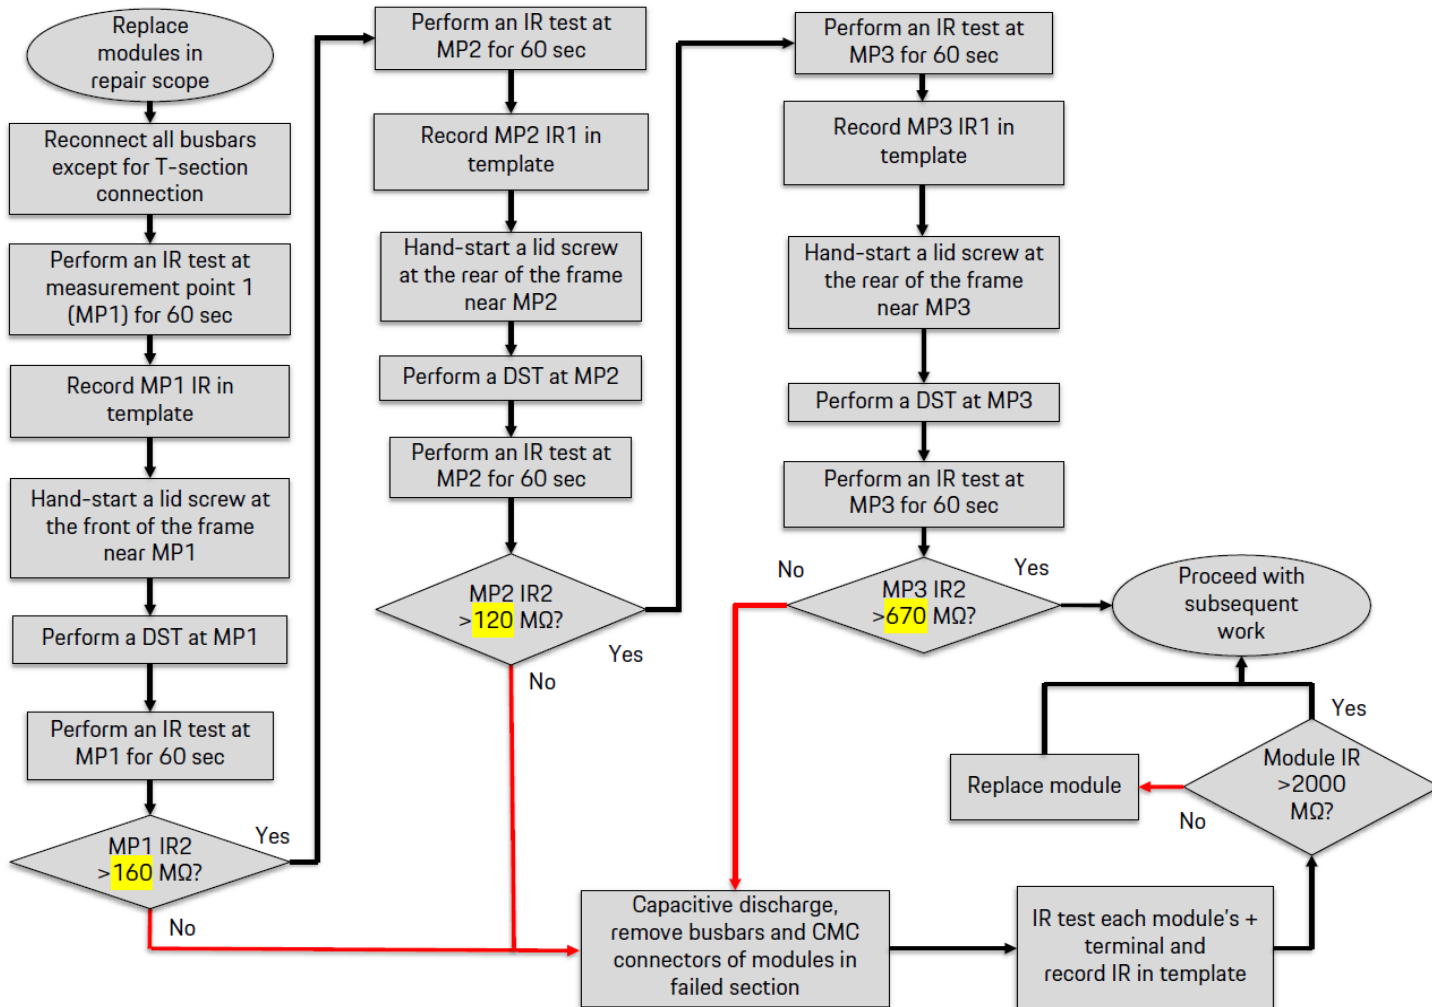
Figure 4 - 33-module Lower Section Flowchart

- Perform IR tests at each measurement point in *Figures 1 and 3* before and after a DST at that point.
 - ▷ If the DST passes but IR falls below the thresholds in *Figures 2, 4, and 5*, proceed with IR testing each module.

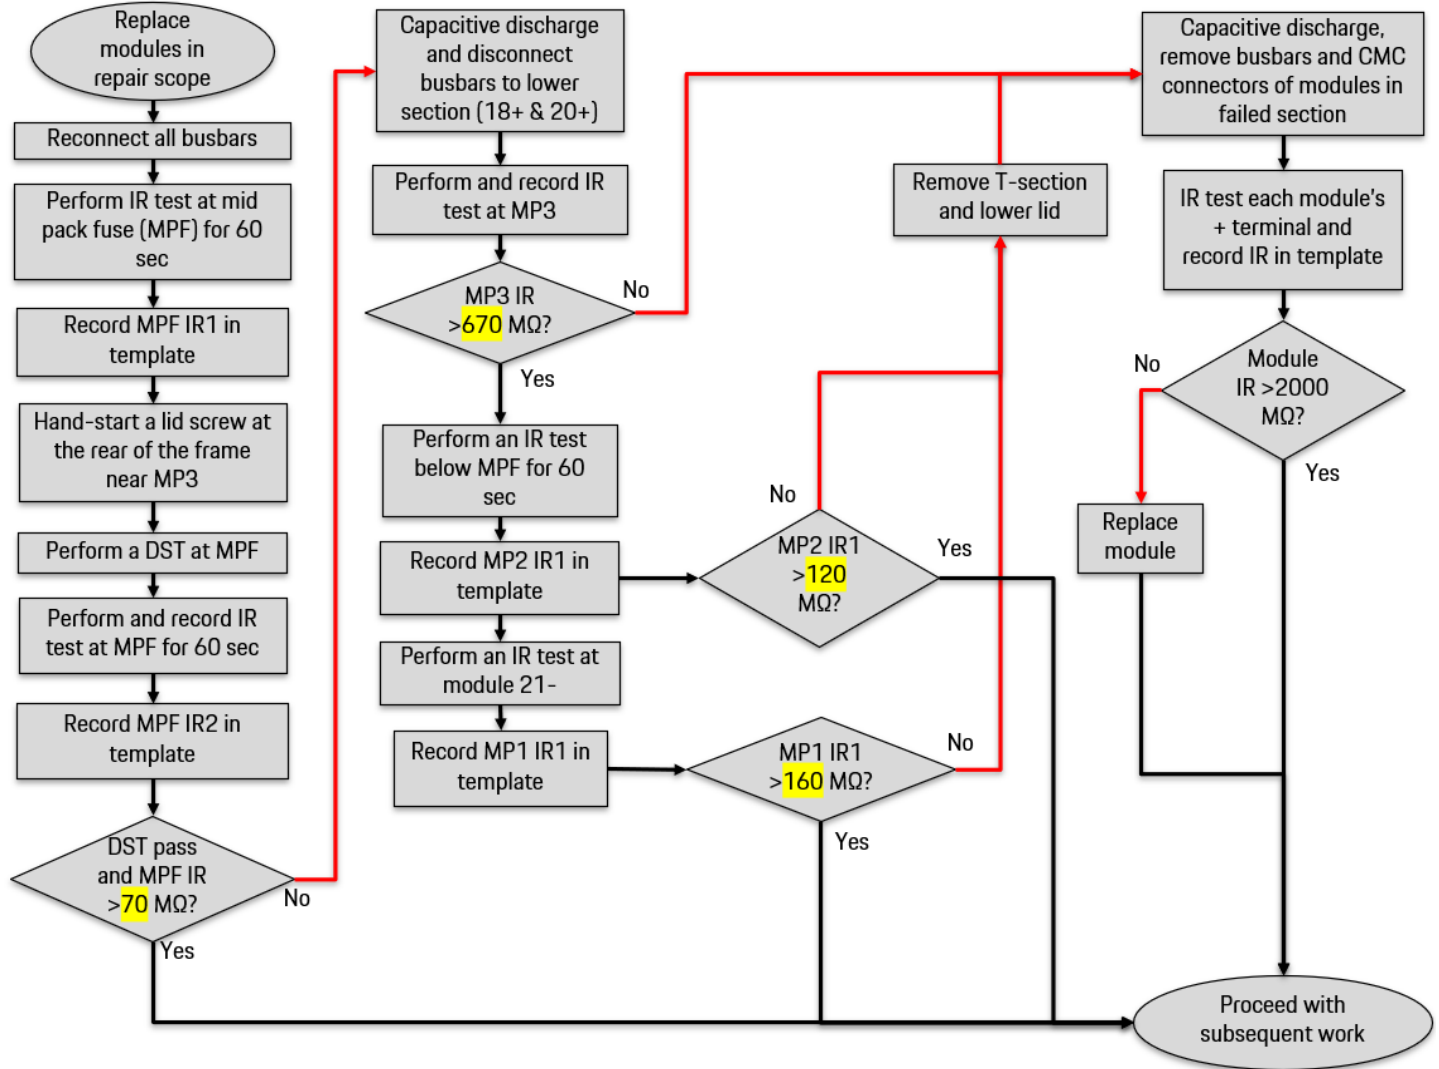
Figure 5 - 33-module Upper Section Flowchart

- For repair scopes only in the upper level, IR test the upper and lower sections separately after an initial DST failure according to the flowchart in *Figure 5*.

- ▷ These measurement points identified below the mid-pack fuse in *Figure 3* serve as alternates to MP1 and MP2 as referenced in the *Figure 5* flowchart when the lower lid is still installed.

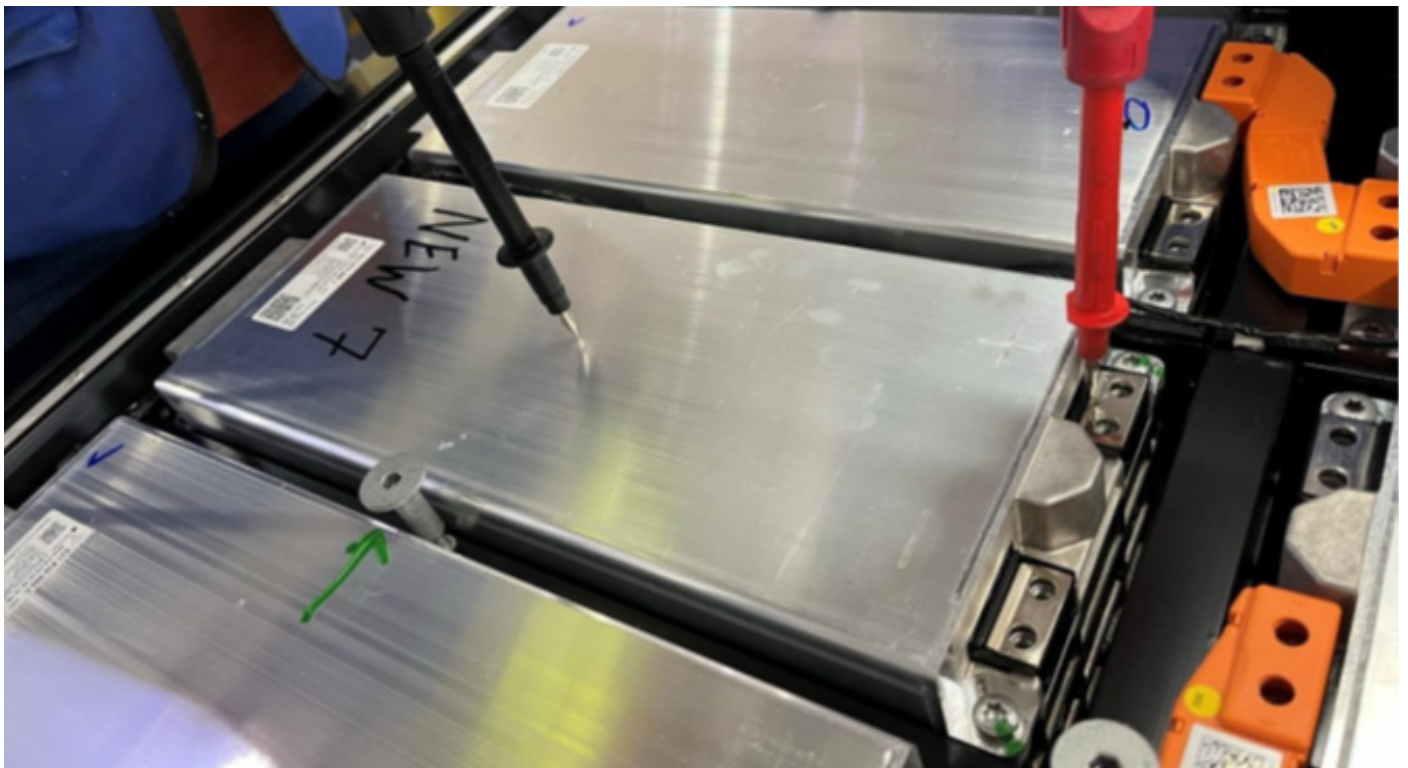
Figure 6 - IR Test at Positive Terminal

- Place the red probe at the edge closest to the black plastic surrounding the terminal to avoid scratching the conductive surface.
 - CAUTION: pay attention to the angle of the red probe in this case. Avoid contact with the side of the probe and the edge of the module housing. Use a plastic probe cap to expose only the tip of the probe if available.
- Maintain contact with the black probe to the module case in the center. Ensure that the module casing surface is clean at the point of contact.
- The equipotential bonding cable is not suitable as a ground point during this test. Use both straight probes directly on the module to isolate conductive influences.

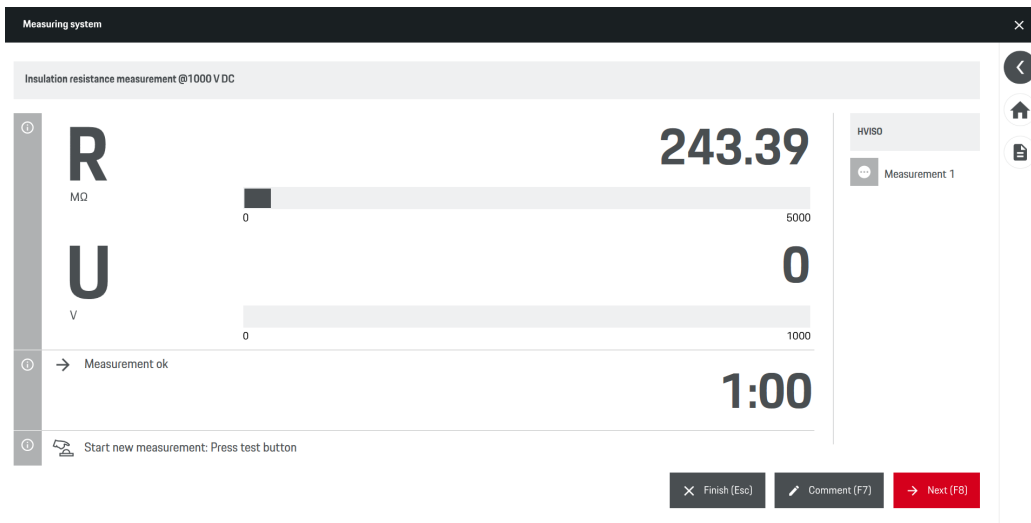
Figure 7 - Insulation resistance measurement in PIWIS Tester

- Shown below is an example of passing test result after 60 seconds of measuring time. This reading can still be displayed as >5000 MΩ when IR measures above the internal software measuring threshold.
- If any module terminal IR test shows a number below 2000 MΩ after 60 seconds of continuous measuring time, this is considered a failure.
- If IR is below the minimum measurement threshold, the IR test won't complete in the measurement equipment display. If the IR test fails to produce a value after multiple attempts on any module terminal, replace it.
- Document any failures in the "Module insulation Resistance Template" Excel file attachment and attach to the repair PCSS entry.
