Spartan Fire, LLC

Technical Service Bulletin
TSB26-560-001

APPLIES TO: This service bulletin applies to certain model year 2025-2026 Gladiator and Metro Star, 2025-2026 FC-94, 2025-2026 KME Panther, and 2025 KME Predator model emergency response chassis cabs built between September 2025 and December 2025.

CONDITION: The CAN I/O module may experience excessive resistance value between pin 3 and 4, which could manifest in a J-1939 fault code.

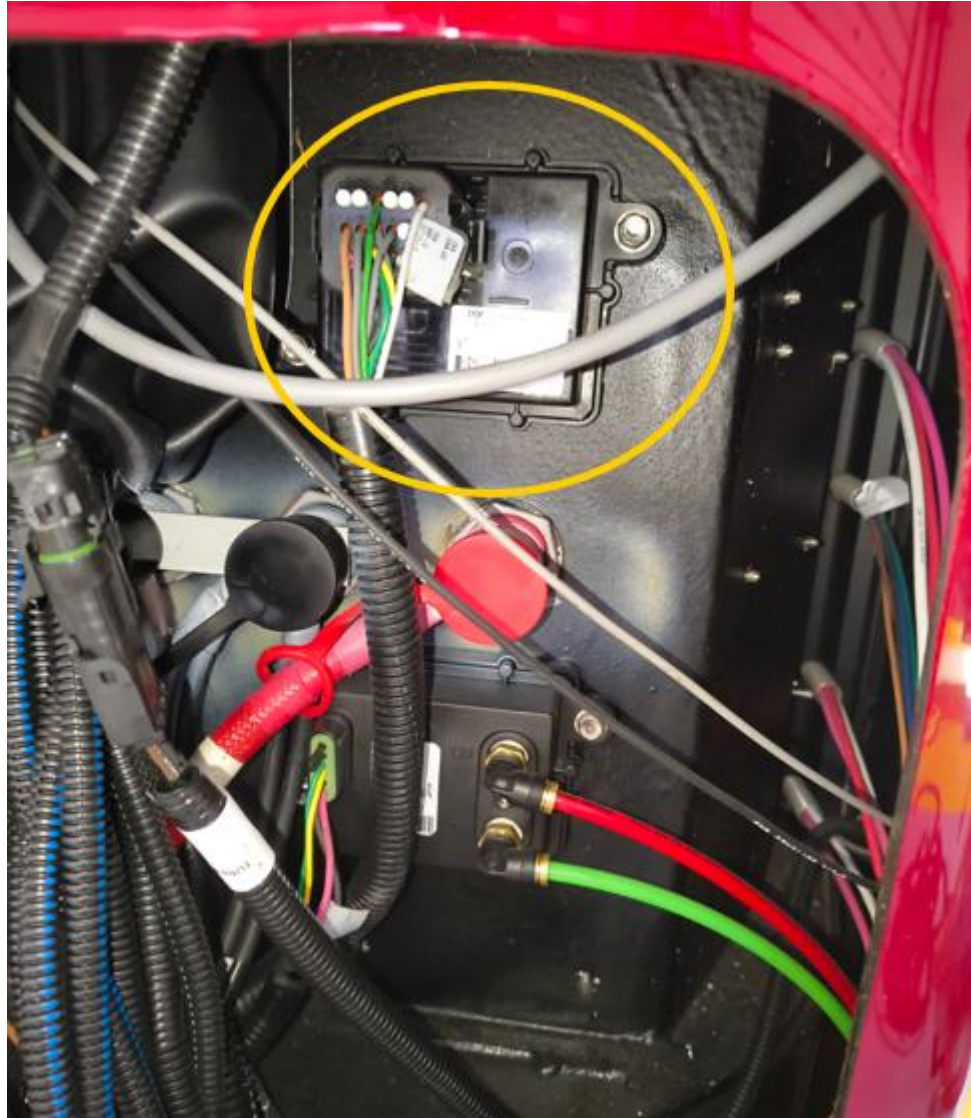
Figure 3.1

- 2) Locate the CAN I/O module behind the headlight bucket assembly. It can be properly identified as the module that does **not** have air lines connected to it. (See Figure 3.1)

- 3) Remove electrical connector.
- 4) Remove CAN I/O module from the firewall and dispose of old module. Retain original fasteners for installation of the new module.
- 5) Install new CAN I/O module using fasteners retained during the removal of the original module.
Be careful to not over-torque the fasteners as it could result in cracking of the plastic mounting ears on the module.
- 6) Reconnect electrical connector to the new CAN I/O module and ensure it is seated properly.
- 7) Reinstall the headlight bucket and bezel.
- 8) Turn on the Master/Ignition switch in the cab.
- 9) Confirm the replacement module is operating correctly by checking the fuel gauge to ensure fuel level is registering.
