## Technical product information

Transaction No.: **2057841/4**

Windscreen replacement criteria whilst under manufacturers warranty

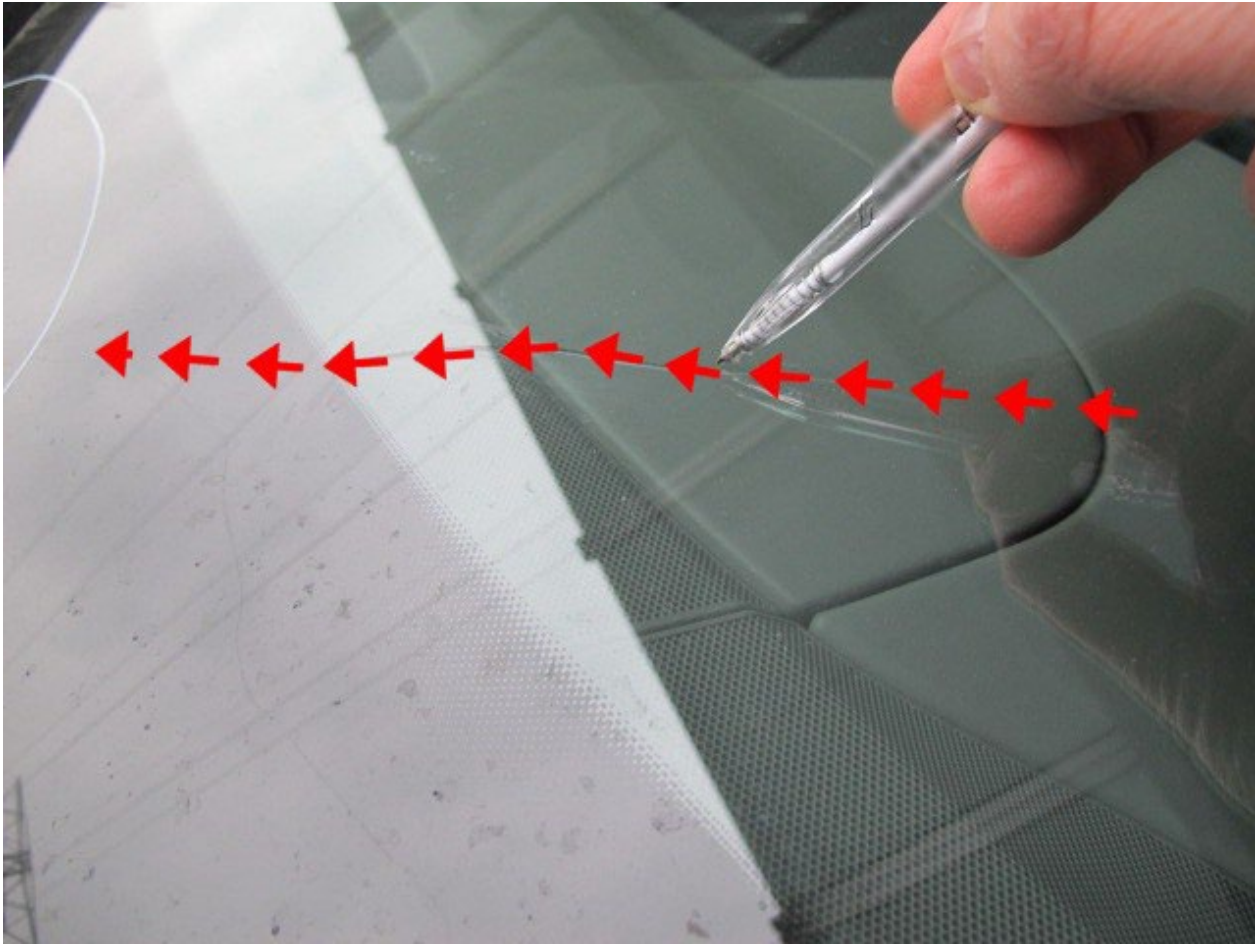
Figure 1

*TIP: A "pen test" can be used to determine if there is a stress crack evident, a ballpoint pen tip is run along the crack (Figure 1), in the event the tip of the pen dips at any point along the crack this MUST be classed as damage from external influences*

Should the pen not dip this can **possibly** be considered as a stress crack

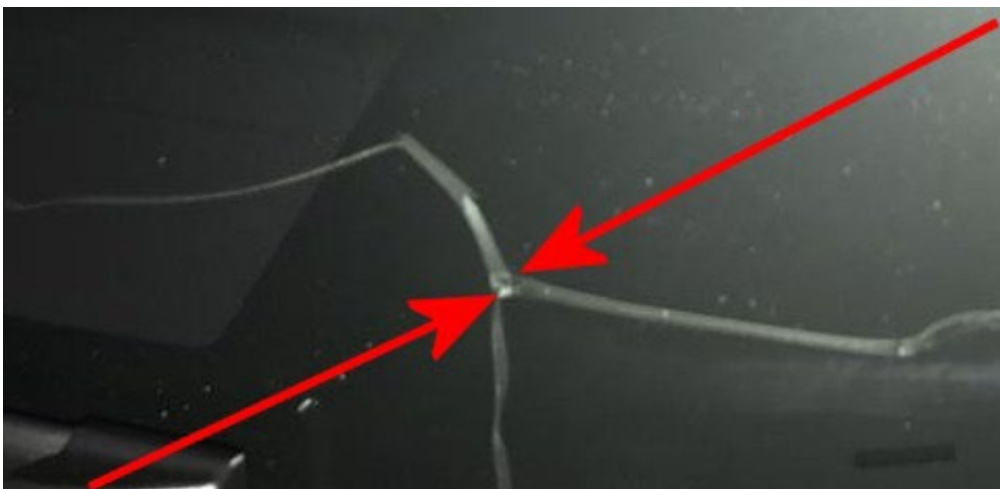
In the event that the windscreen has been identified as cracked/damaged through impact (See Figure 2 as an example), this would NOT be covered under the Bentley Motors Warranty policy, therefore the windscreen MUST be replaced, the cost of replacement would not be covered by Warranty

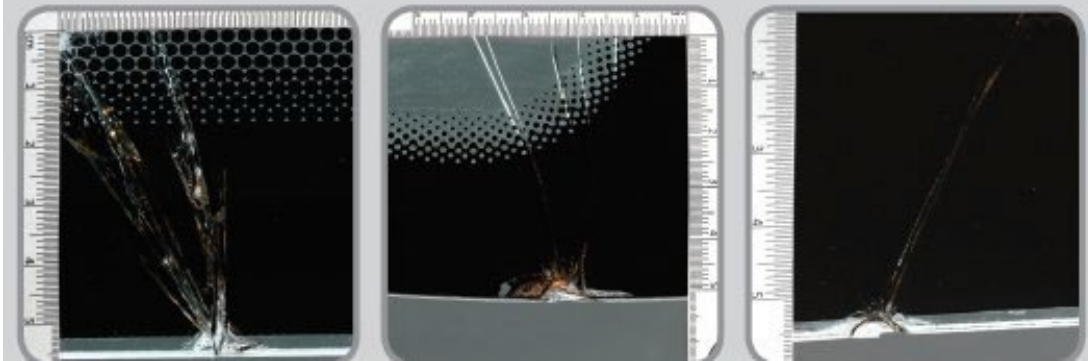
- Refer to the example shown in Figure 3 which details glass edge damage

Glass shelling / glass detached on glass edge. Depending on the force involved, there may be only a little, some or significant radial cracking of the glass from the edge damage, which may be difficult to see because of the black print on the glass.

Glass Edge.

Damaged during assembly to the vehicle. Impact to glass edge (exposed edges e.g. A-post, top of glass)

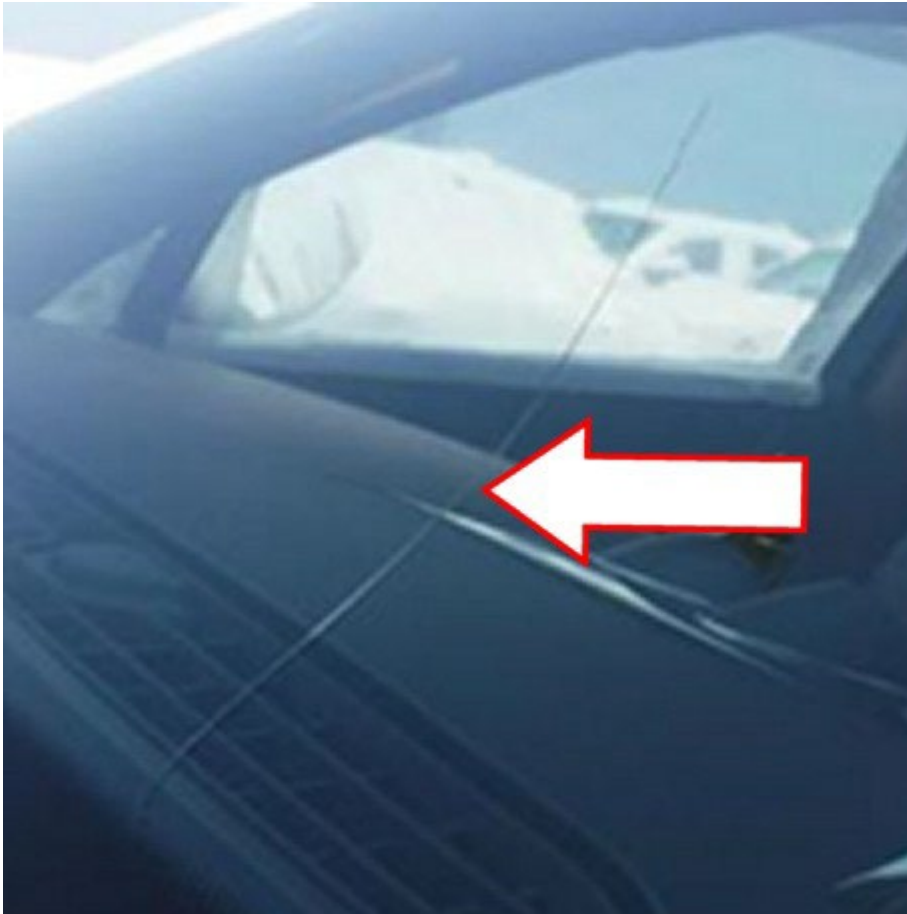
In the event the screen has been identified as cracked/damaged through a stress fracture (See Figure 4 as an example) and the vehicle is covered by manufacturers/extended warranty the retailer **MUST** carry out the following instructions

- Damaged windscreens MUST be reported as per the Mandatory DISS reporting policy
- A DISS query must be raised, the retailer MUST not carry out windscreen replacement or removal until permission has been granted through the open DISS query **NOTE: Product Support may request a Be. C.C call for further diagnosis.**
- The retailer must ensure that the following information is attached within the query:
- Clear photographs of the crack/damage
- Clear description of the location in which the crack/damage is emitting from for example: Right hand front corner
- Video to be attached to the DISS query clearly showing the tip of a ball point pen being run along the length of the suspected crack
- Clear photographs of the Glass ID number (See figure 5).
