GENERAL MOTORS
DCS7493
URGENT - DISTRIBUTE IMMEDIATELY

Subject: REVISION: N262547330-01 – Service Update
Telematic Control Module Reprogramming
Revised Service Procedure & Additional Vehicles Added

N262547330 Telematic Control Module Reprogramming

Revision: 01

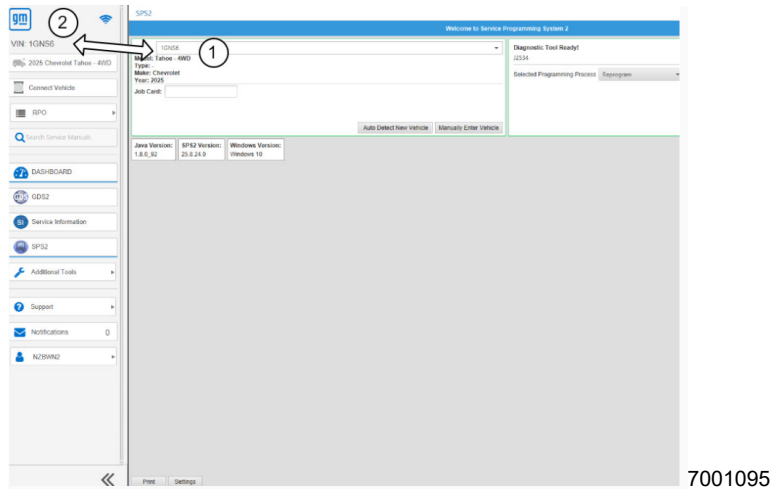
IMPORTANT: The service technician always needs to verify that the VIN displayed in the left side drop down menu (1) and the top center window (2) match the VIN plate of the vehicle to be programmed prior to using Service Programming System 2 (SPS2) for programming or reprogramming a module.

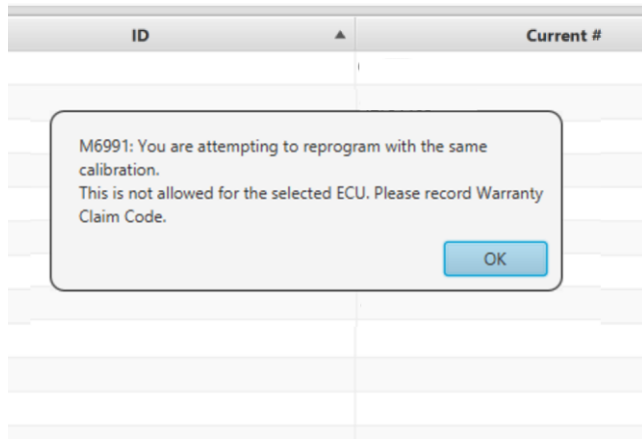
Same Calibration Screen

4.1. If the same calibration screen above is shown, select OK and continue to Step 5. If the screen above is NOT shown, continue to Step 4.2.

4.2. Continue to reprogram the Telematic Control Module until the screen above is shown and select OK. The module may be several software versions behind and could take multiple programming events to bring it to the latest software level (**The same calibration screen MUST be displayed to validate the module has been programmed to the latest level**).

4. Reprogram the Telematic Control Module again.

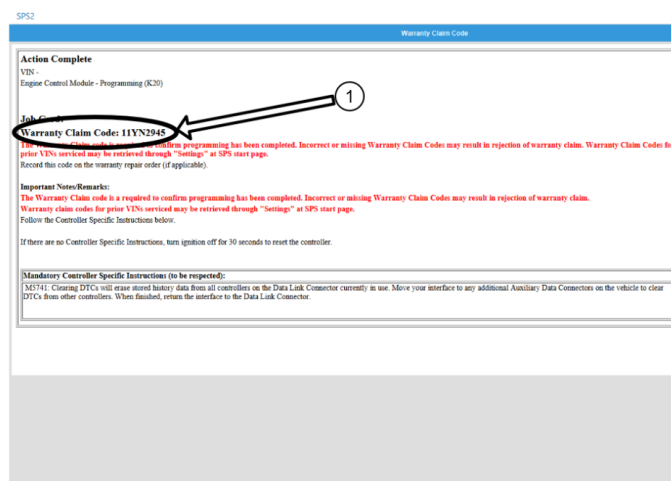
Important: To avoid warranty transaction rejections, you **MUST** record the warranty claim code provided on the Warranty Claim Code (WCC) screen shown above on the job card. Refer to callout 1 above for the location of the WCC on the screen.

6. Record SPS Warranty Claim Code on job card for warranty transaction submission. Refer to *25-NA-281 Information on SPS Warranty Claim Code Submission and Retrieval* in SI.
