MIL ON P140018 - Loose Pin Tension at EGR Connector

Service Category Engine/Hybrid System

Section Engine Control

YEAR(S)	MODEL(S)	ADDITIONAL INFORMATION
2021 - 2024	Camry	
2021 - 2025	RAV4

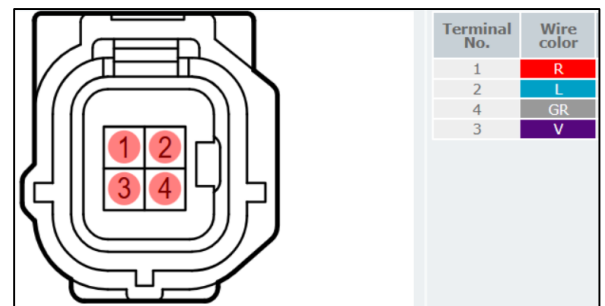
2. Inspect C90/C27 connector at EGR valve and confirm if there are one or more loose terminals as seen in Figure 1. (Often terminal #4 is found to be loose but inspect all four as more than one terminal may be of concern). Are there one or more loose terminals?
 - **YES** — Continue to the applicable step according to the model applicability.
 - A. For RAV4, continue to step 3.
 - B. For Camry, continue to step 4.
 - **NO** — This bulletin does NOT apply. Continue diagnosis using the applicable Repair Manual.

1	R
2	L
3	V
4	GR

3. Remove the outer connector cover and replace all affected terminals shown in Figure 2.
 - A. Access the electrical wiring diagram.
 - B. Refer to TIS, applicable model and model year Electrical Wiring Diagram as shown in Figure 3.
 - 2021 – 2025 RAV4:
 - EWD – General – Introduction*
- (1) Input Division/Model/Year and click search.
 - (2) Select EWD tab.
 - (3) Click the first link:
 - General: INTRODUCTION*

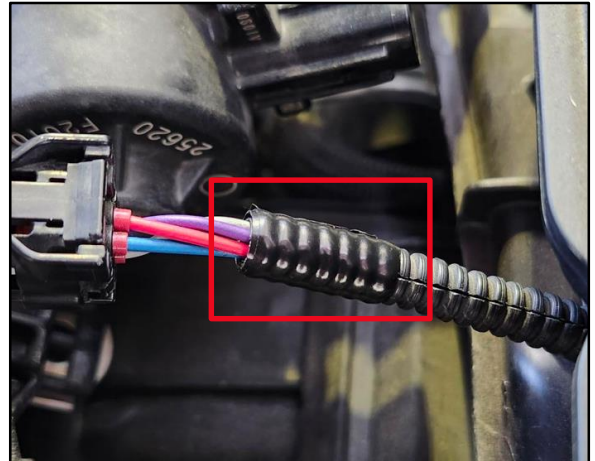
Figure 11. Wire Wrapped in Electrical Tape

5. Do not reinstall outer connector cover.
6. Using electrical tape, wrap the end of wire loom to secure it (see photo).
