Tickling/Abnormal Sound From Top B Pillar Section

Service Category Vehicle Exterior

Section Body Structure

YEAR(S)	MODEL(S)	ADDITIONAL INFORMATION
2024 - 2025	NX250, NX350, NX350H	WMI(s): 2T2

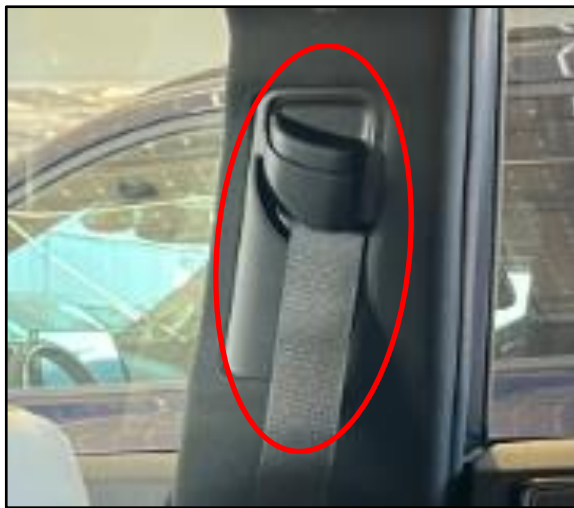
Figure 1. Top of B-pillar to Adjuster Assembly, Front Shoulder Belt Anchor with Trim

- A. Drive the vehicle per the customer's driving habits to confirm a consistent and repeatable abnormal ticking noise from the upper B-pillar section (top of B-pillar to adjuster assy, front shoulder belt anchor, see Figure 1 and 2).

- B. Does the vehicle exhibit a consistent and repeatable abnormal ticking noise while the vehicle drives per the customer's driving habits within the area in Figure 1?
- **YES** — Continue to step 4.
 - **NO** — This bulletin does NOT apply. Continue diagnosis using the applicable Repair Manual.

6. Replace the entire B-pillar section.
Refer to TIS, applicable model and model year Collision Repair Manual.
 - [2024 – 2025](#) NX 250, NX 350, and NX 350h:
Vehicle Interior – Body Panel – Center Body Pillar – Cut and Join Replacement Sections

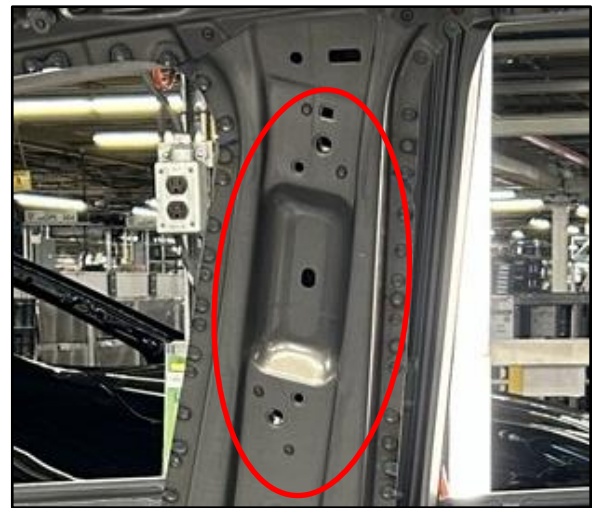
Figure 2. Top of B-pillar to Adjuster Assembly, Front Shoulder Belt Anchor without Trim

Some 2024 – 2025 model year NX 250, NX 350, and NX 350h North American Produced vehicles may exhibit a consistent/repeatable tick/abnormal noise from the top of the B-pillar while driving. The abnormal noise can be heard from either passenger or driver side. The spot welds between the top of the B pillar and the seatbelt anchor may contain weld slag which can create an abnormal noise. Follow the Repair Procedure in this Service Bulletin to fix this condition.
