Shift System Malfunction Warning Message on MID

Service Category Drivetrain

Section Automatic Transmission/Transaxle

Market USA and Mexico

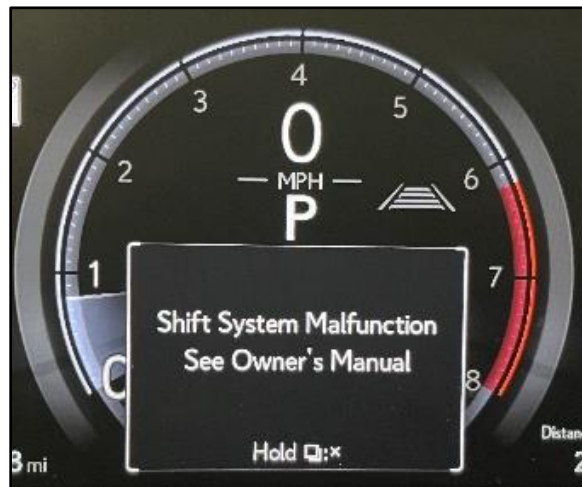
Figure 1.

- A “Shift System Malfunction” message on the Multi-information Display (MID), as shown below.

This condition is more likely to occur when the outside temperatures are near freezing. The Shift Actuator ECU logic has been modified to reduce the possibility of these conditions. Follow the Repair Procedure in this bulletin to address these conditions.
