Rotational Clicking Noise From Front Drive Shaft Assembly on Acceleration

Service Category Drivetrain

Section Drive Shaft/Propeller Shaft

YEAR(S)	MODEL(S)	ADDITIONAL INFORMATION
2024	Grand Highlander, Grand Highlander HV

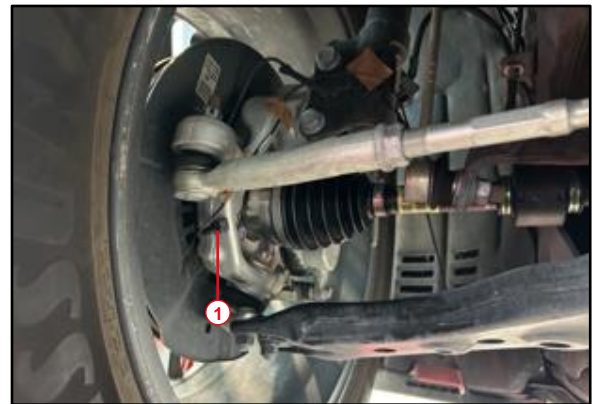
1	ChassisEAR™ on the Front Knuckle Assembly
----------	--

2. Place the vehicle on a lift and install the ChassisEAR™ (or equivalent) on the front knuckle assembly to help isolate the source of the noise, as shown in Figure 1.
