Low Fuel Warning Light Logic Enhancement

Service Category Engine/Hybrid System

Section Fuel System

Applicability

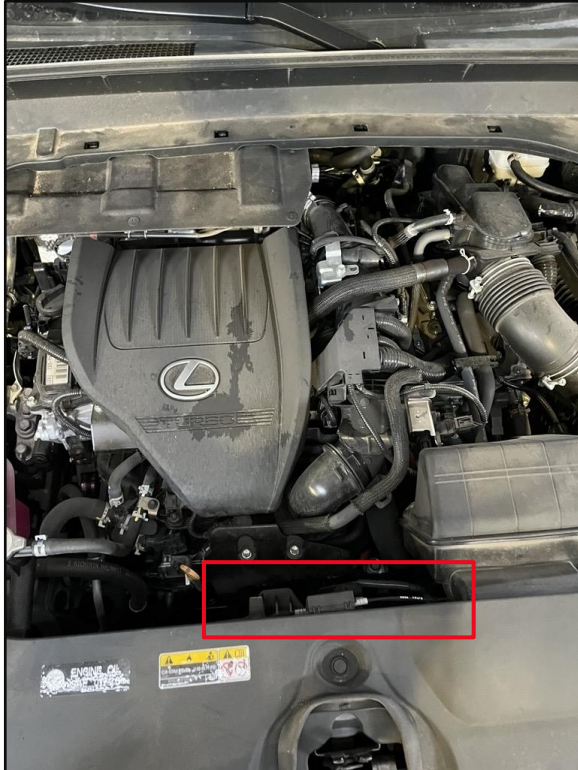
Figure 1. Location of the Cooling Fan Plug

3. Disconnect the engine cooling fan.

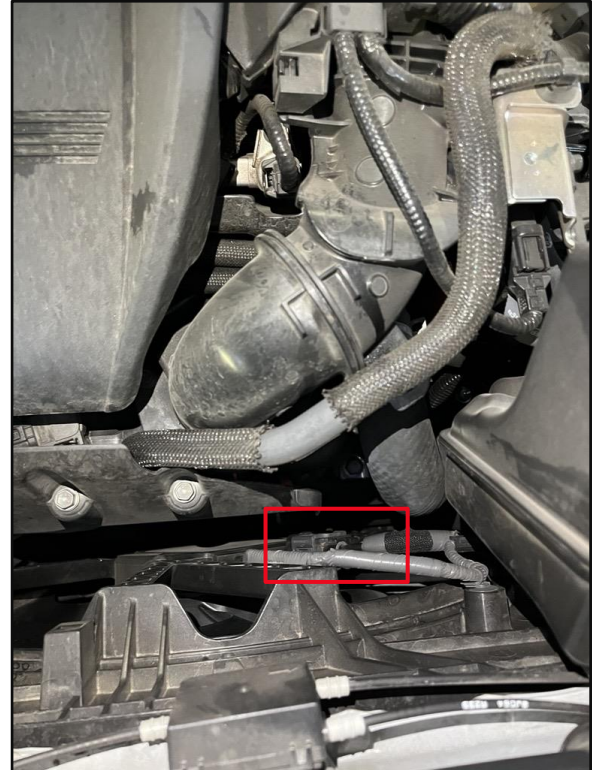
Figure 2. Close Up of the Cooling Fan Plug
