Head Unit Software Update Version 1861 via OTA and USB (Denso-Ten)

YEAR(S)	MODEL(S)	ADDITIONAL INFORMATION
2023 - 2024	RAV4, RAV4 HV, RAV4 Prime

A new head unit software update is available for 2023 – 2024 model year RAV4, RAV4 Hybrid, and RAV4 Prime vehicles equipped with Toyota Multimedia (earlier than version 1861). This software update includes the following improvements:

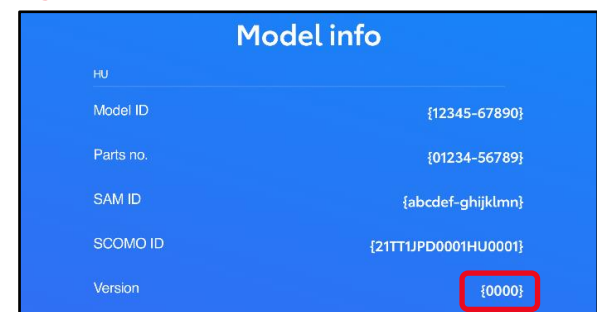
3. Note the version of the head unit (HU), as shown in Figure 5.

Is the HU version up to date per Table 3?

- **YES** — This bulletin does NOT apply, continue diagnosis using the applicable Repair Manual.
- **NO** — Continue to step 4.

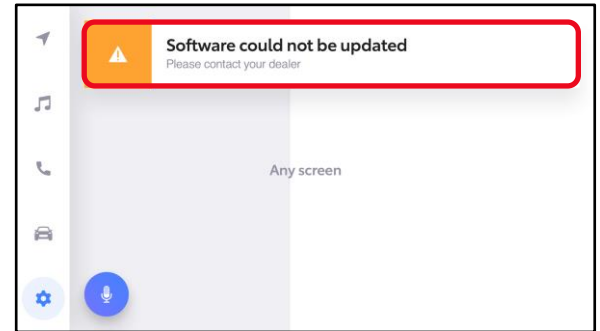
Figure 23.

11. If after IG-OFF/ON a “Software could not be updated” banner appears, continue to the [USB Update Procedure](#) subsection.

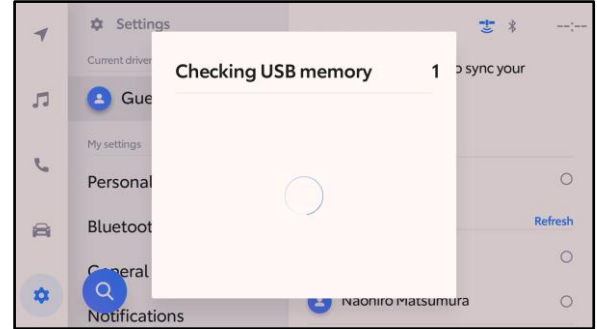
A "Checking USB memory" message pop-up should display as seen in Figure 25.

- If the pop-up in Figure 25 does not appear after five minutes, there may be a problem with the file. Refer to the instructions in page 16 to ensure the file is correct.
- If the pop-up in Figure 25 appears, but the "Update Software" button or "Software Update" pop-up do not appear after five minutes, look closely to see if the "Update Software" button appeared in the background as seen in Figure 28. If so, tap on the visible part of the text.

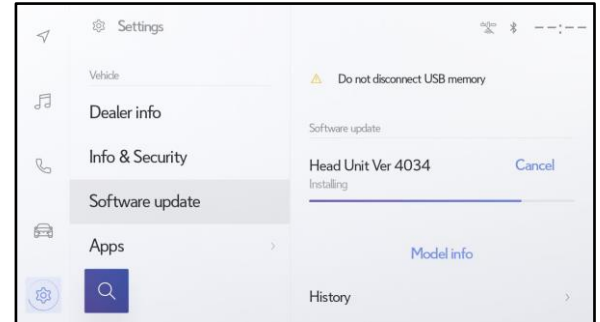
Figure 32.

If the installation progress bar freezes in one place (see Figure 32) for five minutes or more, perform a head unit soft reset:

1. Do NOT remove the USB flash drive.
2. Press and hold the power/volume knob until the head unit resets.
3. Wait for the head unit to boot up.
4. Go to Settings – Software Update.
5. Wait for the software update to automatically restart within 60 seconds.

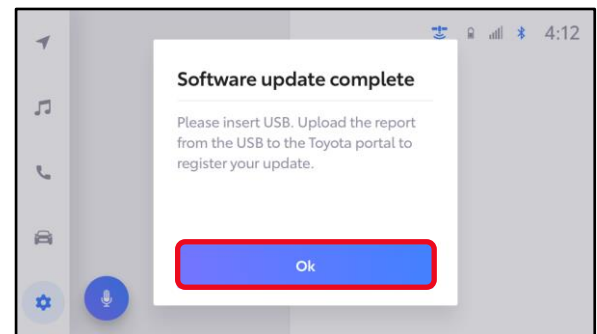
Figure 35.

NOTE
 Failing to follow steps 8 –10 can cause the pop-up in Figure 35 to appear. If so, insert a blank USB to remove the .JSON files. These files are not needed and can be deleted from the USB.
