# Audio Playback is Choppy Across All Sources

YEAR(S)	MODEL(S)	ADDITIONAL INFORMATION
2026	bZ

Some 2026 bZ vehicles with head unit version 2199 may exhibit a condition where the audio playback is choppy across all audio sources. Follow the instructions in this bulletin to address this condition.

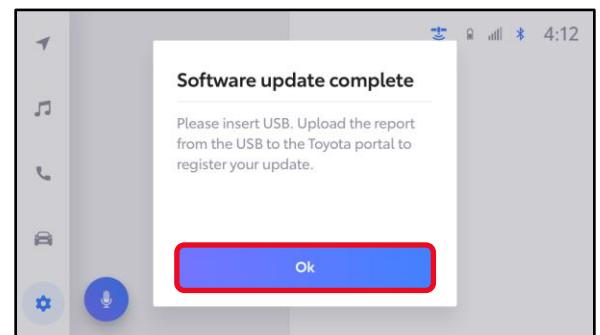
**Figure 13.**

Failing to perform steps 7 – 9 can cause the pop-up in Figure 13 to appear. If so, insert a blank USB to remove the .JSON files. These files are not needed and can be deleted from the USB.
