Technical Service Bulletin

GROUP CAMPAIGN	NUMBER 26-01-040H
DATE APRIL 2026	MODEL(S) TUCSON (NX4A)

SUBJECT: CRACKED INSIDE REAR COMBINATION LAMP ASSEMBLY REPLACEMENT (LIMITED COVERAGE CAMPAIGN LA19)

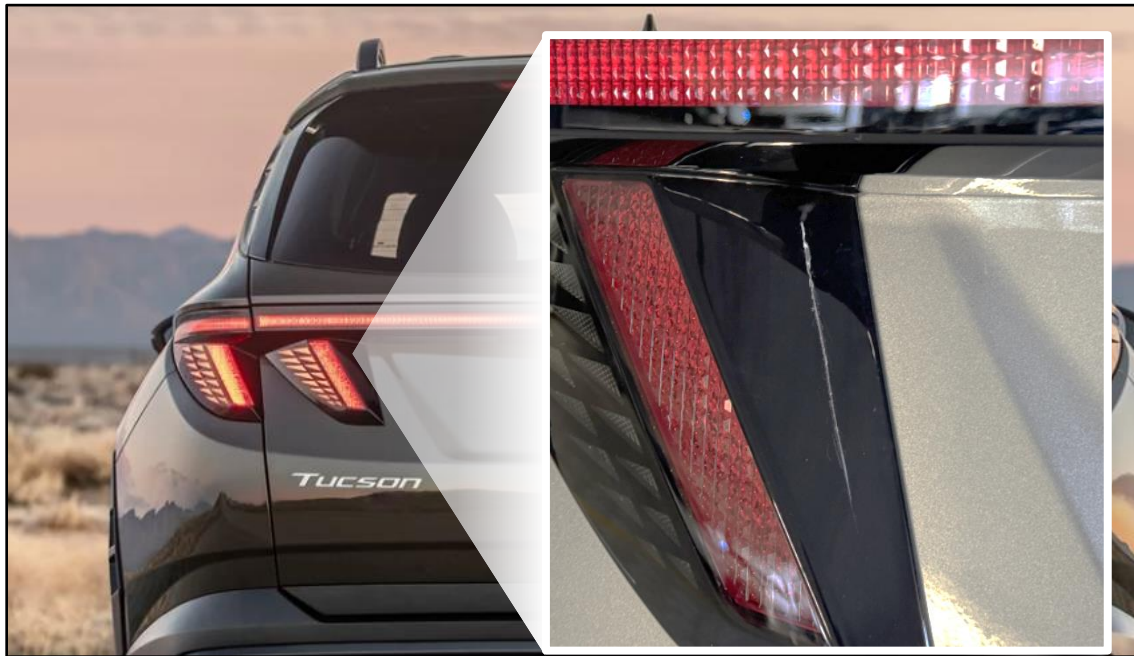
Description: Certain Tucson (NX4A) vehicles have a crack on the left-hand side of the “inside rear combination lamp assembly” due to interference with the tailgate panel. This bulletin provides instructions to replace the “inside rear combination lamp assembly.”
