Technical Service Bulletin

GROUP	NUMBER
BODY ELECTRICAL	26-BE-011H
DATE	MODEL(S)
APRIL 2026	SEE BELOW

SUBJECT: INTERMITTENT AIRBAG WARNING LIGHT & DTC B1763/B1764 - OCS UNIT/WIRE HARNESS REPLACEMENT (WARRANTY EXTENSION Z01)

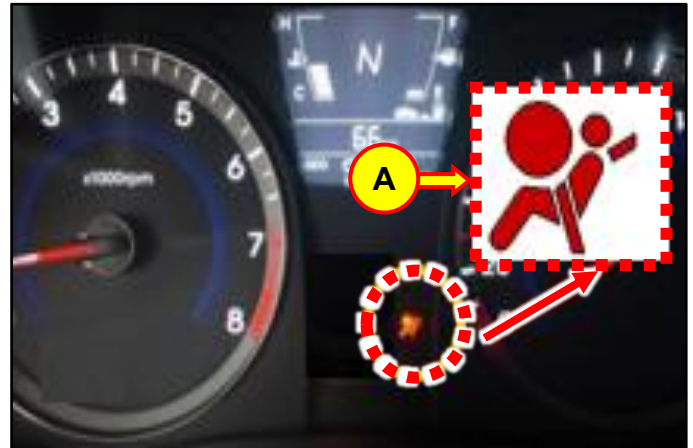
1. Turn the ignition **ON** and inspect for an airbag warning light (A) and any accompanying DTC(s).
 - If the airbag warning light stays **ON** with one of the DTCs below:
 - **B1763:** Proceed to [OCS \(ODS\) ECU Replacement](#).
 - **B1764:** Proceed to [OCS \(ODS\) Wire Harness Replacement](#).
 - If there is **NO** airbag warning light and **NO** DTC is present, the service procedure is complete. No action is necessary.
 - If other DTCs are present, follow the normal diagnostic process. The service procedure is now complete.
