**HYUNDAI**  
**Technical Service Bulletin**

GROUP <b>CAMPAIGN</b>	NUMBER <b>26-01-034H-1</b>
DATE <b>APRIL 2026</b>	MODEL(S) <b>PALISADE (LX3) PALISADE HYBRID (LX3 HEV)</b>

**SUBJECT:** CCU SOFTWARE UPDATE FOR OTA INITIALIZATION  
 (SERVICE CAMPAIGN 9D4)

**This TSB supersedes 26-01-034H to add Palisade Hybrid (LX3 HEV), expand the production dates, and update the event numbers.**

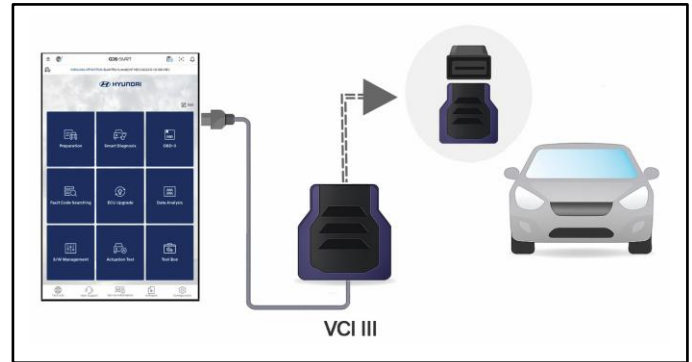
1. Connect the Ethernet Communication Interface (ECI) DLC cable to the OBD connector of the vehicle.
2. Connect the VCI DLC cable to the ECI.
3. Select the appropriate tablet cable (type C, 5-pin) to the ECI.
4. Connect the cable to the tablet PC.

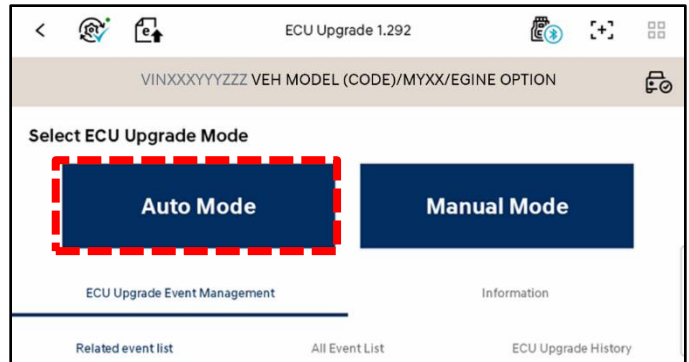
1. Perform the ECU update in **Auto Mode**.

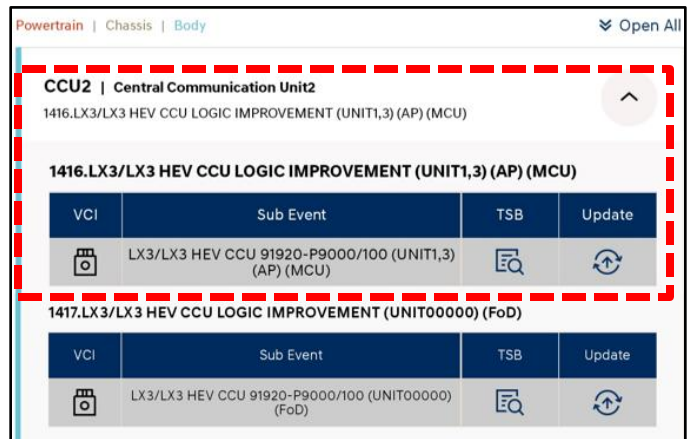
2. Verify the ROM ID by selecting the **CCU2** system to scan the vehicle’s current ROM ID.

If the update fails, remove the power connector from the in-cabin fuse box for at least **5 seconds**. Reassemble and retry the update.

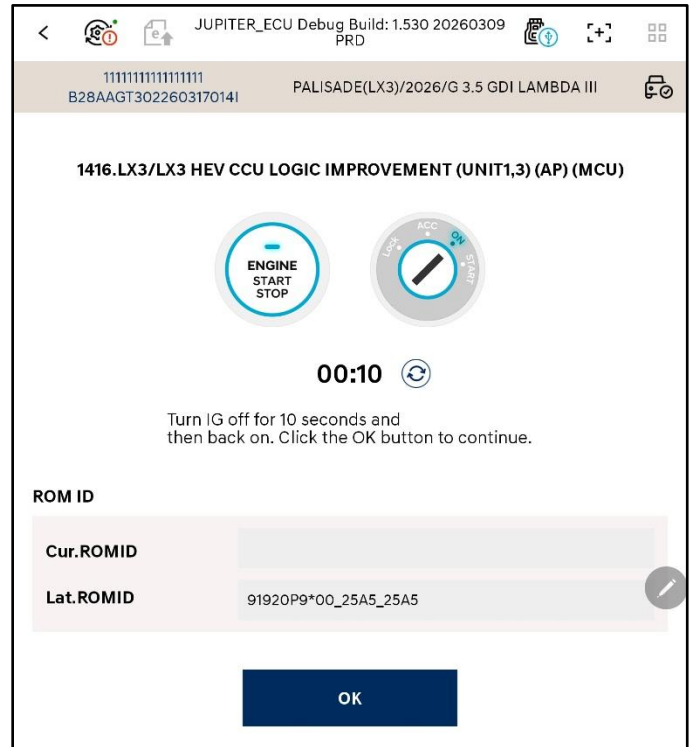
- After the ECU update process shows 100% complete, follow the prompts on the screen to cycle the ignition **OFF** for at least **10 seconds** to reset the control unit (certain models may take up to **30 seconds**).

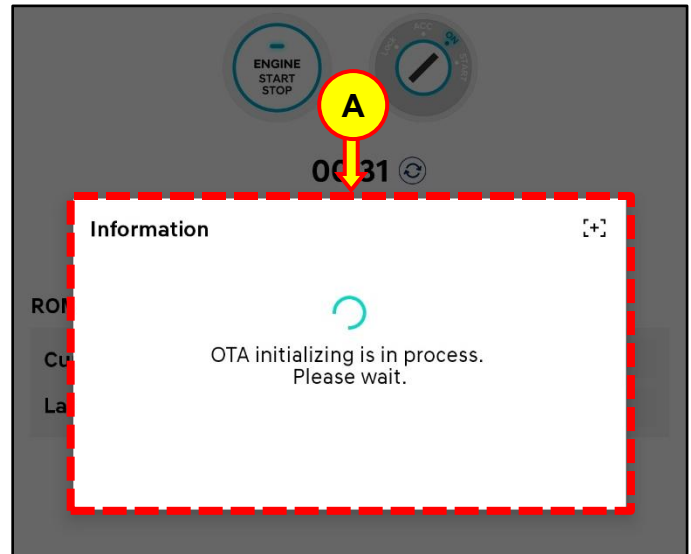
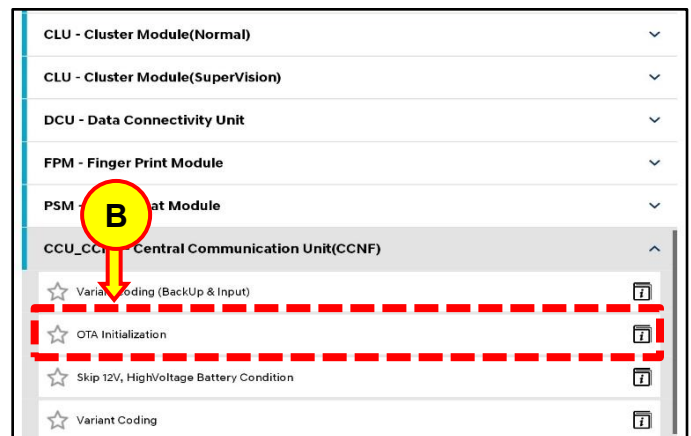
- OTA initialization (A) should perform automatically:
  - If OTA initialization performs automatically, then proceed with the service procedure.
  - If the OTA initialization process fails, complete it manually under: **S/W Management > CCU\_CCNF - Central Communication Unit (CCNF) > OTA Initialization (B)**.

Follow the instructions on the screen.

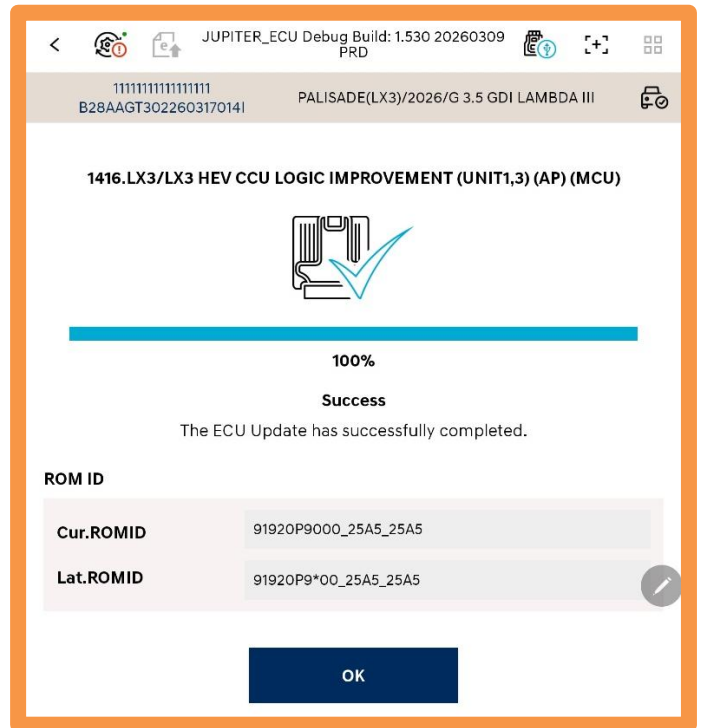
Using the tablet or GDS screen capture function, take a screenshot of the ECU Update “Success” result screen.

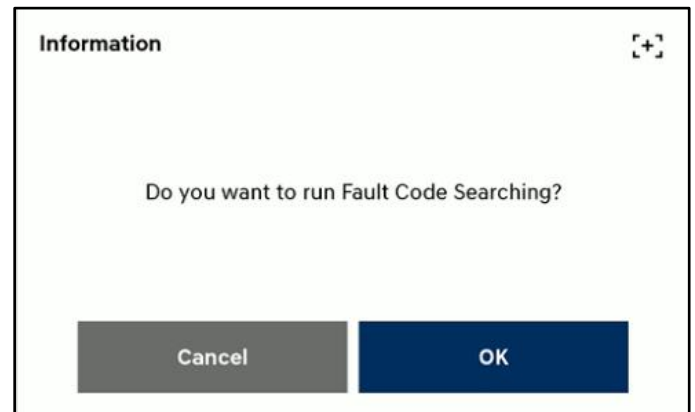
6. Perform an **All Systems Fault Code** search and erase DTC history that had incidentally occurred from the ECU update.

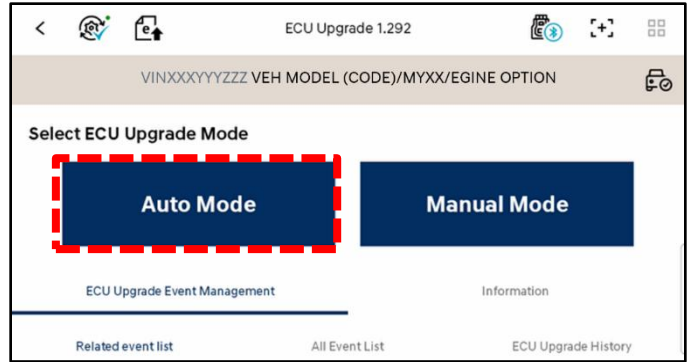
1. Perform the ECU update in **Auto Mode**.

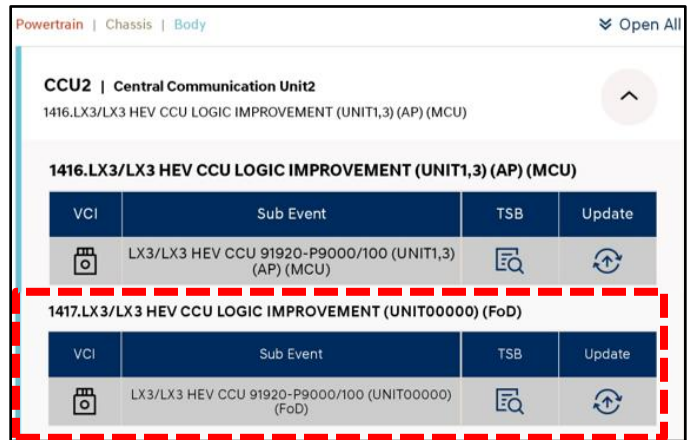
2. Verify the ROM ID by selecting the **CCU2** system to scan the vehicle’s current ROM ID.

If the update fails, remove the power connector from the in-cabin fuse box for at least **5 seconds**. Reassemble and retry the update.

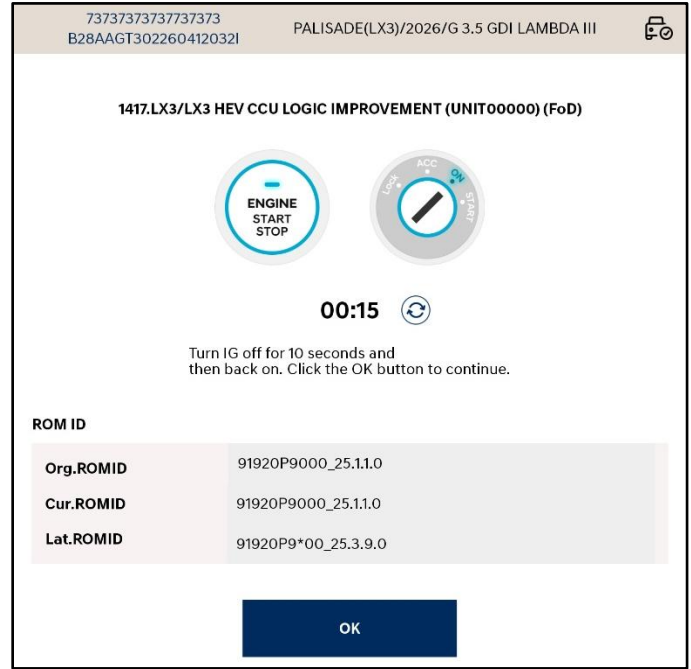
- After the ECU update process shows 100% complete, follow the prompts on the screen to cycle the ignition **OFF** for at least **10 seconds** to reset the control unit (certain models may take up to **30 seconds**).

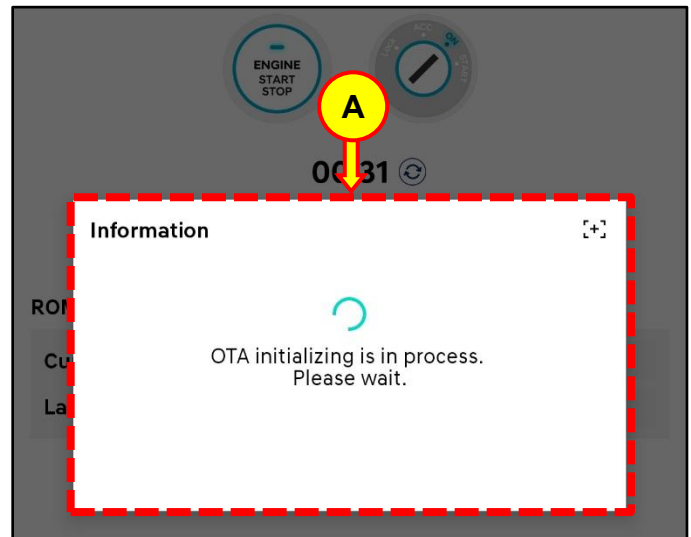
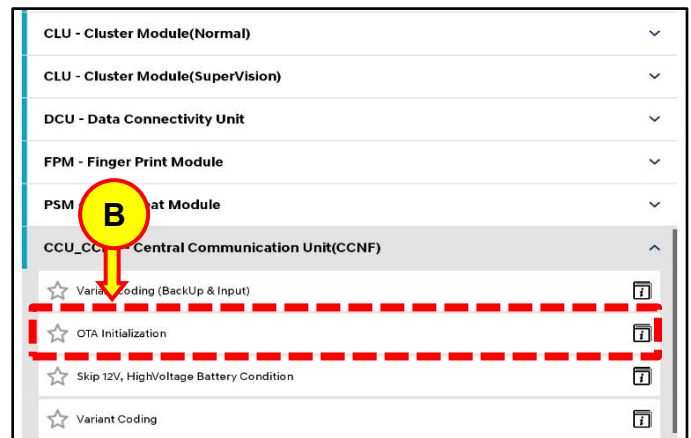
- OTA initialization (A) should perform automatically:
  - If OTA initialization performs automatically, then proceed with the service procedure.
  - If the OTA initialization process fails, complete it manually under: **S/W Management > CCU\_CCNF - Central Communication Unit (CCNF) > OTA Initialization (B)**.

Follow the instructions on the screen.

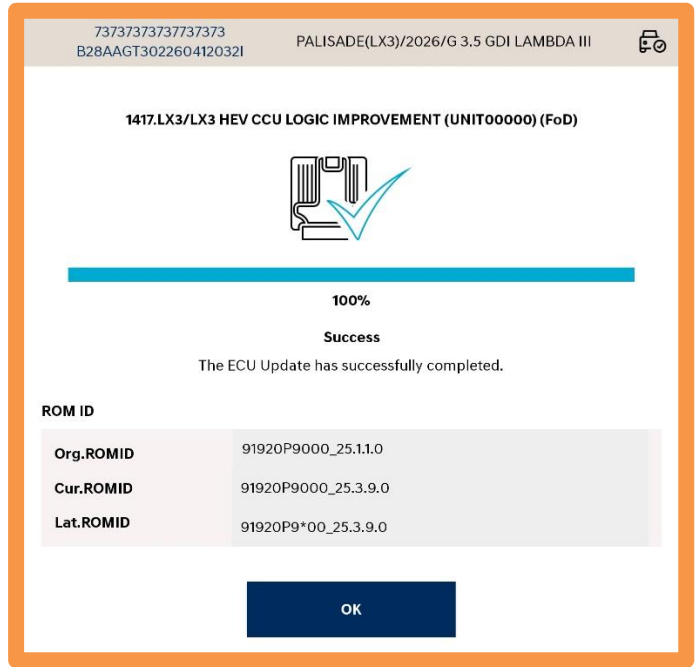
Using the tablet or GDS screen capture function, take a screenshot of the ECU Update “Success” result screen.

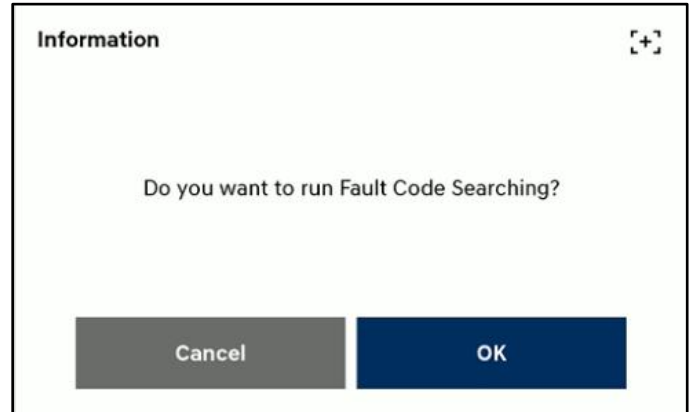
6. Perform an **All Systems Fault Code** search and erase DTC history that had incidentally occurred from the ECU update.
