## Water Ingress in the Load Compartment Between the C and D Pillars

Topic number	LI88.80-P-080031
Version	1
Function group	88.80 - Cover strips
Date	5/7/26
Validity	TYPE 463 as of model year 2018; TYPE 465
Reason for change

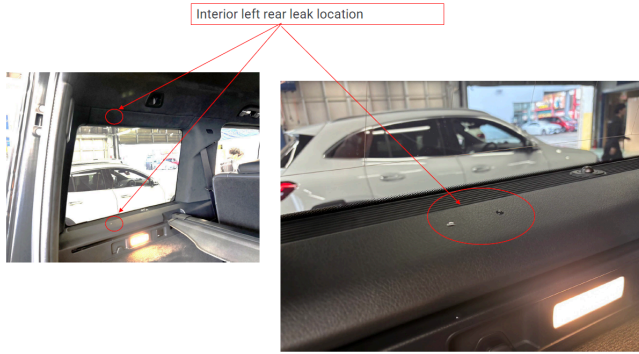
Water ingress in the load compartment between the C and D pillars.

Attachments	
File	Description
Screenshot 2025-05-09 094712.png	Water ingress

In the area of the rounding at the D-pillar, a leakage may occur between the rear side wall and the roof paneling.
