# Quality Bulletin

## Service Action SP1082: Stabilizer Bar Link Model Year 2026 Polestar 4

SP1082

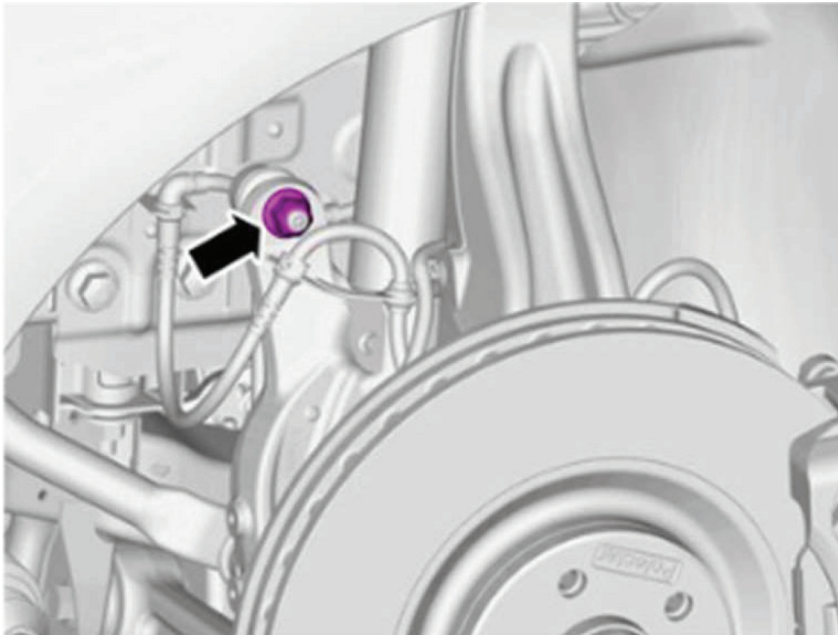
Front only

The concern with the stabilizer is low torque on the nuts for the stabilizer bar link. This may cause noise from the front suspension.

Perform all steps to both left and right, upper and lower end links
