Technical Journal

PS Rear Roof Cover - with Molding Line

| REF NO: TJ 37724.1.0 | ISSUING DEPARTMENT: Technical Service | CAR MARKET: United States and Canada | |

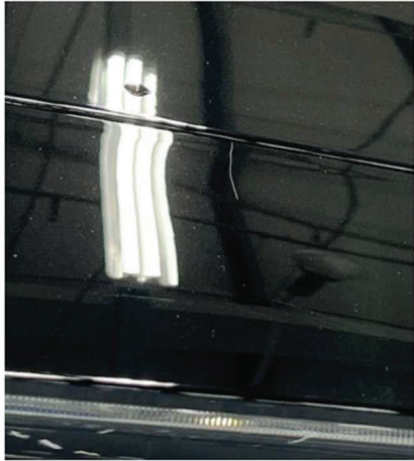
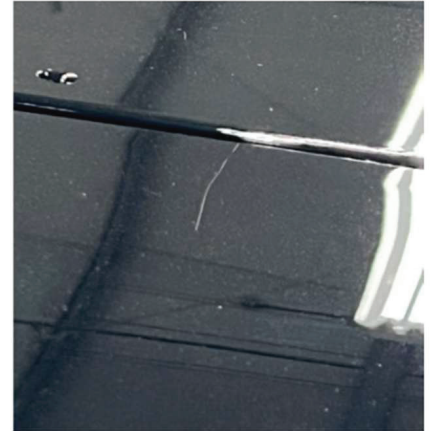
TJ 37724

If customer complains that there is a visible molding line on the rear roof cover, follow advice under "Service". See attachment.

Please, do not replace any parts for the symptom described in this TJ. This is a molding line and not a damage.
