# Quality Bulletin

## Service Action SP1080: PS3 Tailgate Leakage Model Year 2025 Polestar 3

SP1080

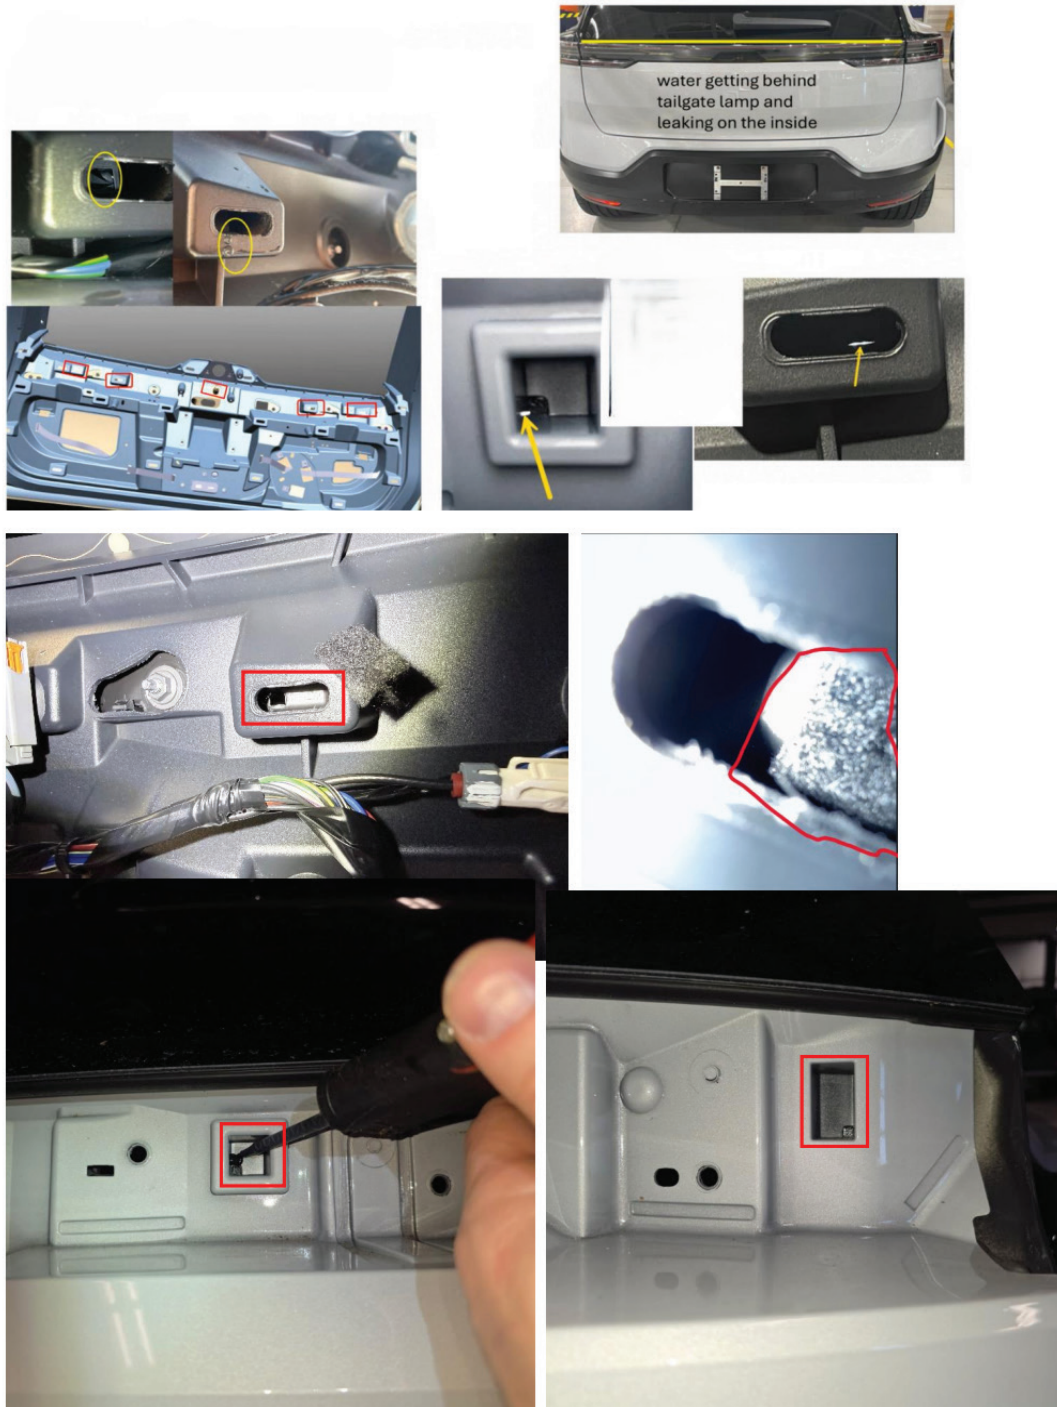
The concern with the tailgate is that 5 holes are drilled and not resealed which may cause water intrusion into the tailgate.

The holes are in the embosses and can be covered by a “tape” or similar in a first attempt to stop the water.
