# Service Bulletin

Bulletin No.: PIC6566C

**Subject: Image Processing Module/Video Processing Module Reset Instructions**

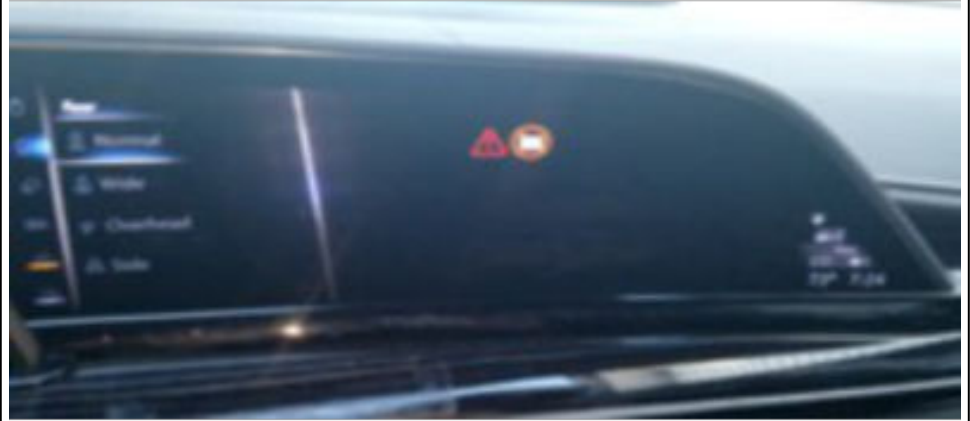
6713886

<b>Involved Region or Country</b>	United States, Canada, Mexico, Europe, Kazakhstan, Uzbekistan, Russia, Middle East, Iraq, Israel, Palestine, Argentina (Mercosur), Brazil (Mercosur), Chile (West), Colombia (West), Ecuador (West), Japan, Cadillac Korea (South Korea), Thailand (ASEAN), Singapore, Philippines, Australia/New Zealand, Caribbean, China
<b>Additional Options (RPO)</b>	IVE, UV2, UKL, IVD, UXP, (See table in correction section for specific vehicle combinations)
<b>Condition</b>	Some Customers may comment on a condition present on startup when shifting to reverse gear on the Radio Display where a black screen with a triangle and a camera with a slash through it is displayed. In addition, it may not be possible to launch the camera app from the Radio home screen.

<b>Cause</b>	This may be due to software anomalies that may be corrected by a reset of the module.
--------------	---

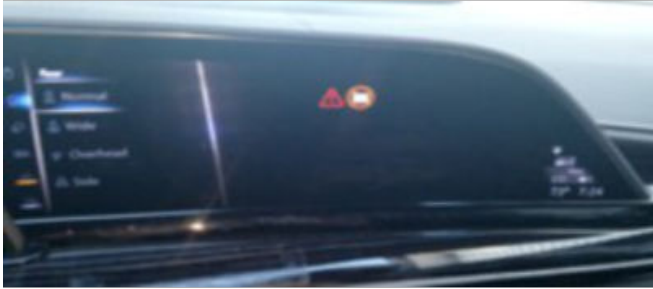
6713886

Shift to Reverse and verify RVC status. If the screen below appears, start with Step 1.

1. If U023C SYM00 is set as Current by the CGM or EBCM, then check if Warranty Labor Code 3459852 has previously been performed on this vehicle.

a. If this is a repeat visit for the same concern, Replace the VPM (Refer to SI Document: Video Processing Module Replacement).

b. If this is the first visit for this concern, refer to the chart below and perform fuse reset(s) based on option codes vehicle is equipped with.

c. After fuse pull, perform a 3-minute sleep cycle and then recheck for DTCs
