# Service Bulletin

Bulletin No.: PIC6629E

### Subject:

<b>Involved Region or Country</b>	United States
<b>Additional Options (RPO)</b>	IVA, IVD, IVE, IOK
<b>Condition</b>	Customer may comment about an issue with either the radio or IPC display. Please reference the appropriate procedure based on the symptom list in the correction section of this document.
<b>Cause</b>	Concerns may be caused by software or hardware anomalies

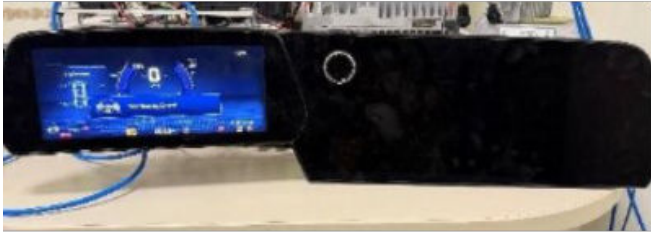
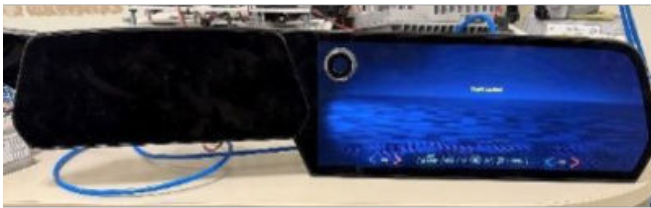
Below are examples of one, or portion of the display is blank
