Service Bulletin

Bulletin No.: PIC6630B

PRELIMINARY INFORMATION

Subject: Device is Starting Screen Recovery

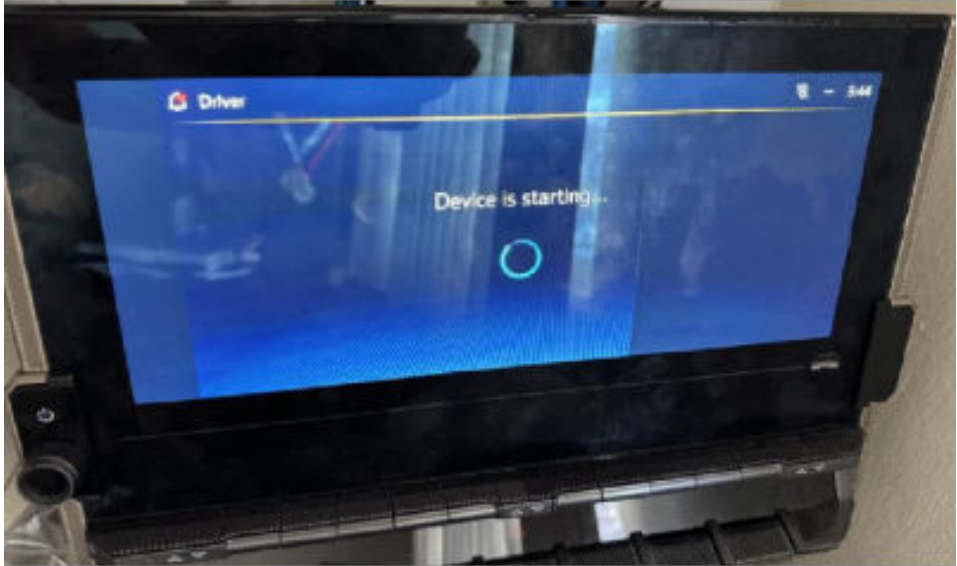
<p>7028486</p>
<p>Cause</p>	<p>The cause of the condition may be software anomaly.</p>

<p>Condition</p>	<p>A customer might bring the vehicle in with radio showing “Device is Starting...” on the display. The recover method in Radio Malfunction may not work.</p>
