STAR ONLINE PUBLICATION

Case Number: S2607000004

Symptom/Vehicle Issue: P0480-COOLING FAN 1 CONTROL CIRCUIT (VARIABLE SPEED FAN)

Models Affected: 2024-2026 Chrysler Pacifica (RU)

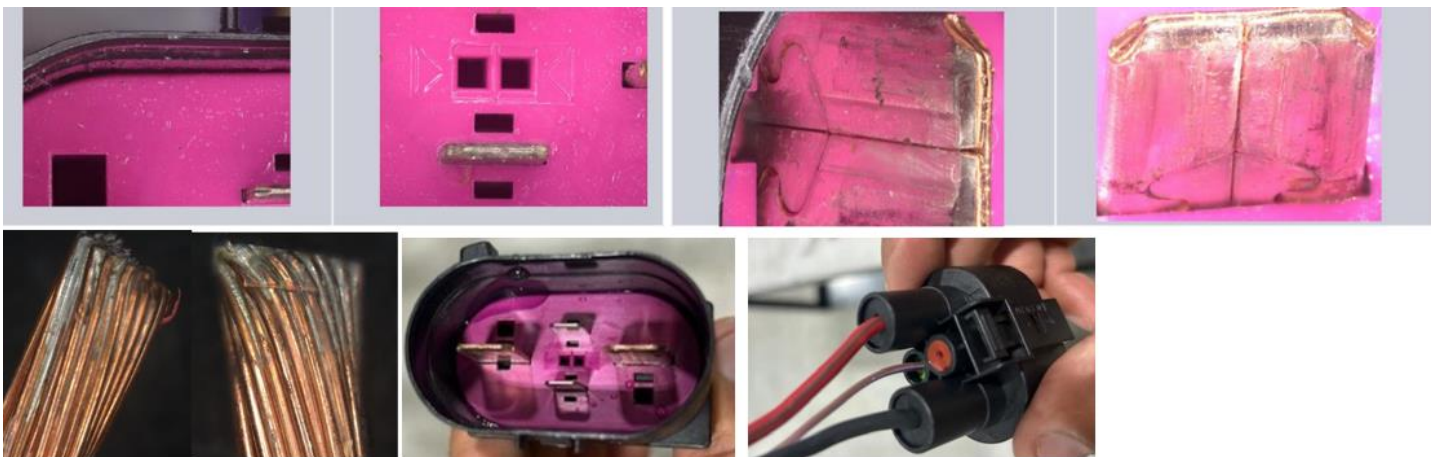
Connector/Connection Examples Causing Faults

Symptom/Vehicle Issue: Water intrusion into the cooling fan motor and radiator fan connectors caused corrosion, short circuits, open circuits, and/or damaged connectors.

Contributing factors included failed weather seals, water leakage from integral harnesses, and corrosion extending into wiring, resulting in increased resistance, shorts, and fan control circuit open conditions.

- Closely inspect circuits A13, K173 and Z905
- Inspect for:
 - Proper seating
 - Pin terminal fitment
 - Water intrusion
 - Terminal or wire corrosion
 - Check for missing seals or cavity plugs on both sides of the connector.
- If any damage or contamination is found please submit a DID-I with photos.
