**Technical Service Bulletin (TSB)**  
**Vehicle Does Not Operate In Electric Mode And/Or Reverse Gear Is Unavailable**

<b>REFERENCE:</b>	<b>TSB:</b> 08-204-26 <b>GROUP:</b> 08 - Electrical	<b>Date:</b>	May 6, 2026	<b>REVISION:</b>	—
<b>VEHICLES AFFECTED:</b>	<b>2021 - 2025 (BV) Jeep Renegade</b> <b>2021 - 2025 (MV) Jeep Compass</b> This bulletin applies to vehicles equipped with a 1.5L I4 DOHC Turbo MHEV Engine (Sales Code EYP).			<b>MARKET APPLICABILITY:</b> <input type="checkbox"/> NA <input type="checkbox"/> MEA <input type="checkbox"/> SA <input type="checkbox"/> IAP <input checked="" type="checkbox"/> EE <input type="checkbox"/> CH <b>NOTE:</b> This bulletin applies to the Enlarged Europe markets.	
<b>CUSTOMER SYMPTOM:</b>	<b>Customers may experience one or more of the following:</b> <ul style="list-style-type: none"> <li>• The vehicle does not operate in electric mode.</li> <li>• Reverse gear is not available.</li> </ul>				
<b>CAUSE:</b>	Various

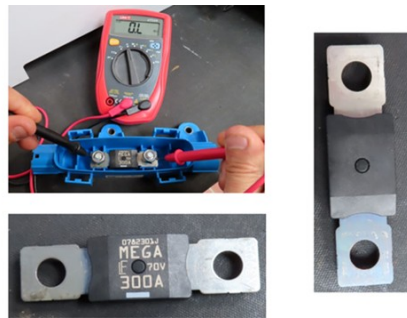
Fig. 2

Check the wiring between the 48V battery and the electric motor. The 300A fuse found on the wiring in a blue box has two nuts. Check the tightness of the nuts.

There is no continuity, open circuit detected. The fuse has a darker side.

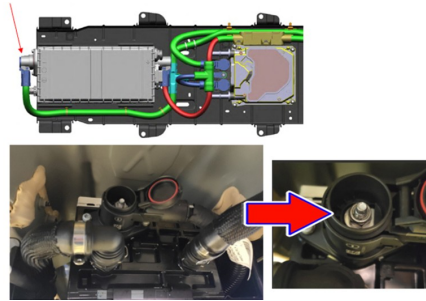
Fig. 4

Check the connection between the wiring harness and the 48V battery. The connector nut on the positive terminal of the 48V must be tightened.

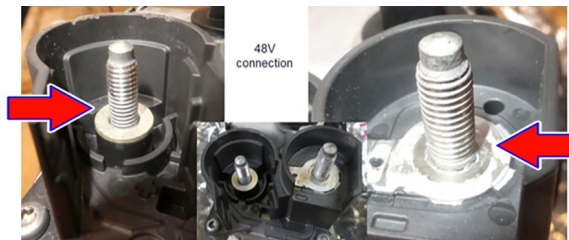
Fig. 6

Check the tightness of the nuts at the 48V battery connection and the Inverter.
