Technical Service Bulletin (TSB)
Tensioner Pad Snubber Assembly Issue

REFERENCE:	TSB: 09-007-26 GROUP: 09 - Engine	Date:	May 6, 2026	REVISION:	—
VEHICLES AFFECTED:	2025 (BV) Jeep Renegade This bulletin applies to vehicles built on or after August 15, 2025 (MDH 0815XX) and on or before November 15, 2025 (MDH 1115XX) equipped with the 1.5L I4 DOHC Turbo MHEV Engine (Sales Code EYP).			MARKET APPLICABILITY: <input type="checkbox"/> NA <input type="checkbox"/> MEA <input type="checkbox"/> SA <input checked="" type="checkbox"/> IAP <input checked="" type="checkbox"/> EE <input type="checkbox"/> CH NOTE: This bulletin applies to Enlarged Europe and India & Asia Pacific markets.	
CUSTOMER SYMPTOM:	Customers must experience a Malfunction Indicator Lamp (MIL) illumination and the vehicle must exhibit/set the following Diagnostic Trouble Code (DTC): <ul style="list-style-type: none"> • P0016 - Crankshaft/camshaft Timing Misalignment - Bank 1 Sensor 1. Customers may also comment on the following: <ul style="list-style-type: none"> • Engine runs rough.

CAUSE:	Wrong assembly of the tensioner pad snubber

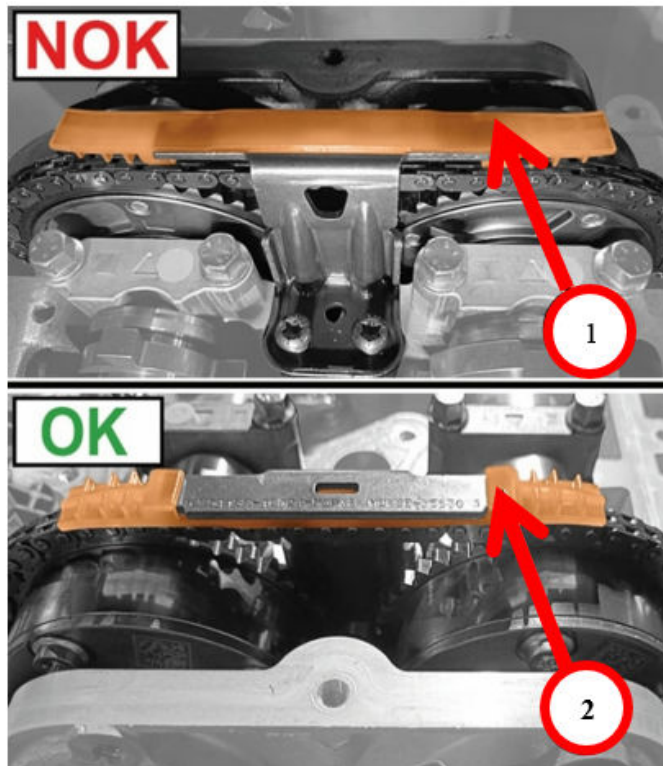
Fig. 1
Snubber Conformity

2. Check conformity of the tensioner pad snubber [Fig. 1](#).

1 - Non Conforming Tensioner Pad Snubber
2 - Conforming Tensioner Pad Snubber

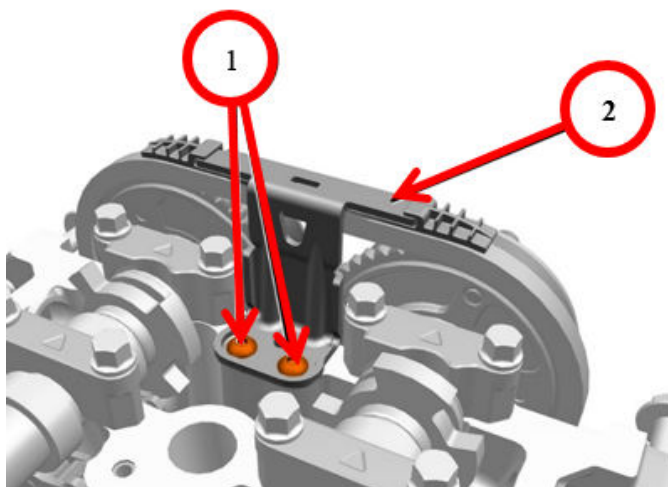
Fig. 2
Remove Cylinder Head Fixed Pad

1 - Cylinder Head Fixed Tensioner Pad Snubber Screws
2 - Cylinder Head Fixed Tensioner Pad Snubber

4. Undo the screws and remove the cylinder head side fixed tensioner pad snubber [Fig. 2](#).

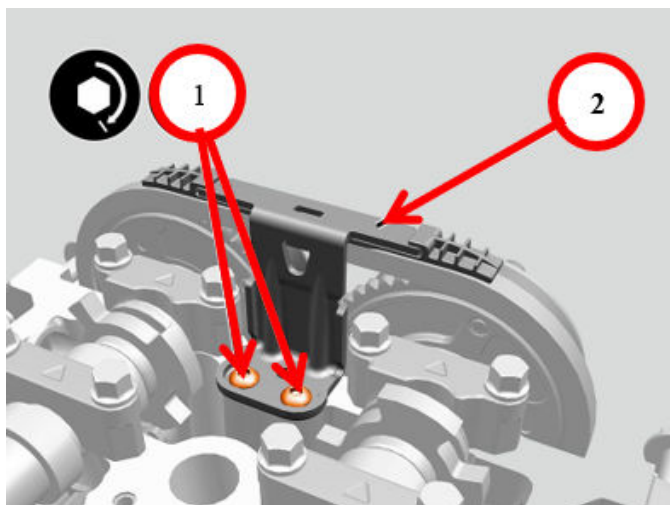
Fig. 3
Install Cylinder Head Fixed Pad

1 - Cylinder Head Fixed Tensioner Pad Snubber Screws
2 - Cylinder Head Fixed Tensioner Pad Snubber

- Put the **NEW** cylinder head side fixed tensioner pad snubber in place and tighten the fixing screws to 0.9 ± 0.1 daNm (90 ± 0.1 cN) Fig. 3.
