## Wind Noises at Top of Windshield Above 60mph

Topic number	LI67.10-P-071418
Version	2
Function group	67.10 - Windshield
Date	5/13/26
Validity	X247 and W177 from start of production
Reason for change	Remedy revised Model series added

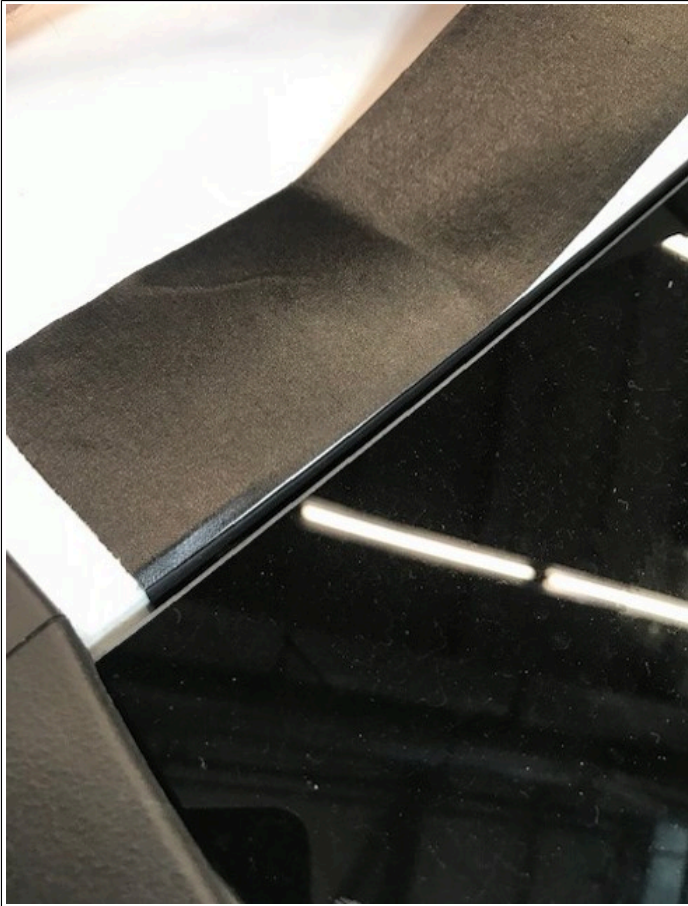
Attachments	
File	Description
<a href="#">Dachvorderkante_abkleben.jpg</a>	Image 1

Insufficient sealing between the windshield lip seal and the body.

1. Using tape, mask off the front edge of the roof along the entire length of the lip seal. (See Image1)
2. Apply window sealant between the lip seal and the body panel. (See Image 2)
3. Press the lip seal onto the front edge of the roof.
4. Clean the work area thoroughly and remove any excess sealant material.
5. Perform a road test to confirm the wind noise concern has been resolved.

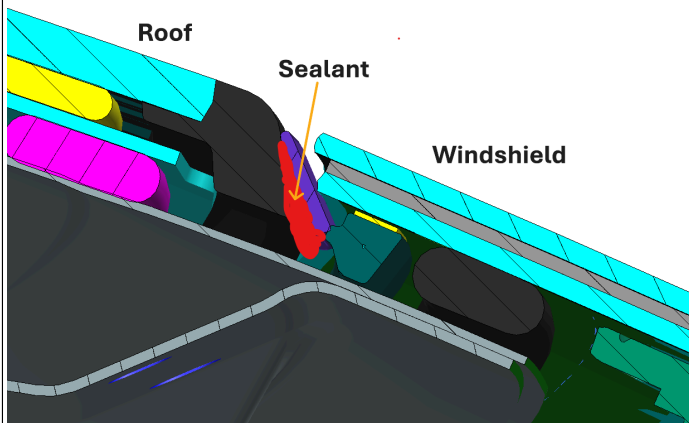
After Application of Sealant.png

Image 2 - See sealant location in red
