## Unwiped Area During Downward Wiper Blade Movement

| Topic number | LI82.30-P-078932 |
| Function group | 82.30 - Windshield wipers |
| Validity | Model series 167 with standard wiper system as from production date 21.10.2022 Tuscaloosa plant, 31.10.2022 CKD |

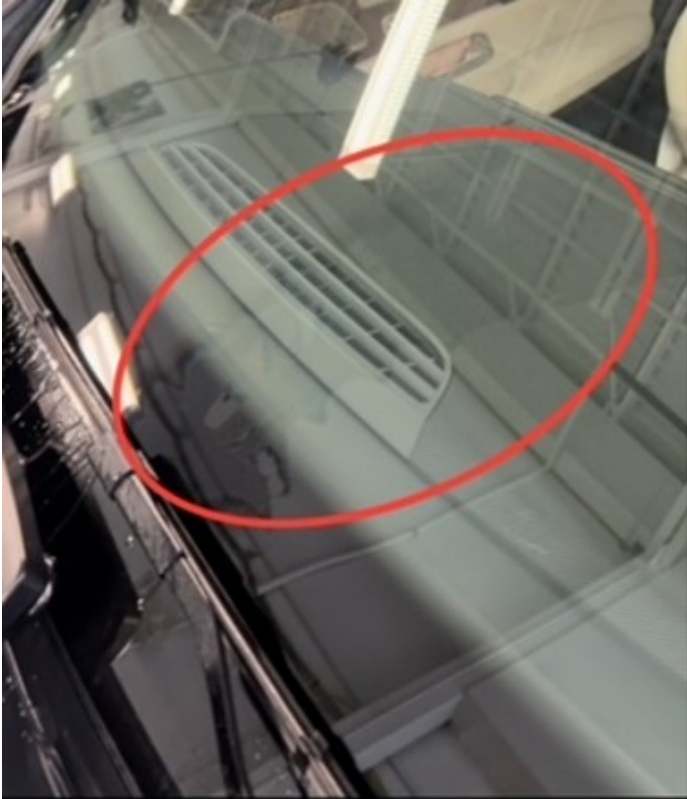
Approx. A 5–10 cm wide unwiped strip remains in the area of the wiper blade attachment during the downward movement of the wiper on the driver's side or front passenger side (see Figure 1).

| Attachments | |
|---|--|
| Bild1.jpg | Example: Streaks in the wiper blade attachment area on driver's side |

The wiper lip of a wiper blade before switchover is deformed due to the higher contact pressure of the wiper arm, which can result in a 5–10 cm wide strip in the area of the wiper blade attachment not being fully wiped.

Install the correct wiper blades intended for the vehicle

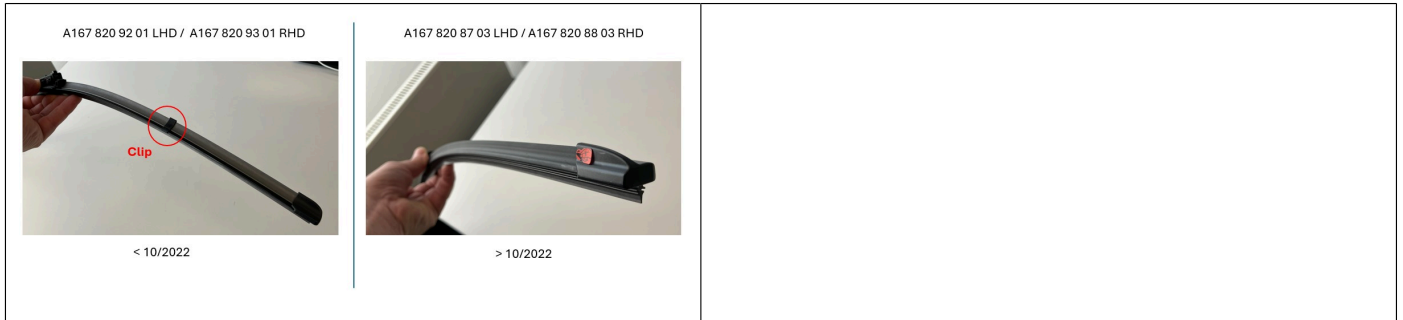
| Attachments | |
|---|--|
| Bild2.jpg | Overview of Characteristics of Wiper Blades Before and After Changeover (Production Month 10/2022) |

The wiper arms of the standard system after the switchover have a higher clamping force and are not compatible with the wiper blades before the switchover.

Wiper blades for vehicles up to October 2022 have a clip between the connector and the end of the blade

Wiper blades for vehicles produced from October 2022 onwards do not have a clip between the connector and the tip of the blade
