SIB 51 12 24

ELECTRIC SUNSHADES FOR THE REAR DOORS DO NOT FUNCTION OR ARE WAVY 2026-05-04

E-Series	Model Description	Affected Option Code
G07	X7 Sports Activity Vehicle	417 – Rear Electric Window Shades

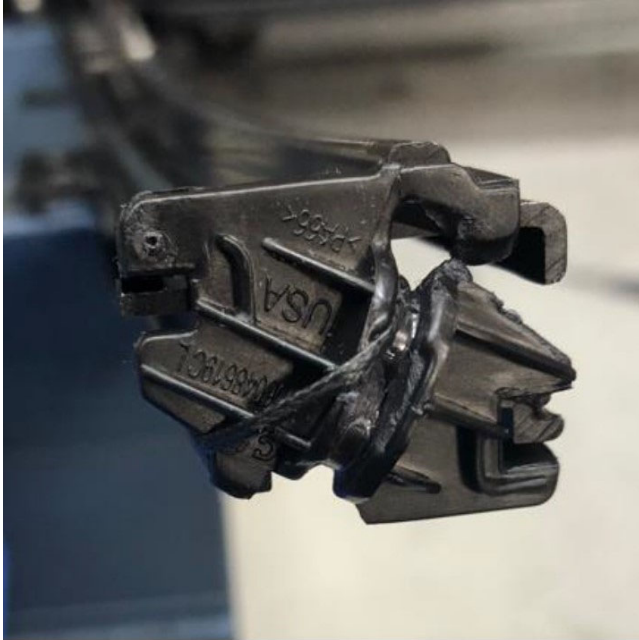
Incorrect routing of the cable.

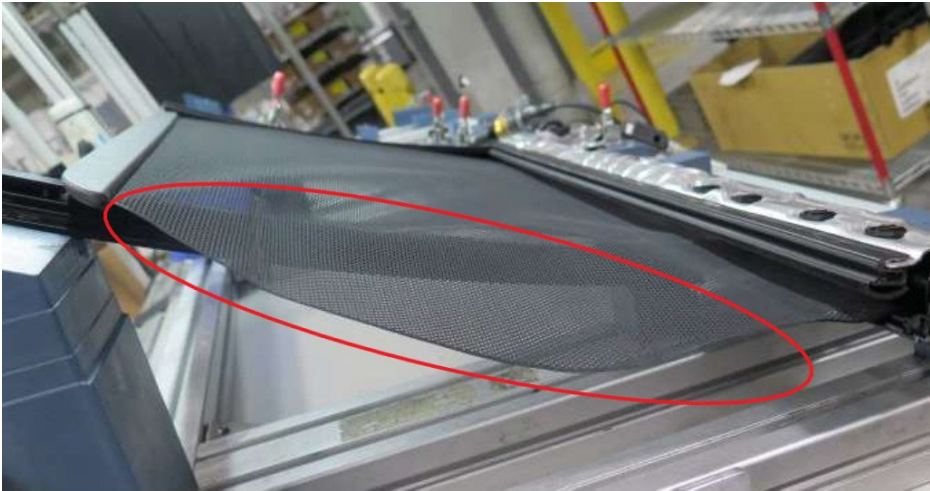
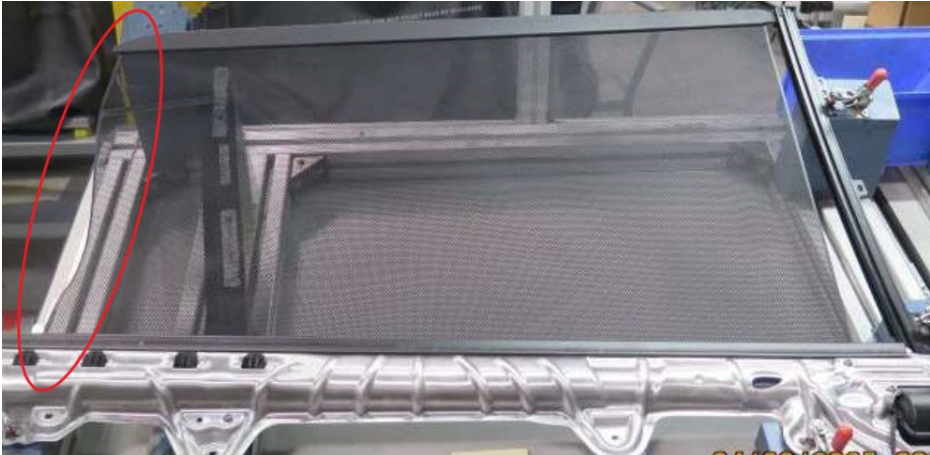
Wavy material, replace ESSR. Review examples below:

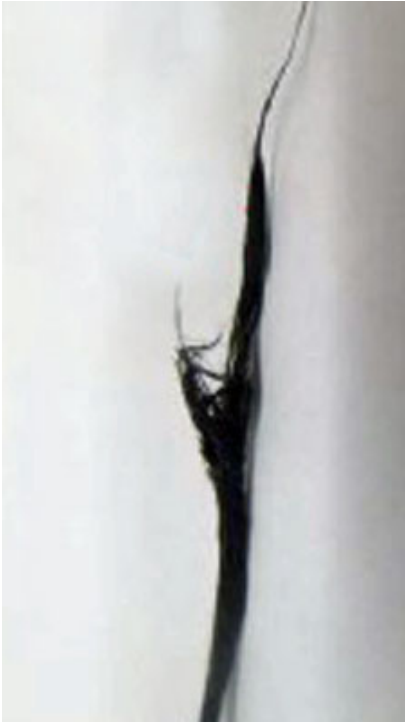
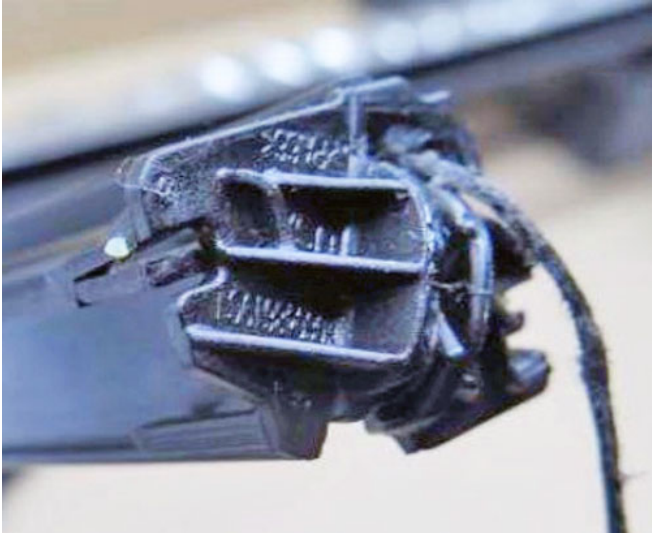
Damaged cable, replace ESSR. Example below:
