SIB 52 19 23

SECOND ROW 60/40 SEAT RAIL FLEX CABLE REPLACEMENT

2026-05-04

G07 (X7) SECOND ROW 60/40 SEAT RAIL

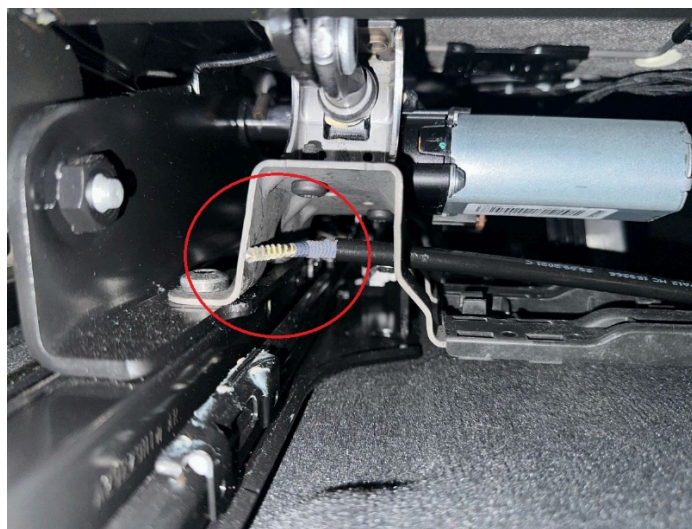
In vehicles equipped with the second row 60% / 40% split seat, the flex cable assembly can come out of the seat rail mechanism (circled). This stops the forwards and backwards travel of the seat.

Something has mechanically jammed the seat movement on one or both sides of the seat.

Locate and remove the foreign object, if still present.

Determine the extent of the damage per the various Situations below, then make the appropriate repair. There are numerous parts kits available, so you don't have to replace the entire seat rail assembly.

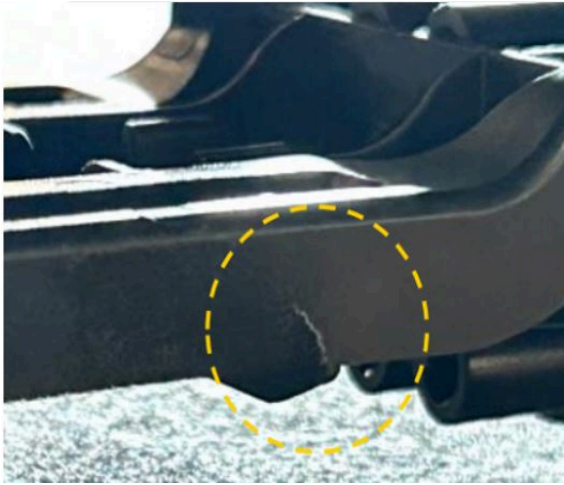
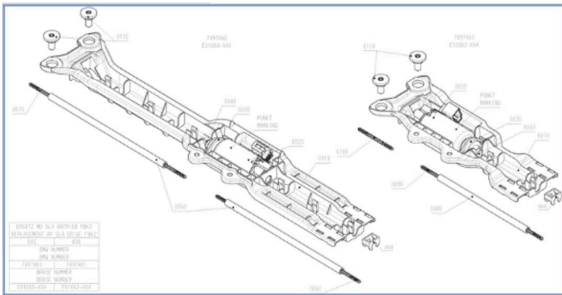
SITUATION 1

The plastic SLV Motor Carrier tray is broken.

The plastic SLV Motor Carrier tray is available with flex shaft kits.

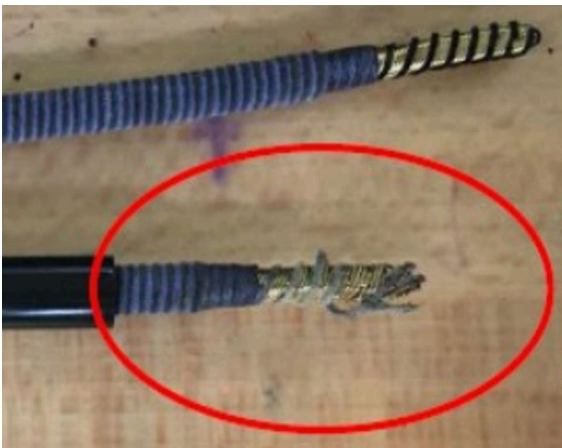
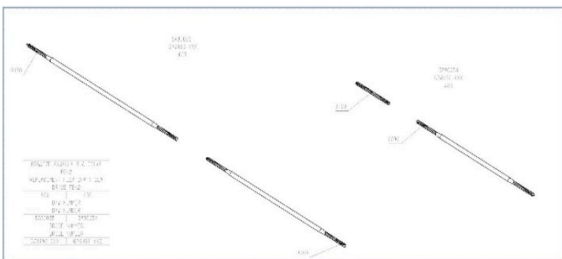
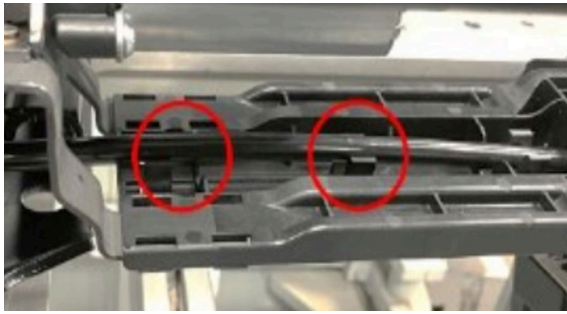
SITUATION 2

The flex cable is damaged.

If the flex cable end has been damaged, do not reuse it.

Replace only the damaged flex cable assembly instead of entire seat rail assembly. Install a new locking clip as per situation 3.

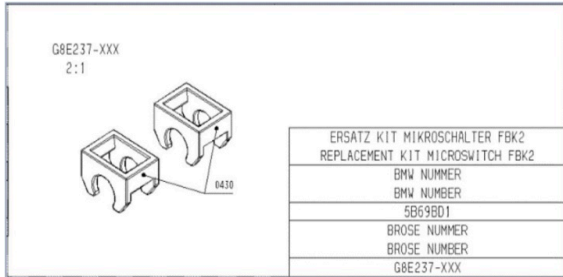
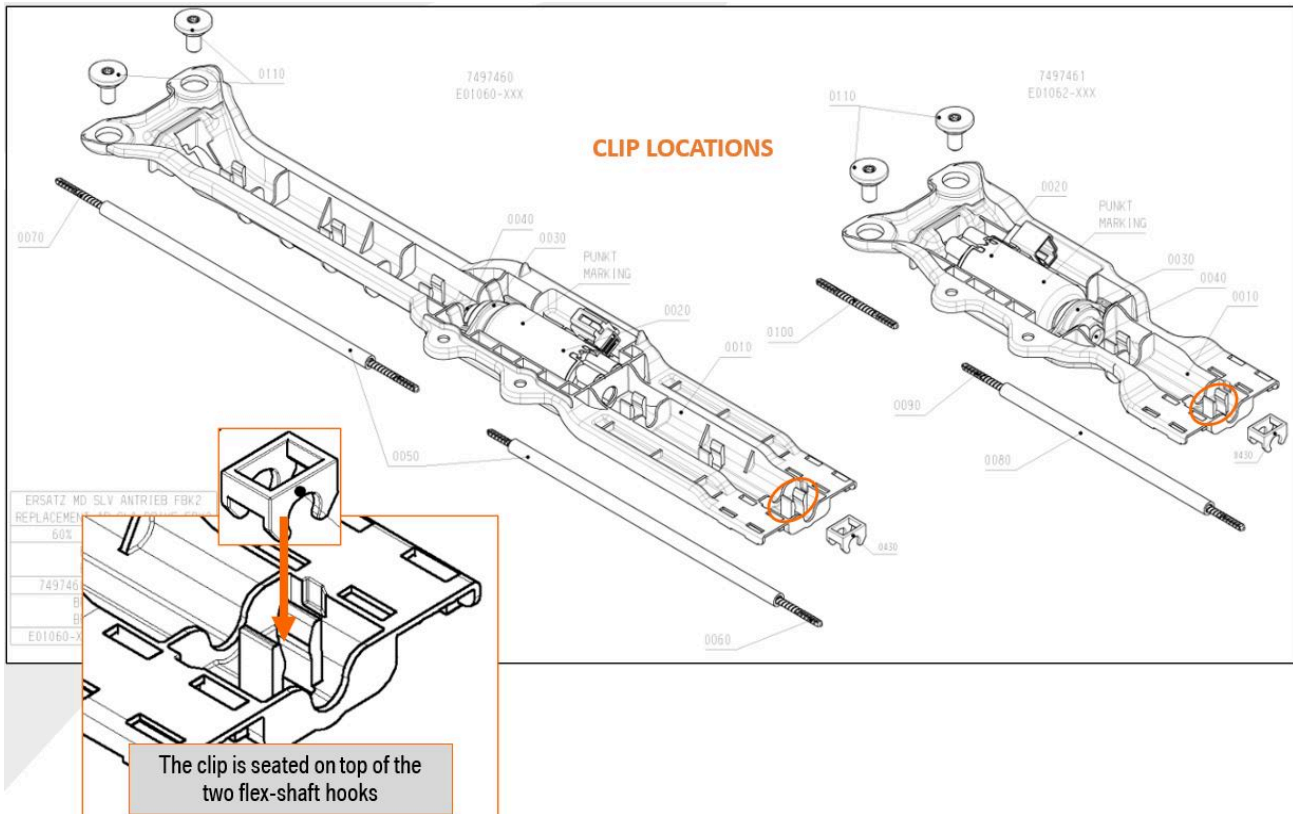
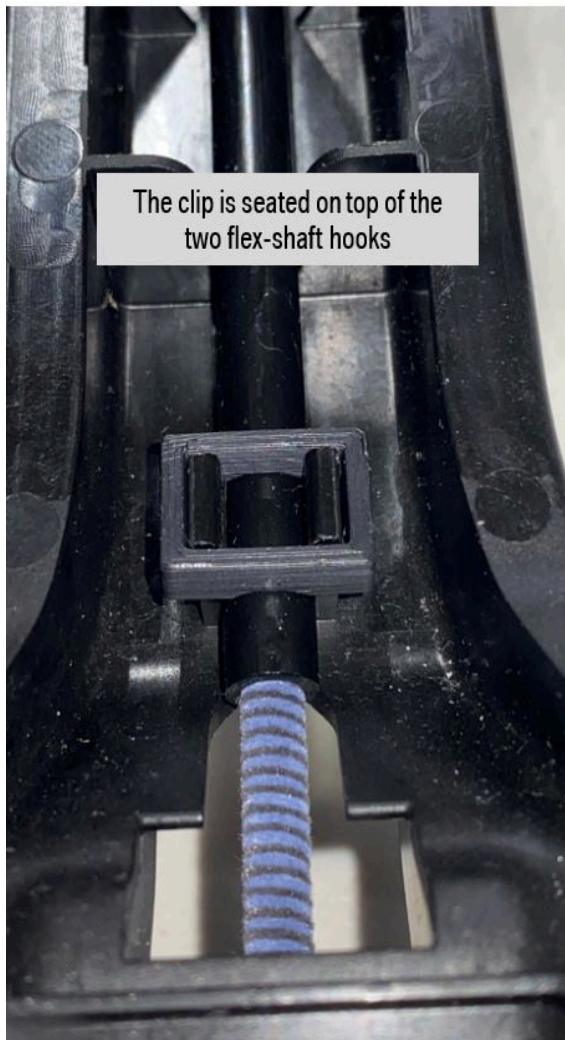
SITUATION 3

The Flex Cable has popped loose from the U-shaped flex shaft hooks. If the flex cable end is not damaged, check the U-shaped hooks on the plastic carrier.

The clip is seated on top of the two flex-shaft hooks

NOTE: If this locking clip has come loose due to the cable popping free, it should be replaced.

- If the U-shaped hooks are damaged, replace SLV Motor Carrier tray (see situation 1)
- If the U-shaped hooks are not damaged, reinstall flex cable into U-shaped hooks and replace locking clip

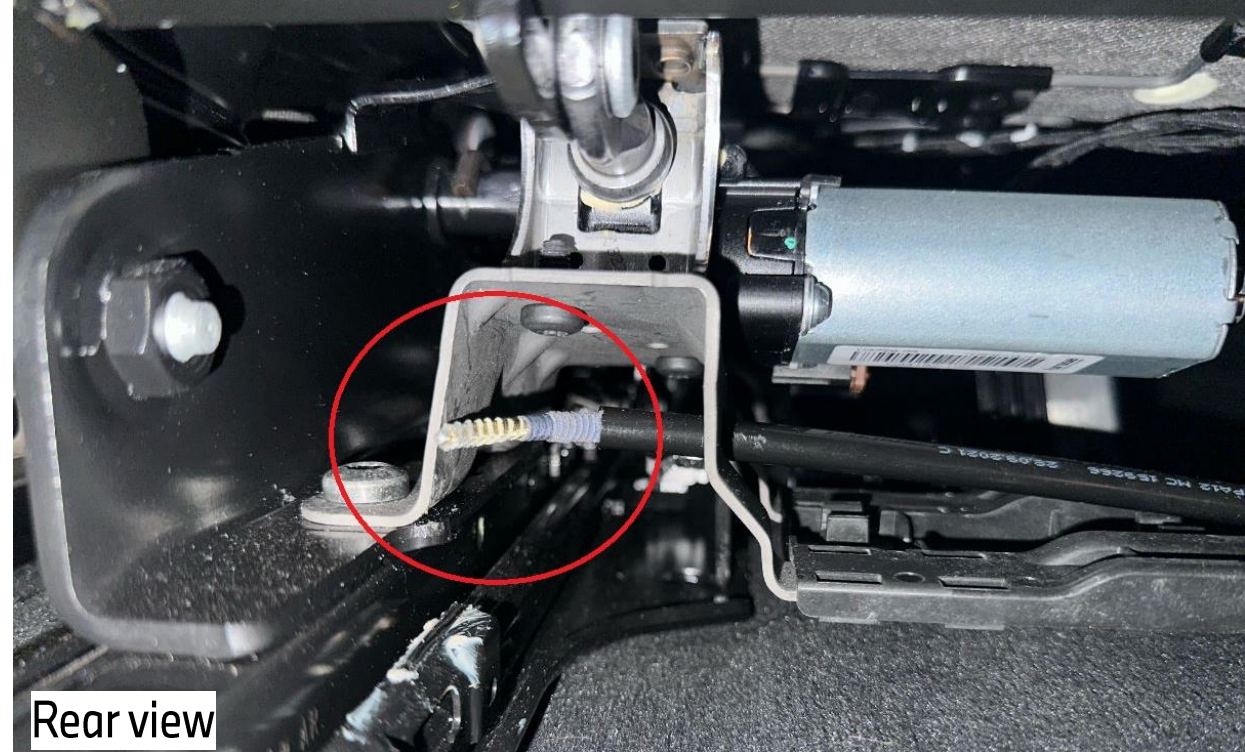
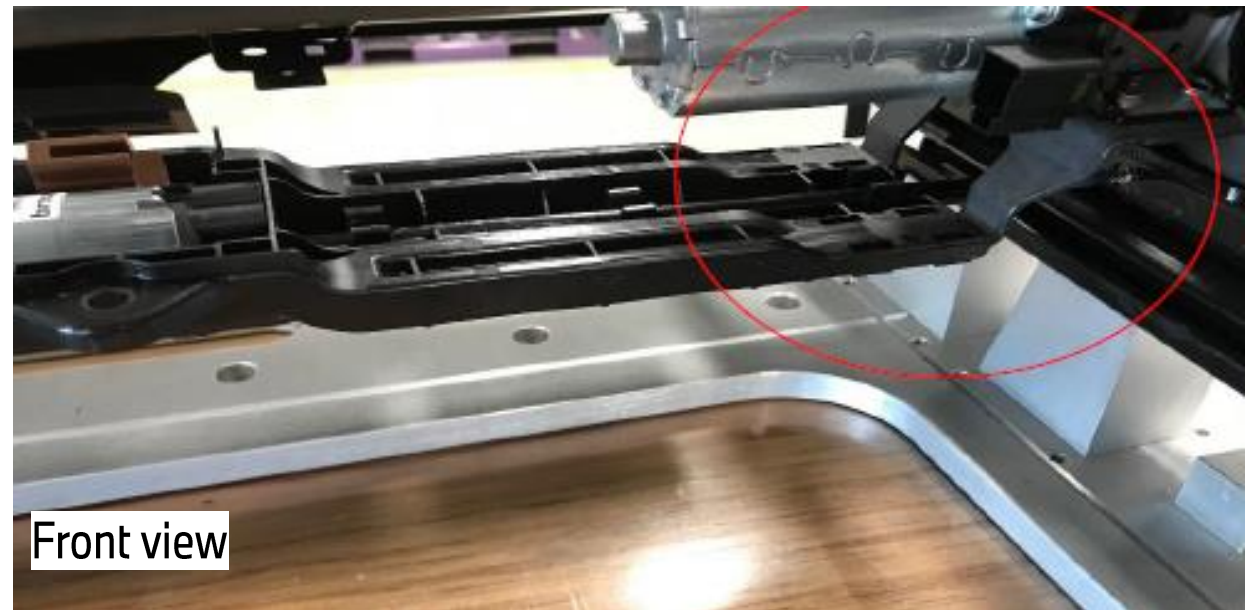
In this example the 60% seat inboard flex cable has come out of the seat rail gearbox. **The locking clip has come loose.**

This will stop the seat from moving forwards and backwards on the rails.

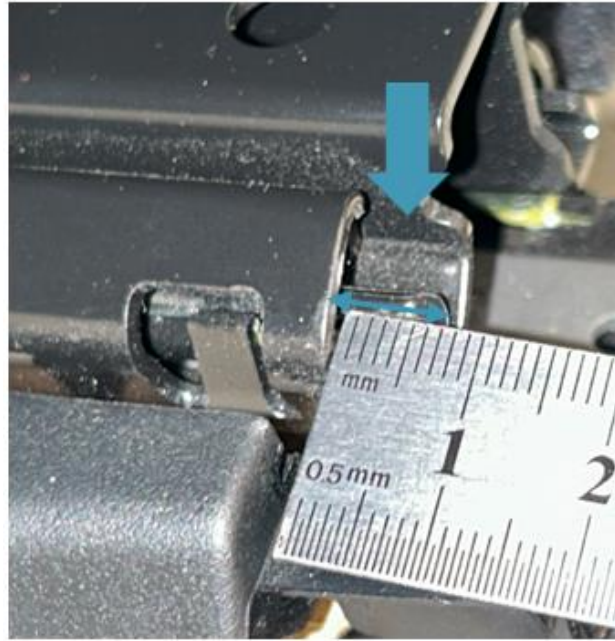
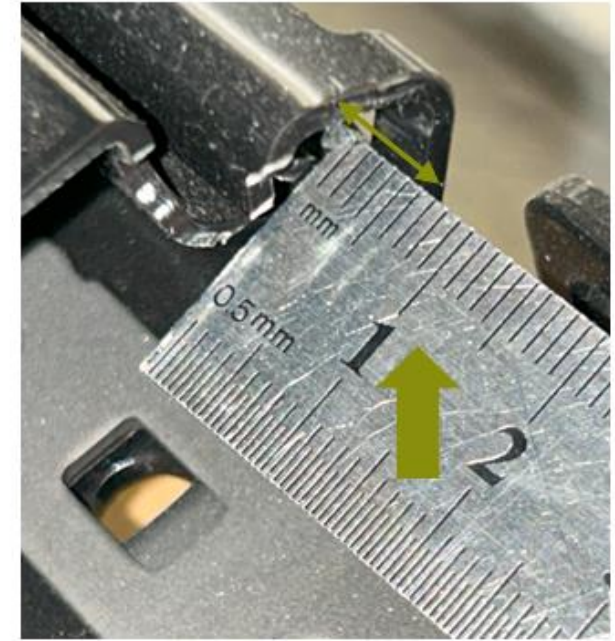
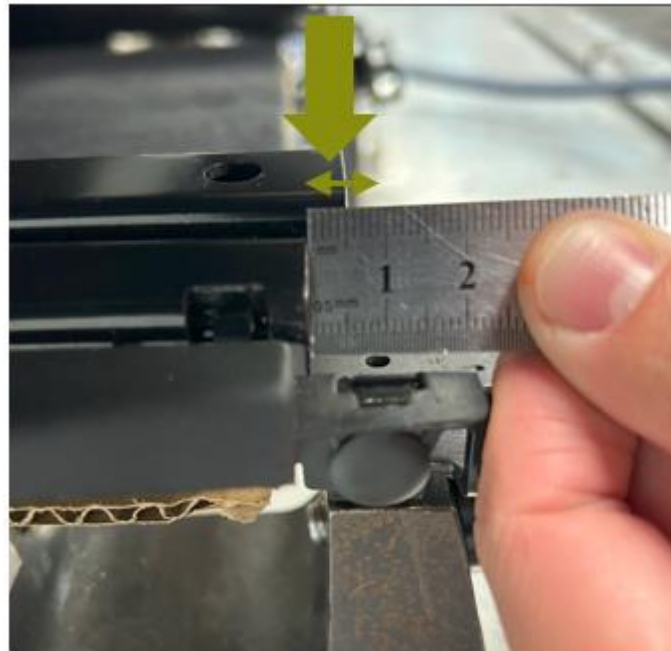
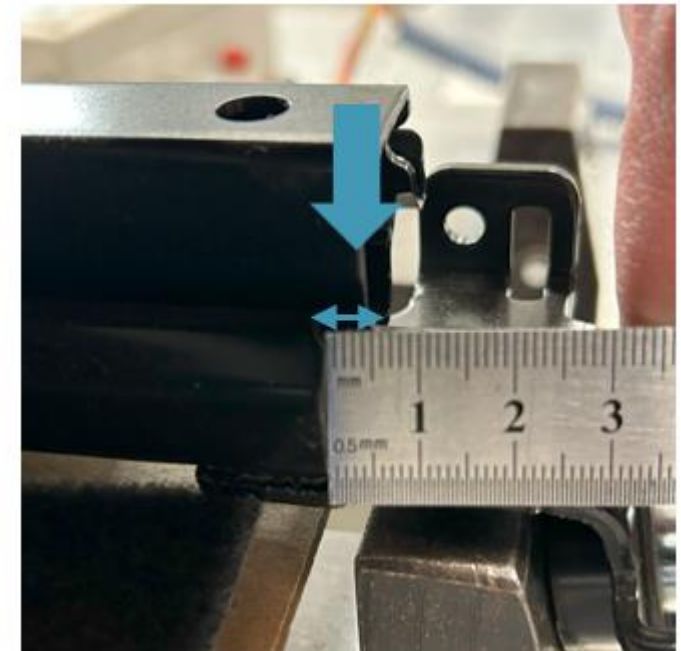
Left Rail: 8 mm outside Frame

Right rail: 6 mm Inside Frame

Considering that the right flex shaft is out of position, the left one must move the necessary distance so that it is aligned with the right one.

Now both rails are at 4 mm

3. Measure the misalignment on both rails and compare how much the difference is. Note: Do the same process for the right side and the left side.

After aligning rails side to side remeasure before flex cable installation.
