SIB 63 09 25

FAILURE/MALFUNCTION OF THE AMBIENT LIGHTING AFTER PROGRAMMING UPDATE 2026-05-04

This Service Information Bulletin (Revision 3) replaces SI B63 09 25 dated **March 2026**.

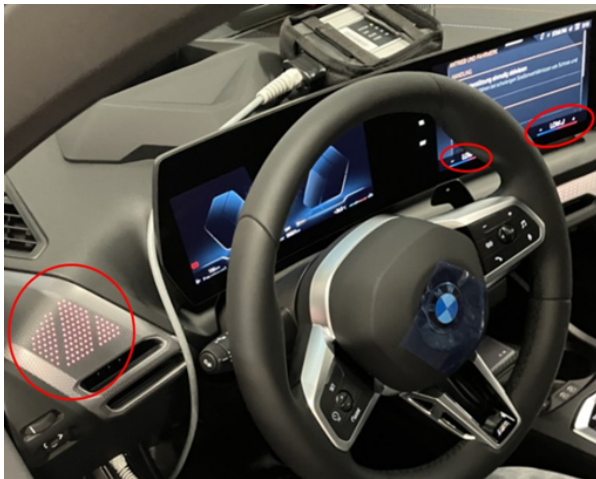
After programming the vehicle via ISTA/RSU to 25-07-5xx, some of the interior ambient lighting strips (examples circled) may no longer function properly.

- **804A38 – Interior lights layering (IL-LIN_3): versioning incorrect: LIN slave 5**
- **804A39 – Interior lights layering (IL-LIN_3): versioning incorrect: LIN slave 6**
- **804A3E – Interior lights layering (IL-LIN_3): versioning incorrect: LIN slave 11**

Unfavorable logic in the LED control unit hub.

Follow the test plan to encode the LED control unit hub.
