SIB 64 03 26

COOLANT PUMP NOISES PERCEPTIBLE IN VEHICLE INTERIOR

2026-05-07

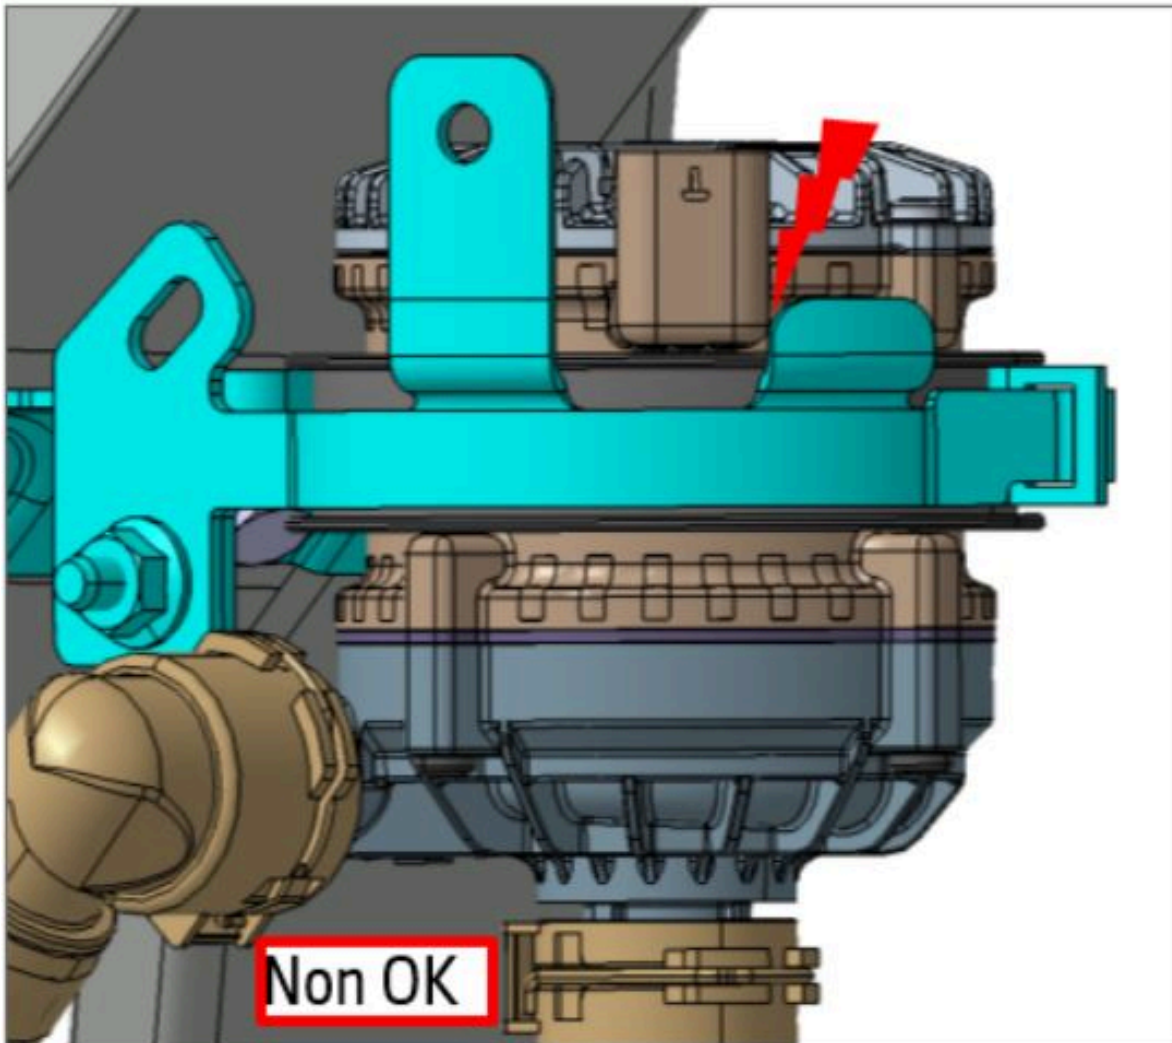
Incorrect positioning of the auxiliary coolant pump (brown) within the metal holder (blue) renders the acoustic decoupling of the pump ineffective. Interference noises can travel into the vehicle interior via the body. Reference the picture below.

Check the positioning of the auxiliary coolant pump in the holder. Loosen the pump in the holder and rotate to a position where there is no direct contact between the pump electrical connector and the holder.

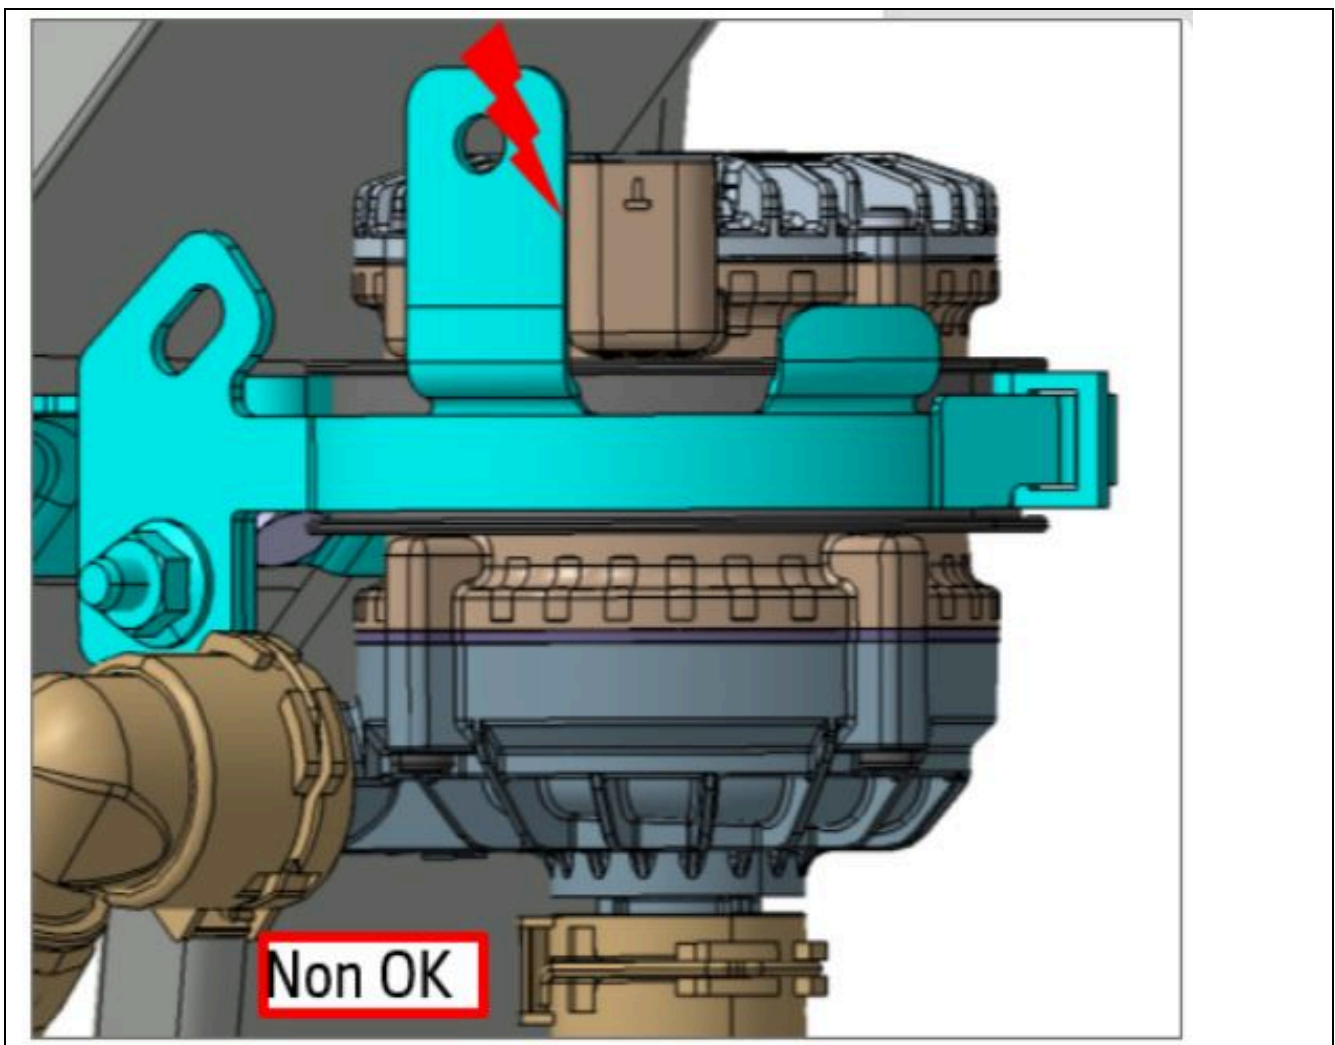
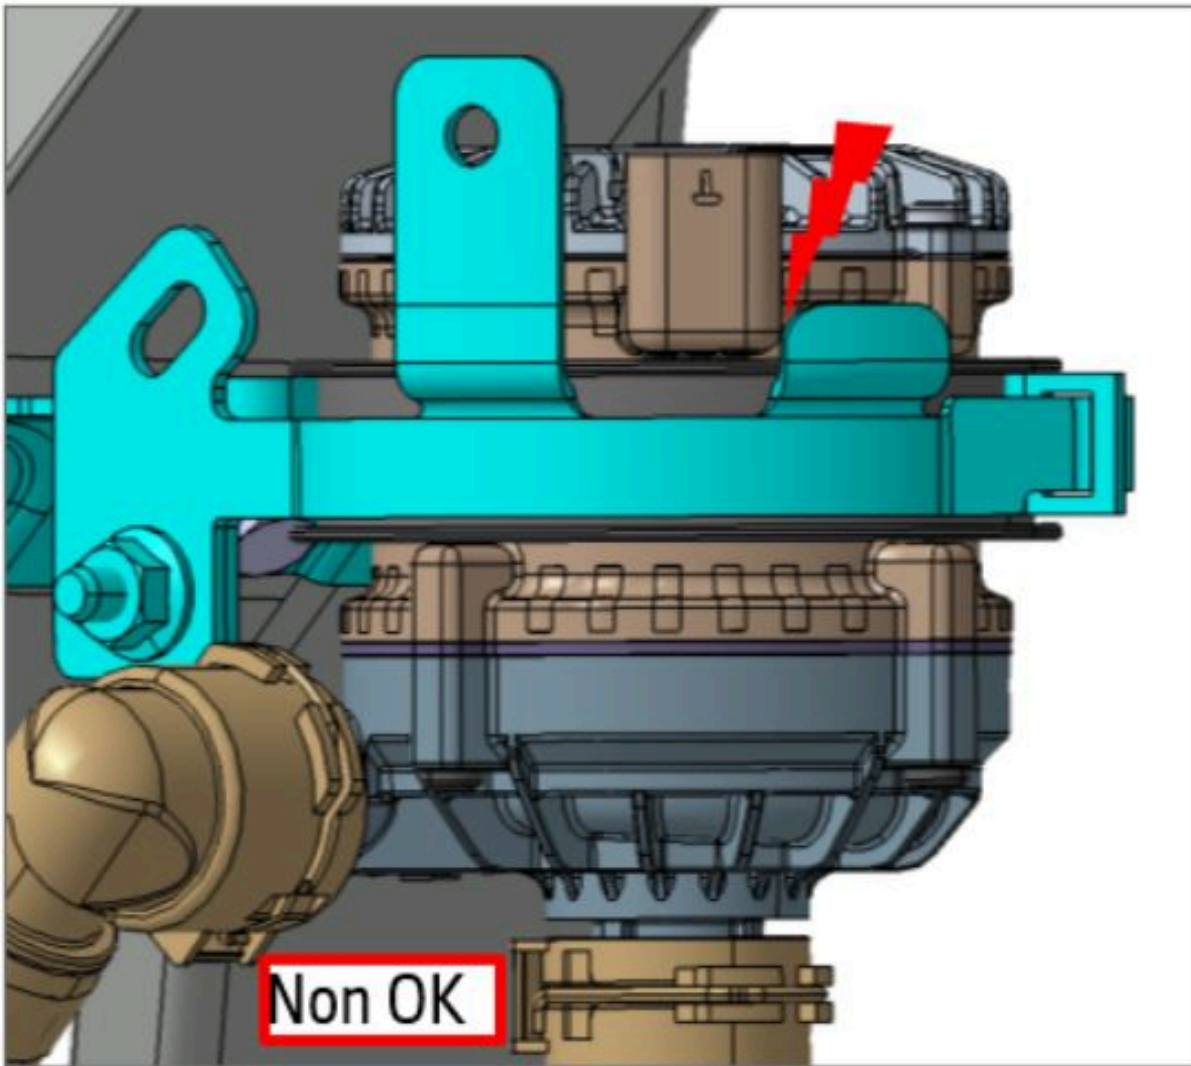
If the connector housing is in contact with the bracket of the holder (along the vertical edges shown at red "lightning bolt" in either photo below), the rubber-like decoupling ring of the auxiliary coolant pump becomes ineffective. Interference noises occur during the operation of the auxiliary coolant pump.

2-If you find it in one of the above positions, the positioning of the auxiliary coolant pump in the holder must be changed.

Unscrew the clamp connection of the holder.
