SIB 64 12 24

FRONT CENTER DASH VENT ASSEMBLY – AIR SLAT REPAIR KITS

2026-05-04

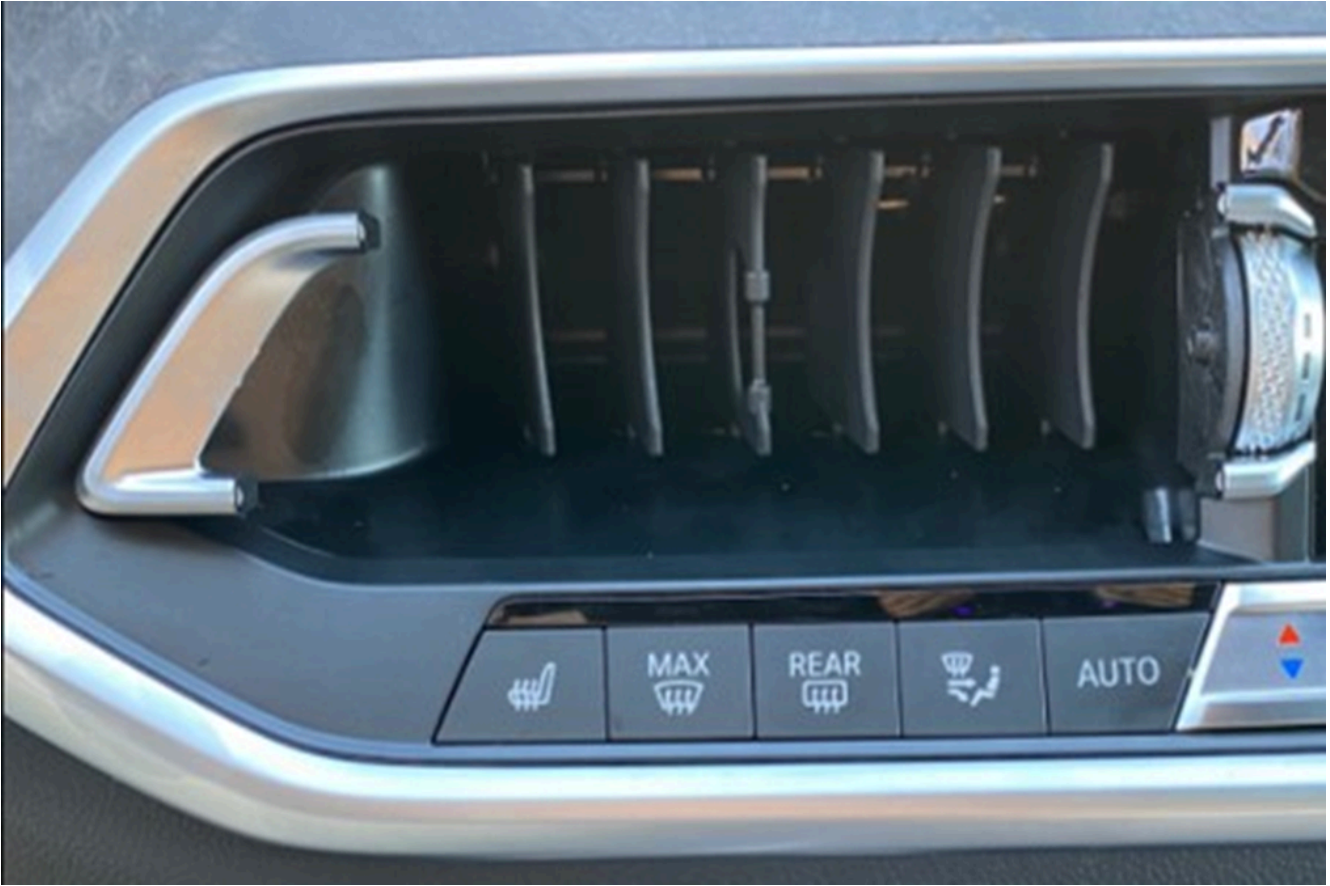
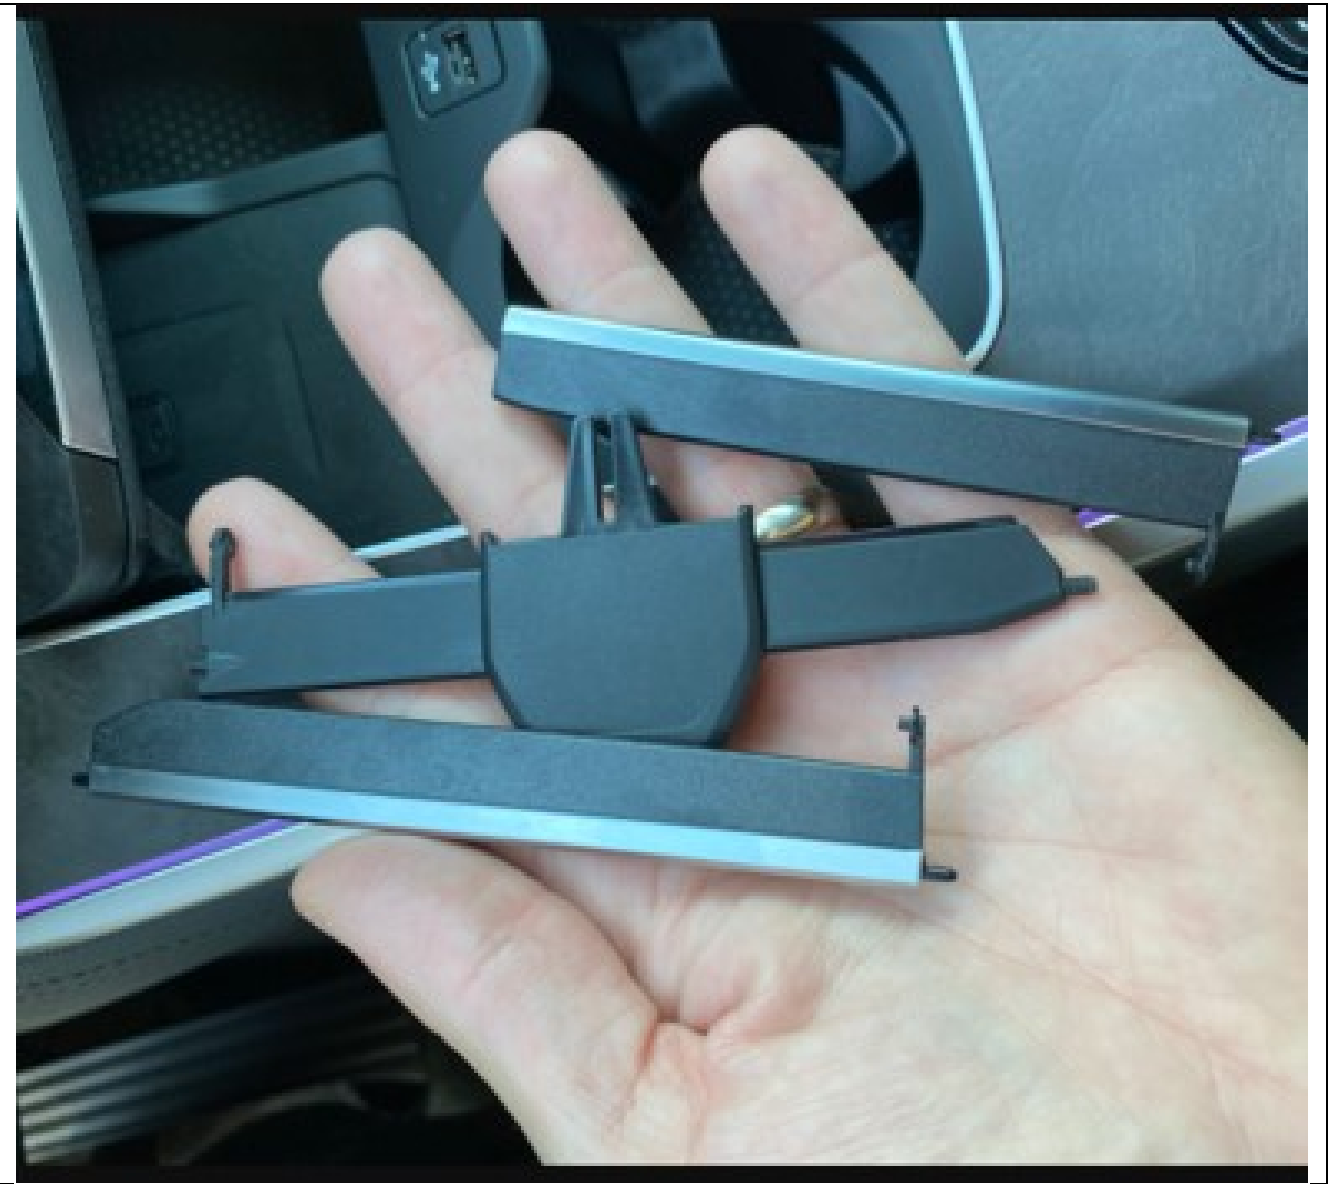
1. Use of aftermarket accessory hang-on cellular phone holders and/or air fresheners can break the instrument panel air vent slats.

Originally, the air vent slats were only repairable by replacing the entire front center dash vent assembly; which in some applications, also included the IHKA control module.

The plastic vent slats were only designed to direct air for the climate control. They cannot support the additional weight of these aftermarket accessories.

1. Replace damaged vent slats using the vehicle-specific vent slat repair kit. All vehicles.
2. Replace the chrome end cap. Only for F95, F96, G05, G06/G07 up to 3/23.

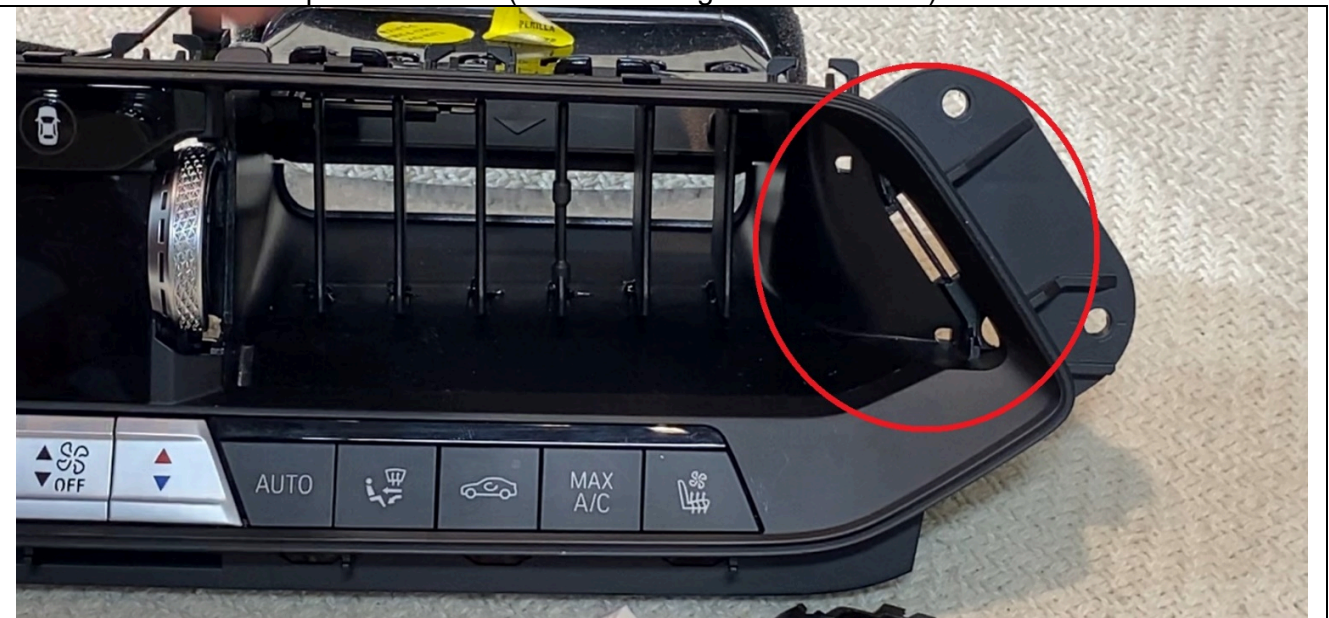
2. The chromed end cap comes loose (shown missing within the circle):

2. To replace the chrome end cap, the climate control panel must be removed from the dashboard.

The white plastic locking clip is attached from the rear of the panel.

Only for F95, F96, G05, G06/G07 up to 3/23.
