TECHNICAL SERVICE BULLETIN

Carpet Loose Or Torn

26-2205

15 May 2026

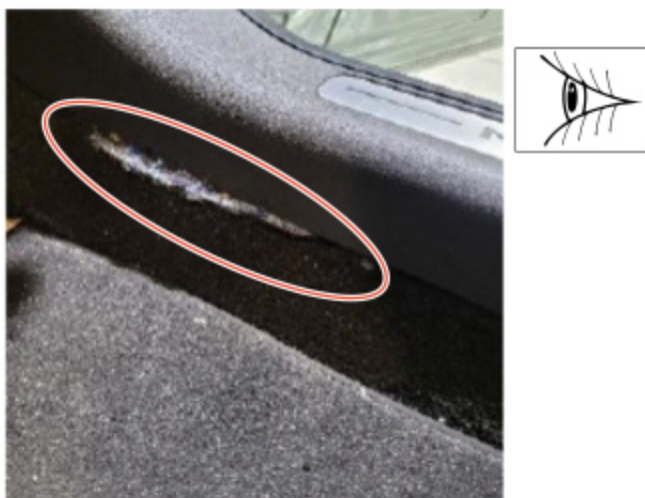
Figure 1

Issue: Some of the vehicles listed in the Model statement above may exhibit a condition where the carpet is loose or torn near the front/rear scuff plate trim panel. This may be due to the carpet tearing at or near the retainer hole.

1. Remove the front/rear scuff plate trim panel from the vehicle to expose the loose carpet area. Refer to the [WSM](#), Section 501-05 Interior Trim and Ornamentation > Removal and Installation. (Figures 1-2)
