SIM 18 01 26

DISCOLORIZATION OF EXHAUST SYSTEM REAR SILENCER

U25 (Countryman S ALL4/JCW Countryman ALL4)

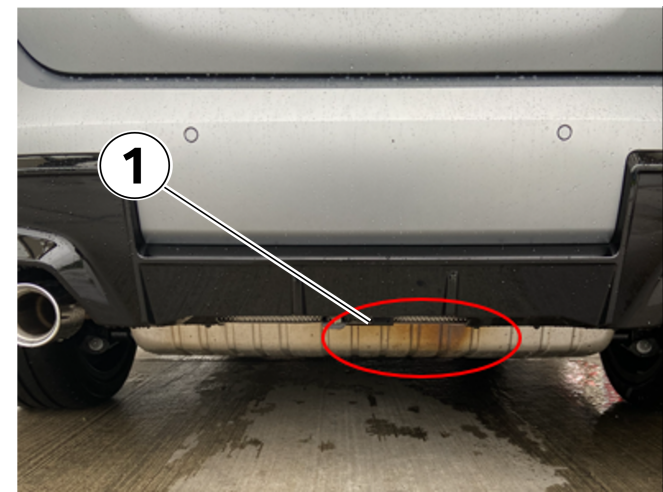
The rear silencer is discolored.

Tarnishing of the metal (1) on the rear silencer is caused by the heating and cooling of the exhaust.

Inform the customer this is a normal occurrence when the metal of the exhaust system gets to operating temperatures.

It does not affect the functionality, or the durability of the exhaust system.

This is not rust/corrosion.
