Service Bulletin

Bulletin No.: PIT6209J

Subject: Update Failed See Dealer to Restore System Screen Recovery

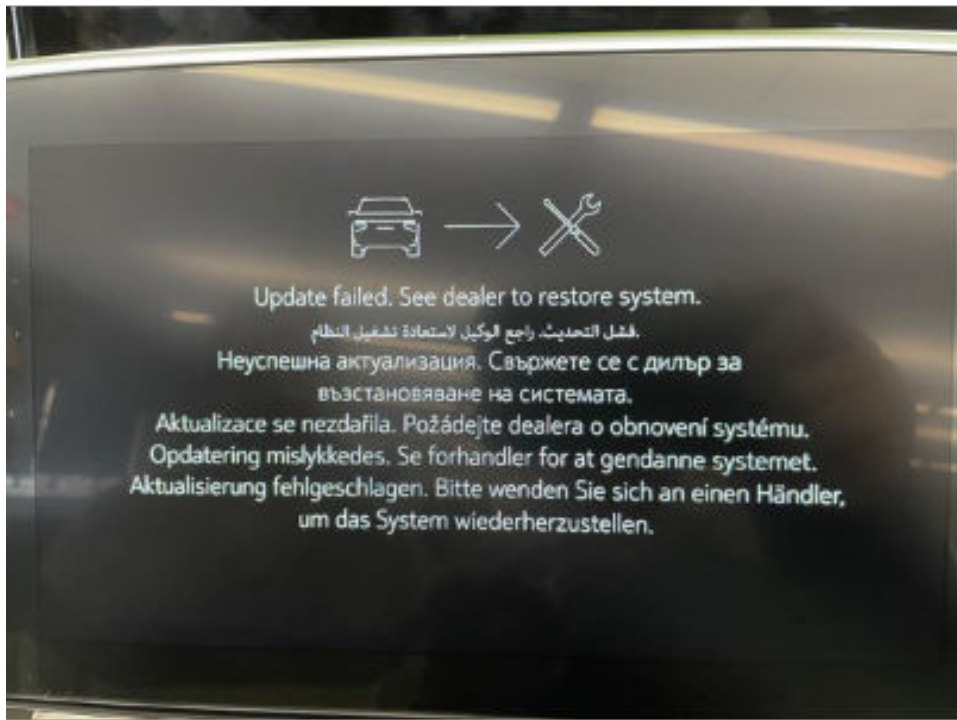
<p style="text-align: right;">6873187</p>
<p>Cause</p>	<p>The cause of the condition may be software anomalies.</p>

<p>Condition</p>	<p>A customer might bring the vehicle in with radio showing a vehicle and an arrow pointing to a wrench. The recover method in Radio Malfunction may not work.</p>

Note: Perform the procedure below prior to replacing any A11 radio if necessary.
