<b>REFERENCE:</b>	<b>TSB:</b> 08-208-26 REV. A <b>GROUP:</b> 08 - Electrical	<b>Date:</b>	May 13, 2026	<b>REVISION:</b>	08-208-26
<b>VEHICLES AFFECTED:</b>	<p>2019 - 2026 (DT) RAM 1500 Pickup                  2018 - 2026 (DJ) RAM 2500 Pickup                  2018 - 2026 (D2) RAM 3500 Pickup                  2018 - 2026 (DD) RAM 3500 Cab Chassis                  2018 - 2026 (JL) Jeep Wrangler                  2020 - 2026 (JT) Jeep Gladiator                  2024 - 2026 (KM) Jeep Cherokee/Wagoneer S                  2024 - 2026 (LB) Dodge Charger                  2018 - 2026 (MP) Jeep Compass                  2018 - 2026 (RU) Chrysler Pacifica/Voyager                  2018 - 2026 (WD) Dodge Durango                  2021 - 2026 (WL) Jeep Grand Cherokee/Grand Cherokee L                  2022 - 2026 (WS) Jeep Wagoneer/Grand Wagoneer</p> <p><b>This bulletin applies to vehicles equipped with:</b></p> <ul style="list-style-type: none"> <li>• <b>**Front Row USB Type A and C (Sales Code RTX).**</b></li> <li>• Media Hub-2 USBs (both charge only) (Sales Code RS2).</li> <li>• Remote USB Port - Charge Only (Sales Code RS3).</li> <li>• Media Hub-2 USB, Full Funct, Aux (Sales Code RSF).</li> <li>•

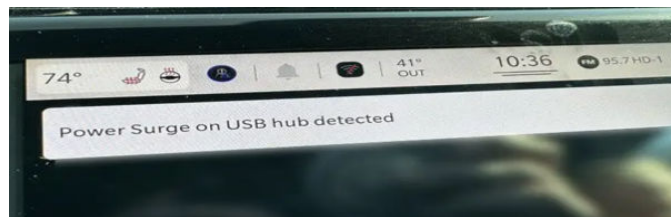
<b>CUSTOMER SYMPTOM:</b>	<p><b>Customers may comment on the following:</b></p> <ul style="list-style-type: none"> <li>• The radio displays the message: "Power surge on USB hub detected" <a href="#">Fig. 1</a>.</li> </ul> <p><b>NOTE:</b> After the message appears, no USB devices function in the hub (no charging, no data).</p> <p><b>NOTE:</b> Hub operation does not return until the vehicle undergoes a full key cycle.</p>				
<b>CAUSE:</b>	Customer's USB device, cable, or accessory short on the customer facing side

**Fig. 1**  
Power Surge Message

This Information Only bulletin provides information concerning the radio message that is displayed when there is an overcurrent or short condition on the customer's USB device, cable, or accessory.

- A damaged or shorted customer USB cable/device.
- The USB hub is in protection mode, which disables power and data lines.

- Identify the customer device/cable in use when the message appeared.
- Disconnect that device/cable and perform a full key cycle.
- Test hub operation with a known good USB device and cable.
- If normal operation is restored after the key cycle, the concern was caused by the customer device/cable or bad wire associated with that connection.
