Technical Service Bulletin (TSB)
Wrong A/C Label Under Hood

REFERENCE:	TSB: 23-014-26 GROUP: 23 - Body	Date:	May 15, 2026	REVISION:	—
VEHICLES AFFECTED:	2026 (LB) Dodge Charger This bulletin applies to vehicles built on and after January 22, 2026 (MDH 0122XX) and on and before January 23, 2026 (MDH 0123XX) equipped with the 3.0L Twin Turbo Sixpack HO ESS (Sales Code EFC).			MARKET APPLICABILITY: <input checked="" type="checkbox"/> NA <input type="checkbox"/> CH <input type="checkbox"/> EE <input type="checkbox"/> IAP <input type="checkbox"/> SA <input type="checkbox"/> MEA NOTE: This bulletin applies to the North America market.	
CUSTOMER SYMPTOM:	Customers may comment on the following: <ul style="list-style-type: none"> A/C not blowing as cold as it should if serviced. 				
CAUSE:	Incorrect A/C label under hood. Incorrect volume of refrigerant indicated. (Correct volume installed).

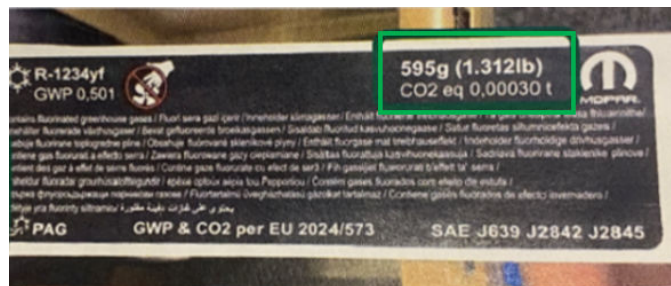
Fig. 1
Incorrect Label

1. Open the hood.
2. Inspect the underhood sticker for correct label [Fig. 1](#), [Fig. 2](#).

3. Is the label correct (595g (1.312lb.)) [Fig. 1](#), [Fig. 2](#)?
 - YES>>> This bulletin is complete. Use Inspect LOP (23-01-18-90) to close this active RSU.
 - NO>>> Replace label:
 - Apply a length of masking tape on the body, parallel to the top of the label.
 - Using a heat gun or lamp, heat the label to a temperature BELOW 52° C (120° F).
 - Use a trim stick or equivalent to remove the label from the body.
 - Thoroughly clean all residue from the label area of the body.
 - Wipe the attachment area with a clean, lint-free cloth moistened with a 50% solution of water and alcohol, wipe dry the area immediately with a dry, lint-free cloth.
 - Remove the protective covering from the backside of the label.

NOTE: If ambient temperatures are below 21° C (70° F), warm the body area using a heat gun or lamp to ensure proper adhesion.

- Using the previously installed masking tape as a guide, install the new label by pressing firmly to ensure proper adhesion.
4. Close the hood.
