STAR ONLINE PUBLICATION

Case Number: S2608000006 Rev. B

Models Affected: 2026 Jeep Cherokee (KM)

Symptom/Vehicle Issue: Limp Home Mode, Red Wrench Lamp Illuminated. DTCs P0C01-00 - Drive Motor A Current High And/Or P0C04-00 - Drive Motor B Current High

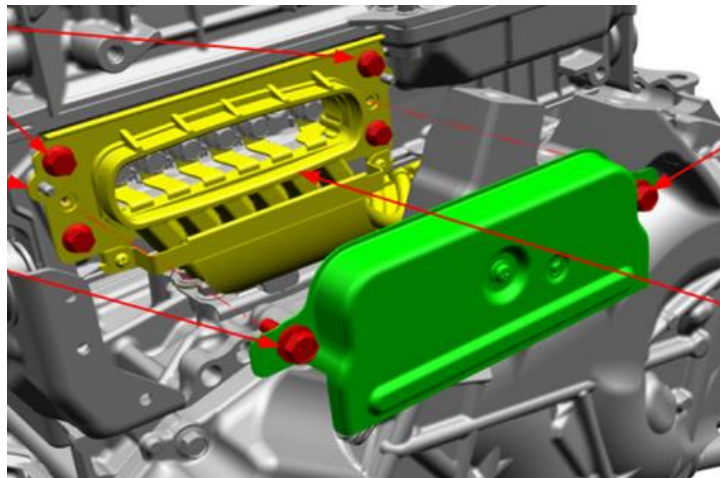
1. Remove the DMPI cable interface cover (Green) and bolts securing the cables.
DO NOT USE POWER TOOLS

Inspect the DMPI connections for signs of cross-threading, damage, loose connections, and/or metallic debris.

Caution: Different length bolts for Trans and DMPI, ensure bolts are in the right position.

DMPI Bolts Part Number: 06514796AA

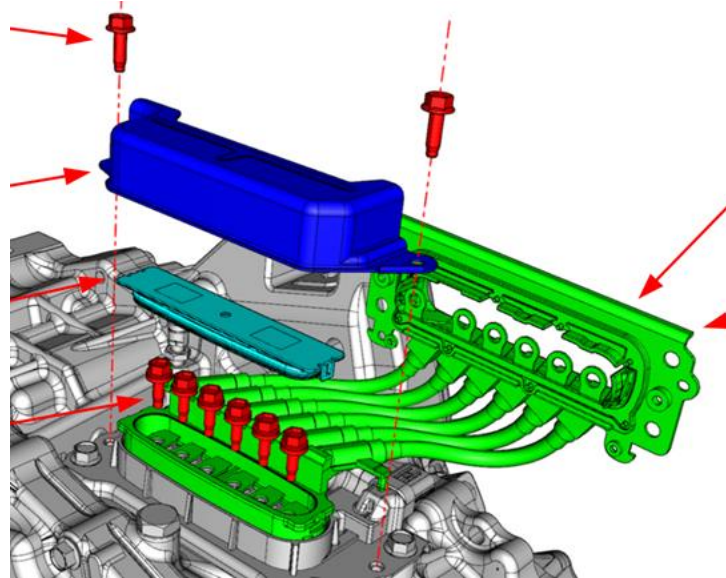
2. Remove the Transmission cable interface cover (Blue) and bolts securing the cables.

Inspect the Transmission connections for signs of cross-threading, damage, loose connections, and metallic debris.

Caution: Different length bolts for Trans and DMPI, ensure bolts are in the right position.

Transmission bolts Part Number: 06514797AA

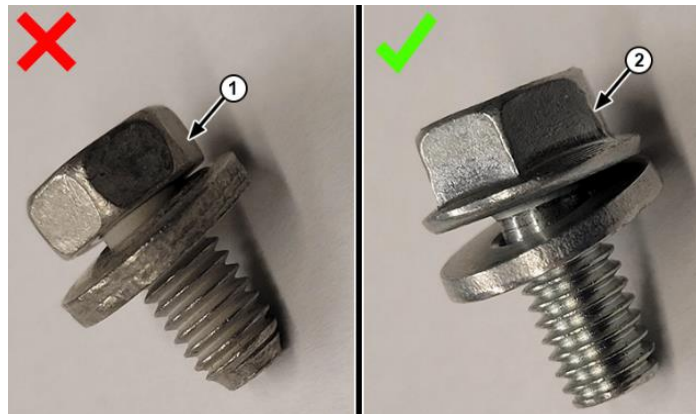
The bolts that secure the HV cables to both the DMPI and Transmission are not only different sizes, but both have also changed from a conical washer to flat washers. During reassembly only use the updated bolt design which utilizes a flat washer. Order replacement bolts as needed.

- 1 - Cable to Transmission Bolt - With Conical Washer (Note Standard Bolt Head)
- 2 - Cable to Transmission Bolt - With Flat Washer (Note Flanged Bolt Head)

Torque to specifications:

12 Nm - Cables to DMPI

8 Nm - Cables to Transmission

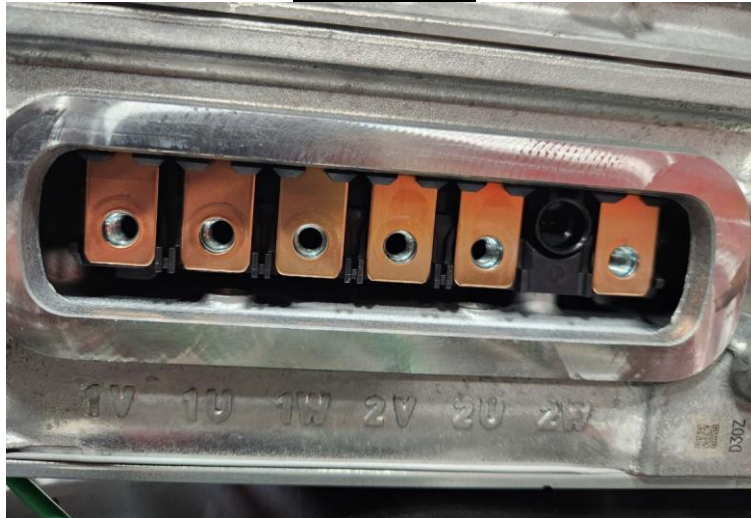
(1)

DMPI Side

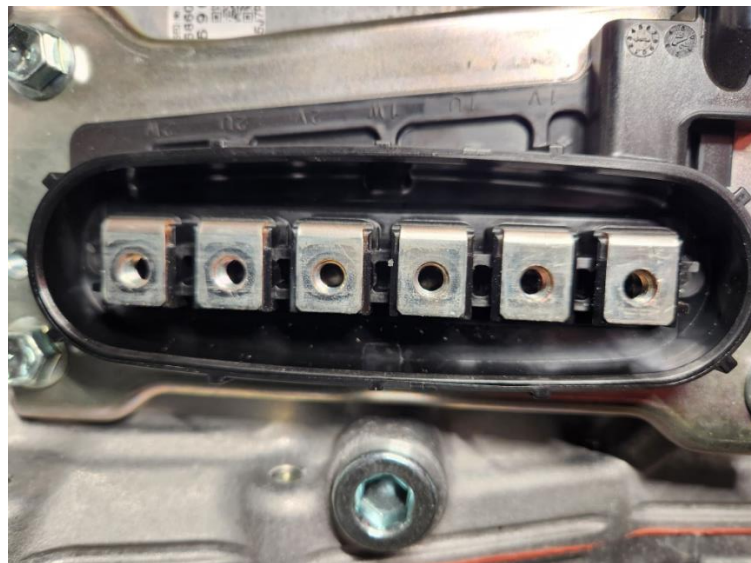
(2)

Transmission side

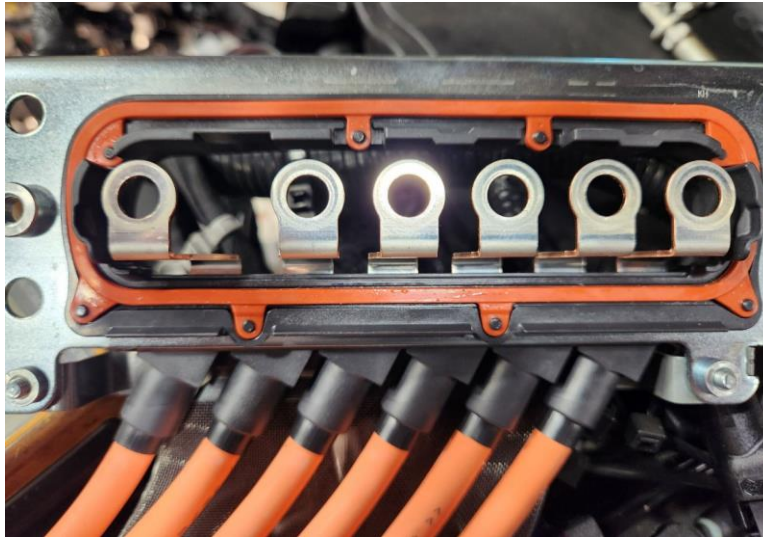
(3)

Wire Harnesses

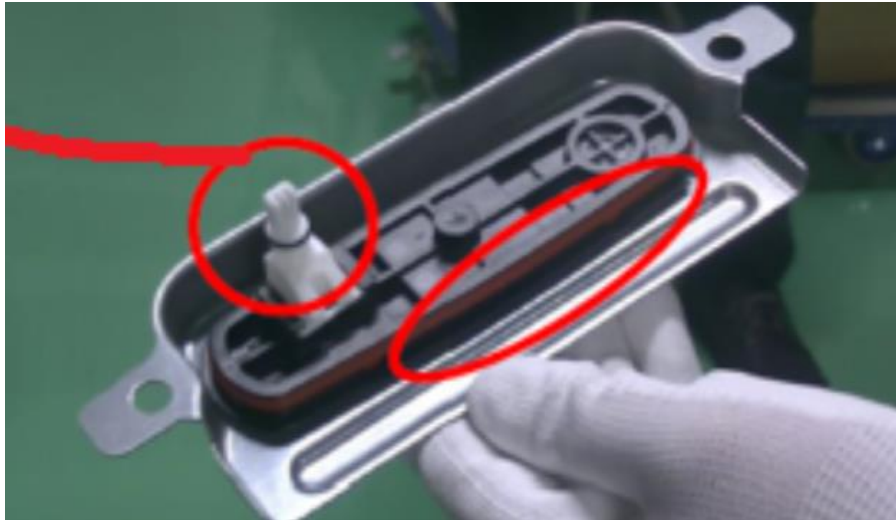
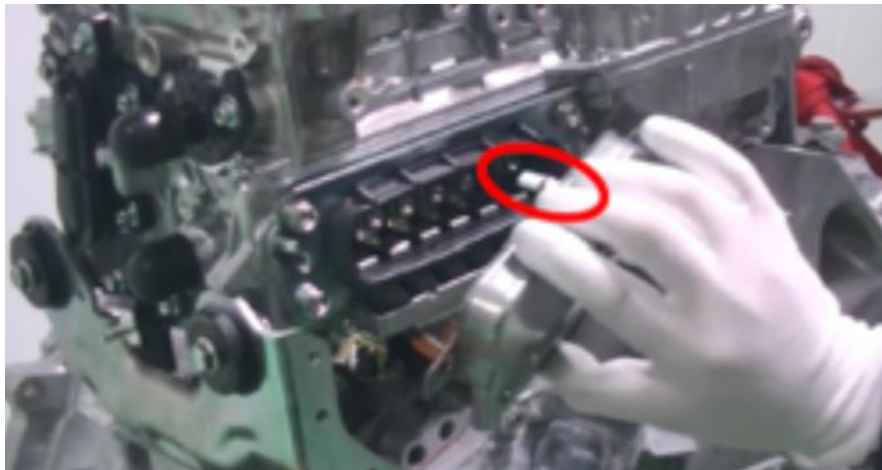
Caution: HVIL interlock pin could fall off, ensure position prior to reassembly.
Reference pictures 5 & 6 for correct placement of HVIL interlock pin.

HVIL Interlock Pin
