Subject: N262552010 - Customer Satisfaction Program  
Incorrect Power Seat Switch

Models: 2026 Cadillac OPTIQ

## N262552010 Incorrect Power Seat Switch

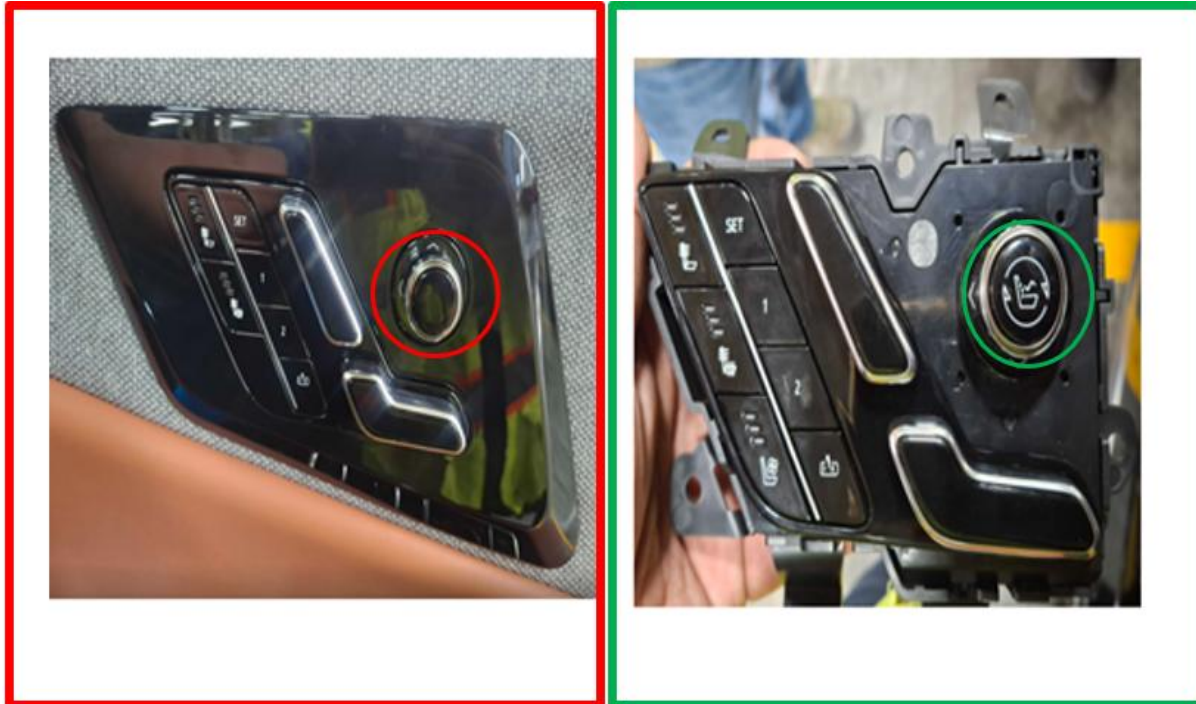
7135950

1. Inspect the Driver's side Front Seat Adjuster Switch. If the switch looks like the switch pictured on the left (red) the switch MUST be replaced, please proceed to step 2.

**Note: The suspect switch assembly will also be missing the ventilated seat button.**

If the switch looks like the switch on the right (green), no further action is required.

2. Replace the Driver's side Front Seat Adjuster Switch. Refer to *Front Seat Adjuster Switch Replacement* in SI.
