Complaints About Noises or Poor Windshield Wiper Wiping Performance

Topic number	LI82.30-P-059239
Version	14
Function group	82.30 - Windshield wipers
Date	5/19/26
Validity	All passenger car model series
Reason for change	Validity extended

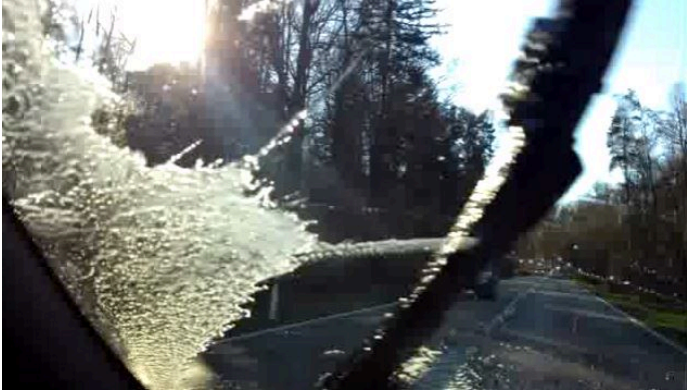
C: During the downward movement water is pulled back onto the windshield from the A-pillar (Figure 1)

Figure 1 - During the downward movement water is pulled back onto the windshield from the A-pillar
Bild 2.JPG	Figure 2 - After windshield cleaning, water keeps spraying onto the windshield for several wipe cycles

Water is pulled back onto the windshield by the differential pressure created as the wiper arm moves downwards.

Problem inherent in design for which there is no technical remedy.

Exception: X204 up to 02/2014. In these vehicles, it is possible to install the design configuration of vehicles as of 02/2014. This includes wiper arms (styled arms) with improved behavior in this respect. It is also necessary to replace the wiper blades because the styled arms feature a Top Lock connection (previously Side Lock). When installing the front-passenger-side wiper arm, observe the new park position (21 mm) via the marking on the windshield (Figure 4).

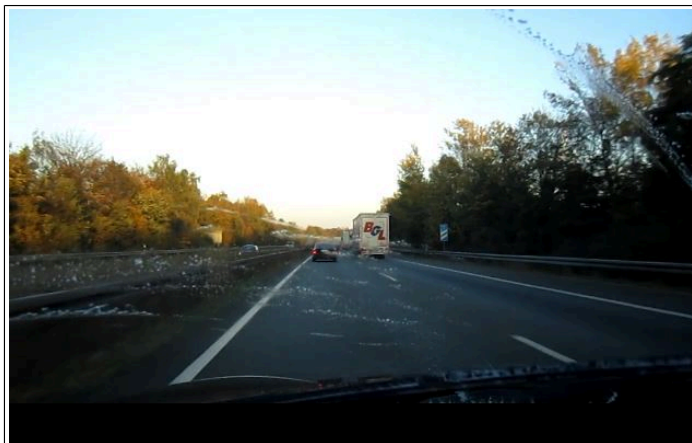
D: After windshield cleaning, water keeps spraying onto the windshield for several wipe cycles (Figure 2)

Washer water collects in the fastening of the wiper blade and is blown onto the windshield by the airstream over several wipe cycles.

Problem inherent in design for which there is no technical remedy.

Exception: model series 204 C-Class and model series 207. The wiper blades from model series 212 can be used on these vehicles to improve performance.

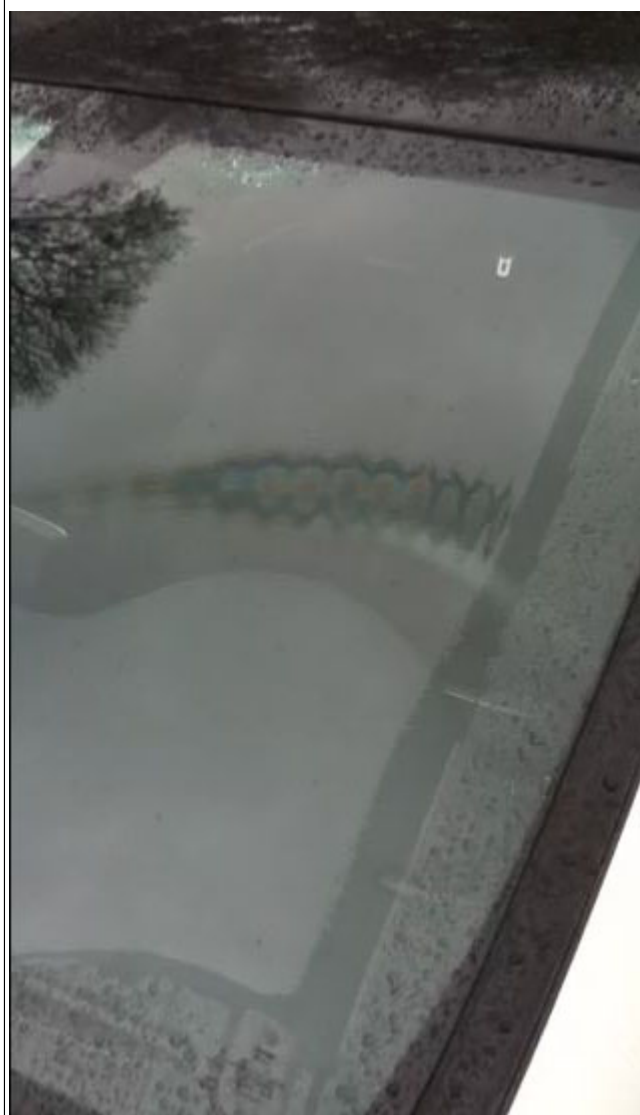
Bild 3.JPG

Figure 3 - Streaking due to excessive downforce of the wiper arm

B3: Downforce of wiper arm not OK (Figure 3)

B3: Check the wiper arm for excessive resistance in the bearing. Restore mobility or replace wiper arm if necessary.

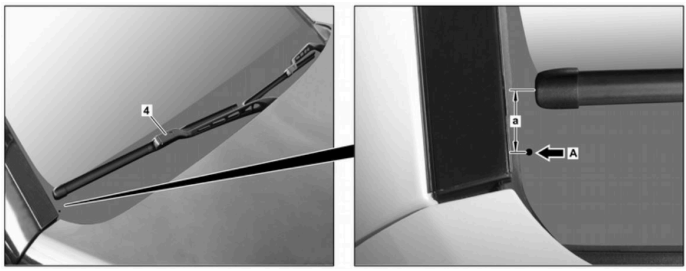
Attachments	
File	Description
Bild 4.JPG	Figure 4 - Park position of tip of blade on X204 passenger-side wiper arm with Top Lock
