AMG models with torque converter 725.0 (NAG3 Classic) and M177/ M279 engine - Harsh shift concerns due to speed sensor installation

Topic number	LI27.00-P-080462
Version	4
Function group	27.00 - General
Date	5/19/26
Validity	<p>Affects all 167 with M177 engine and transmission 725.085 (NAG3 Classic w/ torque converter) produced as of July 1, 2025</p> <p>Affects all 223 with M279 engine and transmission 725.095 (NAG3 Classic w/ torque converter) produced as of July 1, 2025</p> <p>Older models with 725.085/095 (NAG3 Classic w/ torque converter) transmissions were NOT affected in production, but may have received affected replacement parts (A725 270 55 09) during valve body replacement</p>
Reason for change	added part number

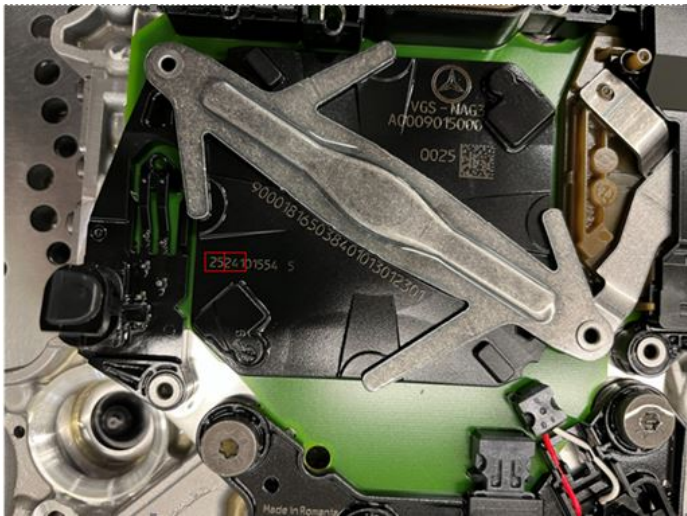
Figure 2
EEPROM txt file - ECU date code.png	Figure 1

This only affects vehicles with VGS control units produced between days 185-296 of 2025 (July 4, 2025-October 23, 2025).

1. Collect initial transmission EEPROM file
 2. Check EEPROM .txt file for VGS control unit serial number and production date (attachment figure 1)
- If the valve body is already removed, you can inspect the control unit for its stamped serial number (attachment figure 2)

The complete valve body will require replacement.

- Verify the new valve body production date is outside of day 185-296 of 2025 (attachment figure 2)
