AMG models with wet clutch 725.0 (NAG3 Classic) and M177 engine - Harsh shift concerns due to speed sensor installation

Topic number	LI27.60-P-080449
Version	2
Function group	27.60 - Gearshift, control
Date	5/19/26
Validity	Affects all 290 with M177 engine and transmission 725.096 (NAG3 Classic w/ wet clutch) produced as of July 1, 2025 Older models with 725.066/96 (NAG3 Classic w/ wet clutch) transmissions were not affected in production, but may have received affected replacement parts (A725 270 53 09) during valve body replacement.
Reason for change	updated dirt point

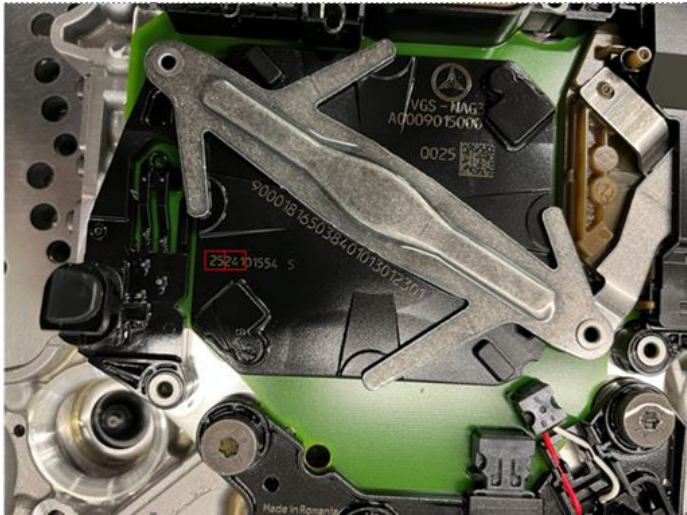
Attachments	
File	Description
Valve body - ECU serial number and date code.jpg	Figure 2

1. Collect initial transmission EEPROM file
 2. Check EEPROM .txt file for VGS control unit serial number and production date (attachment figure 1)
- If the valve body is already removed, you can inspect the control unit for its stamped serial number (attachment figure 2)

- Verify the new valve body production date is outside of day 185-296 of 2025 (attachment figure 2)

The complete valve body will require replacement.

1. Remove transmission oil pan & inspect fluid/pan/filter condition
- compare findings to extended fluid condition examples provided in Xentry blue book under general information for VGS
2. Replace complete EHS valve body, fill to near max fluid level, & complete initial start-up
- Ensure all oil guide pipes are installed in the new valve body to prevent a new concern after replacement. (See photos in WIS instructions)
