GROUP	MODEL
CHA	2021-2024MY Sorento (MQ4a) <u>and</u> 2023-2024MY Sportage (NQ5a)
NUMBER	DATE
126 (Rev 2, 05/06/2026)	October 2024

TECHNICAL SERVICE BULLETIN

FRONT BRAKE DISC REPLACEMENT & BURNISHING

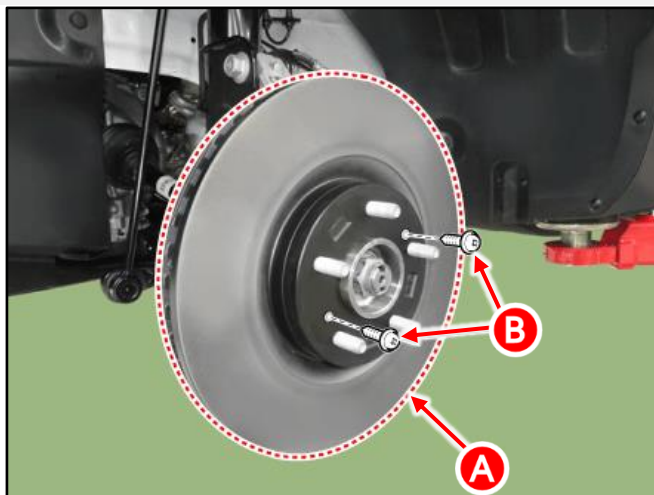
1. Replace **both** front brake discs (A) by referring to "Brake System → Brake System → Front Brake Disc → Repair procedures" in the applicable Shop Manual on KGIS.

Tightening torque for screws (B):
3.6 - 4.3 lb.ft (4.9 - 5.8 N.m)

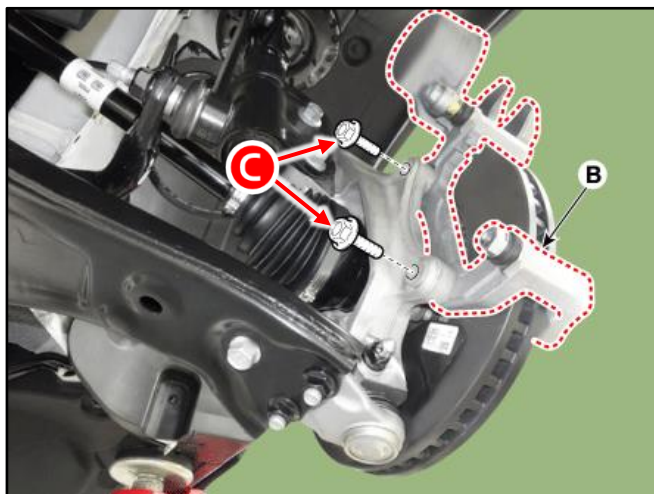
Flange bolts (C) are NOT reusable.
Install NEW parts. SST 09581 11000 is required.

Tightening torque for flange bolts (C):
72.3 - 86.8 lb.ft (98.1 - 117.7 N.m)
